NYC Department of Education
Building Condition Assessment Survey 2023 - 2024

Architectural Inspection

Asset: P.S. 129 - QUEENS, 128-02 7TH AVENUE, New York, 11356

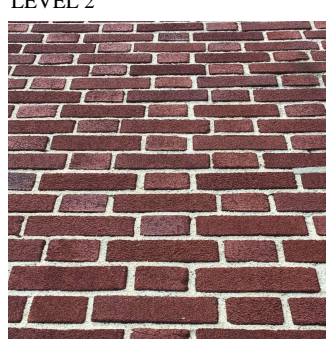
Question	Response
EXTERIOR	
AREAWAY	Inspected
Instance on AW1-AW3	Inspected
Instance Condition	2 - Between Good and Fair
Instance Quantity	3
Instance Quantity Uom	EACH
Deficiency	No deficiencies recorded
Instance on AW4	Inspected
Instance Condition	1 - Good
Instance Quantity	1
Instance Quantity Uom	EACH
Deficiency	No deficiencies recorded
AWNINGS AND CANOPIES	Inspected
Condition	2 - Between Good and Fair
Deficiency	No deficiencies recorded
CHIMNEY	Inspected
Material Type(s)	Masonry
Condition	3 - Fair
Deficiency	BRICK: DETERIORATED JOINTS
Roof Plan reference

Deficiency Quantity	200
Quantity Uom	S.F.
Potential Action	REPOINT
Urgency of Action	PRIORITY 3
Purpose of Action	LEVEL 2
Deficiency Photo1

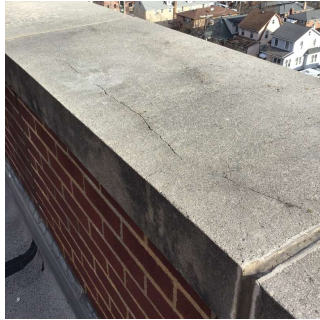
Roof 5
Violations	No violations recorded.
CORNICE	Does not Exist
DOORS	Inspected
DOORS AND FRAMES	Inspected
Condition	4 - Between Fair and Poor
Deficiency	METAL: DETERIORATED DOOR AND FRAME - MAJOR DETERIORATION
Roof Plan reference

CAST STONE: DISINTEGRATING / FREEZE THAW

Question	Response
EXTERIOR	
COPING	
Quantity Uom	L.F.
Potential Action	REPLACE-IN-KIND
Urgency of Action	PRIORITY 4
Purpose of Action	LEVEL 2
Deficiency Photo1

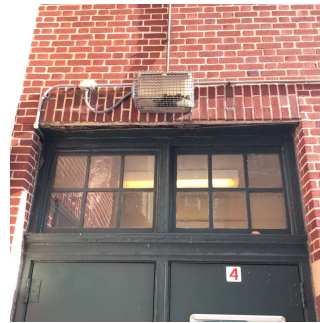
Facade E - Exit 4

STEEL: MAJOR RUSTING

20
 L.F.
 REPLACE
 PRIORITY 4
 LEVEL 2

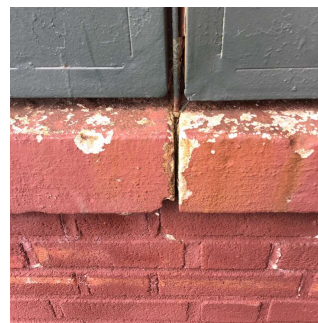
Facade F

BRICK: MASONRY SILLS - DETERIORATED JOINTS

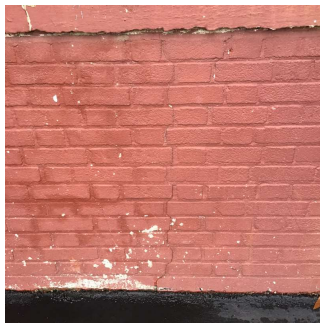
BRICK: MINOR CRACKS AND SPALLING

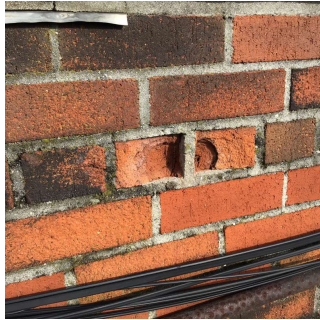
BRICK: MAJOR DETERIORATION/CRACKS

Question	Response
EXTERIOR	
PARAPETS	
Quantity Uom	S.F.
Potential Action	REMOVE AND REBUILD
Urgency of Action	PRIORITY 4
Purpose of Action	LEVEL 2
Deficiency Photo1

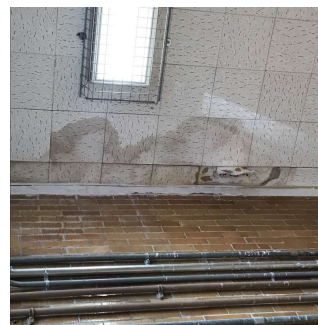
Roof 2 - Gymnasium (Roof 2 - Rooms 352A, 352E similar)

Deficiency **BUILT-UP: ROOFING: MAJOR ACTIVE ROOF LEAKS IN INSTRUCTIONAL SPACE**

300
 S.F.
 REPLACE ROOFING WITHOUT MAJOR EQUIPMENT
 REMOVAL
 PRIORITY 5
 LEVEL 2

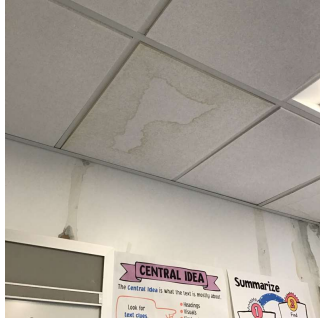
Roof 7
Instance Quantity	12,500
Instance Quantity Uom	S.F.
Does the roof have major mechanical equipment sitting on Dunnage Steel less than 18" above the Roofing?	No
Does this roof instance have a Sustainable Roof System?	No
Do solar panels exist on these roofs?	No
Is/Are the roof(s) suitable for Solar Panel installation?	No
Installation Year	2020
Source of Installation	Custodial Staff
Deficiency	IRMA: ROOFING: MAJOR ACTIVE ROOF LEAKS IN INSTRUCTIONAL SPACE
Roof Plan reference

Deficiency Quantity	200
Quantity Uom	S.F.
Potential Action	REPLACE ROOFING WITHOUT MAJOR EQUIPMENT REMOVAL
Urgency of Action	PRIORITY 5
Purpose of Action	LEVEL 2

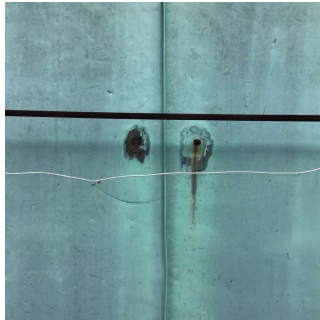
Violations	BH1 No violations recorded.
Deficiency	BULKHEAD/PENTHOUSE WALLS/INTERIOR: PLASTER CRACKS/SPALLING

Roof 7 - Room 386 (Roof 7 - Room 383 similar)
Violations	No violations recorded.
ROOFING DRAINS	Inspected
Condition	2 - Between Good and Fair
Deficiency	No deficiencies recorded
Specialties	Inspected
BULKHEAD/PENTHOUSE	Inspected
Condition	3 - Fair
Deficiency	BULKHEAD/PENTHOUSE WALLS/EXTERIOR: DAMAGED METAL SIDING
Roof Plan reference

Deficiency Quantity	20
Quantity Uom	S.F.
Potential Action	REPLACE
Urgency of Action	PRIORITY 4
Purpose of Action	LEVEL 2
Deficiency Photo1

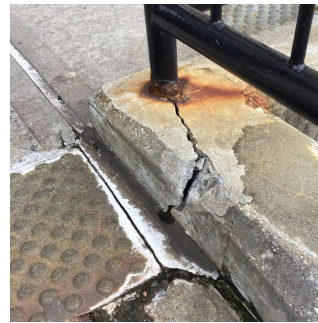
Facade A

CAST IN PLACE CONCRETE: CRACKS/SPALLING - MAJOR

20
 S.F.
 REPLACE
 PRIORITY 4
 LEVEL 2

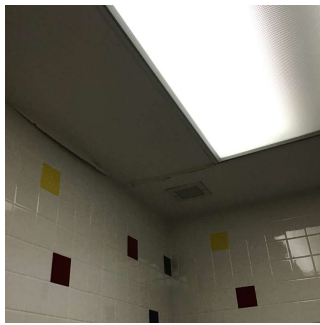
Question	Response
INTERIOR	
TOILET ROOMS - STUDENTS	
Ceiling	
Deficiency Photo1
