**NYC Department of Education**  
**Building Condition Assessment Survey 2023 - 2024**

Architectural Inspection

**Asset:** P.S. 132 - QUEENS, 132-15 218 STREET, New York, 11413

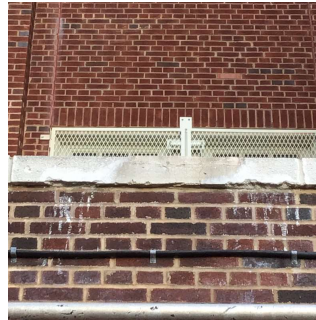
Roof 5

<b>COPING</b>	
Condition	Inspected
Condition	3 - Fair
Deficiency	CAST STONE: CRACKED/BROKEN PIECES
Roof Plan reference	<p>Q132</p> <p align="center">218th Street</p>
Deficiency Quantity	20
Quantity Uom	L.F.
Potential Action	REPLACE-IN-KIND
Urgency of Action	PRIORITY 4
Purpose of Action	LEVEL 2

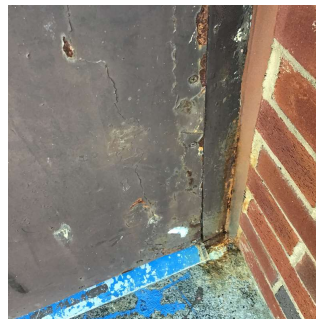
Facade E

METAL CLAD: DETERIORATED DOOR AND FRAME - MAJOR DETERIORATION

REPLACE

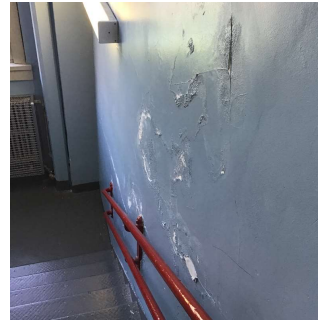
Facade F - Stair C

Violations	Facade E No violations recorded.
<b>EXTERIOR WALLS</b>	Inspected
Material Type(s)	Masonry
Replacement Quantity	38,000
Replacement Uom	S.F.
Instance on All Facades	Inspected
Instance Condition	3 - Fair
Instance Quantity	38,000
Instance Quantity Uom	S.F.
Deficiency	BRICK: WATER INFILTRATION IN INSTRUCTIONAL SPACE
Roof Plan reference	Q132

Deficiency Quantity	100
Quantity Uom	S.F.
Potential Action	REPAIR
Urgency of Action	PRIORITY 5
Purpose of Action	LEVEL 2

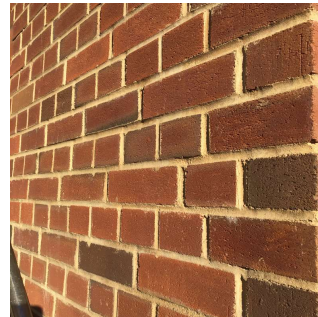
Facade D

**BRICK: DETERIORATED JOINTS**

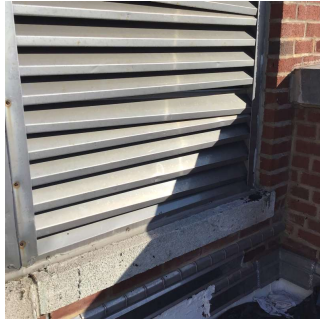
Deficiency Quantity	1,000
Quantity Uom	S.F.
Potential Action	MAINTENANCE
Urgency of Action	PRIORITY 1
Purpose of Action	LEVEL 1
Deficiency Photo	No photo recorded
Violations	No violations recorded.
<b>EXTERIOR SOFFITS</b>	Does not Exist
<b>LOADING DOCK</b>	Does not Exist
<b>LOUVER</b>	Inspected
Condition	3 - Fair
Deficiency	<b>BROKEN/ DENTED BLADES</b>
Roof Plan reference	Q132

Deficiency Quantity	20
Quantity Uom	S.F.
Potential Action	REPLACE
Urgency of Action	PRIORITY 4
Purpose of Action	LEVEL 2

Violations	Roof 1 - Roof vent No violations recorded.
<b>PARAPETS</b>	Inspected
Material Type(s)	Masonry
Replacement Quantity	5,200
Replacement Uom	C.F.
Instance on All Facades	Inspected
Instance Condition	3 - Fair
Instance Quantity	5,200
Instance Quantity Uom	C.F.
Deficiency	<b>BRICK: DETERIORATED JOINTS</b>
Roof Plan reference	Q132

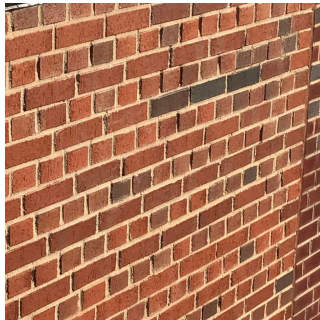
Deficiency Quantity	30
Quantity Uom	S.F.
Potential Action	REPOINT
Urgency of Action	PRIORITY 4
Purpose of Action	LEVEL 2
Deficiency Photo1

Violations	Roof 1 No violations recorded.
Deficiency	<b>BRICK: EFFLORESCENCE</b>

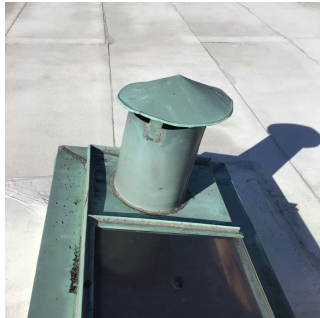
SHAFT VENTS DAMAGED

Deficiency Quantity	1
Quantity Uom	EACH
Potential Action	MAINTENANCE
Urgency of Action	PRIORITY 3
Purpose of Action	LEVEL 2

Violations	Roof 1 No violations recorded.
<b>ROOF/GRAVITY TANK</b>	Does not Exist
<b>STAIRS/RAMPS: EXTERIOR</b>	Inspected
<b>BUILDING CHEEK/FLANK WALLS</b>	Inspected
Condition	2 - Between Good and Fair
Deficiency	BRICK: CRACKS/SPALLING - MINOR
Roof Plan reference	Q132

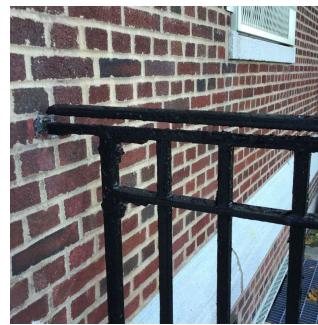
Facade A  
No violations recorded.

Violations	Facade D No violations recorded.
<b>RAILINGS</b>	Inspected
Condition	5 - Poor
Deficiency	RUST - MAJOR

40  
L.F.  
REPLACE  
PRIORITY 5  
LEVEL 6

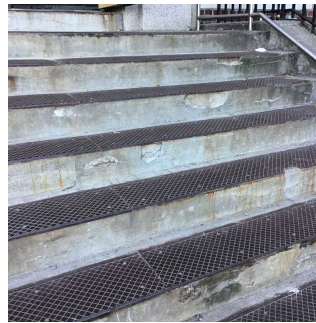
Facade A

CONCRETE: WORN-OUT TREAD/RISER/NOSING

30  
S.F.  
REPLACE  
PRIORITY 4  
LEVEL 2

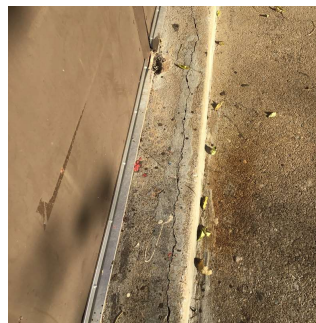
Facade D

**CONCRETE: CRACKS/SPALLING - MINOR**

10  
S.F.  
REPAIR  
PRIORITY 3  
LEVEL 2

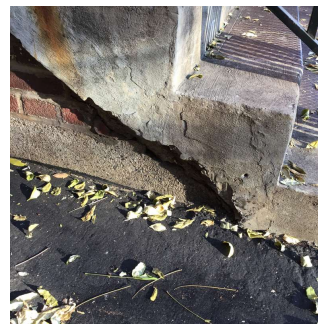
Facade D

**CONCRETE: CRACKS/SPALLING - MAJOR**

10  
S.F.  
REPLACE  
PRIORITY 4  
LEVEL 2

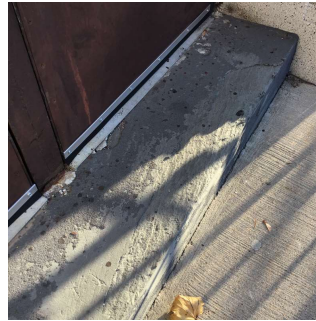
Facade G

**STONE: WORN-OUT TREAD/RISER/NOSING**

40  
S.F.  
REPLACE  
PRIORITY 4  
LEVEL 2

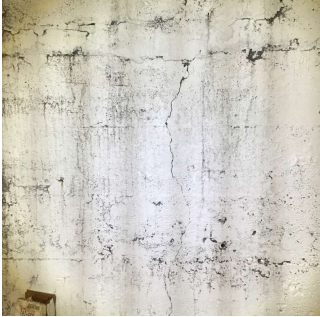
Question	Response
<b>INTERIOR</b>	
<b>STRUCTURAL</b>	
<b>COLUMNS/BEAMS/BEARING WALLS</b>	Inspected
Violations	Basement - Fan Area No violations recorded.
<b>FLOOR STRUCTURE</b>	Inspected
Condition	2 - Between Good and Fair
Deficiency	No deficiencies recorded
<b>FOUNDATION WALLS</b>	Inspected
Material Type(s)	Concrete
Condition	2 - Between Good and Fair
Deficiency	CONCRETE: CRACKED/SPALLED/REINFORCEMENT EXPOSED
Deficiency Location/Instance	Basement - Storage
Deficiency Quantity	10
Quantity Uom	S.F.
Potential Action	REPAIR
Urgency of Action	PRIORITY 3
Purpose of Action	LEVEL 5
Deficiency Photo1

Violations	Basement - Fan Area No violations recorded.
<b>ROOF STRUCTURE</b>	Inspected
Condition	2 - Between Good and Fair
Deficiency	No deficiencies recorded
<b>VAULTS-BUNKERS</b>	Inspected
<b>Foundation Walls</b>	Inspected
Condition	2 - Between Good and Fair
Deficiency	CRACKS, SPALLING
Deficiency Location/Instance	Basement - Fan Area

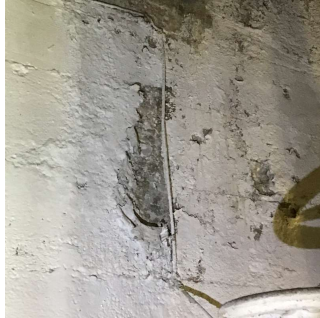
Deficiency Quantity	10
Quantity Uom	S.F.
Potential Action	REPAIR
Urgency of Action	PRIORITY 3
Purpose of Action	LEVEL 5

Violations	Basement - Fan Area No violations recorded.
<b>Slab Structure</b>	Inspected
Condition	3 - Fair
Deficiency	CONCRETE: WATER INFILTRATION IN NON- INSTRUCTIONAL SPACE
Deficiency Location/Instance	Basement - Fan Area
Deficiency Quantity	50
Quantity Uom	S.F.
Potential Action	INSTALL WATERPROOFING
Urgency of Action	PRIORITY 5
Purpose of Action	LEVEL 5
Deficiency Photo1

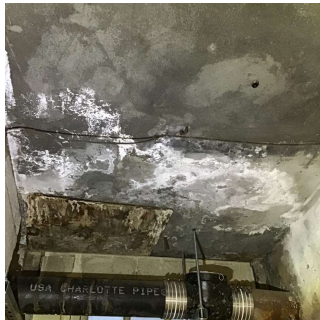
Violations	Basement - Fan Area No violations recorded.
<b>Vault/Ash Hoist Doors and Framing</b>	Inspected
Condition	5 - Poor
Deficiency	WATER INFILTRATION
Deficiency Location/Instance	Basement - Ash Hoist Vault
Deficiency Quantity	10
Quantity Uom	S.F.
Potential Action	REPAIR
Urgency of Action	PRIORITY 5
Purpose of Action	LEVEL 2

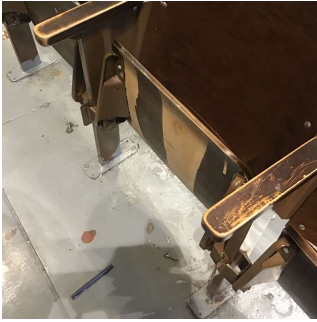
Violations	Entrance No violations recorded.
<b>Fixed H/C Lift</b>	
Instance on 1st Floor (Seats 562)	Does not Exist
<b>Fixed Seating</b>	
Instance on 1st Floor (Seats 562)	Inspected
Condition	5 - Poor
Deficiency	DAMAGED/BROKEN/INOPERABLE
Deficiency Location/Instance	Seat C/4,14,16, F/3,7, and others
Deficiency Quantity	73
Quantity Uom	EACH
Potential Action	REPLACE
Urgency of Action	PRIORITY 3
Purpose of Action	LEVEL 2
Deficiency Photo1

Violations	Seat C/4 No violations recorded.
Deficiency	DAMAGED/BROKEN/INOPERABLE
Deficiency Location/Instance	Seat A/2, B/6, E/20, G/2,8,Q/13,R/15
Deficiency Quantity	3
Quantity Uom	EACH
Potential Action	REPLACE
Urgency of Action	PRIORITY 5
Purpose of Action	LEVEL 6

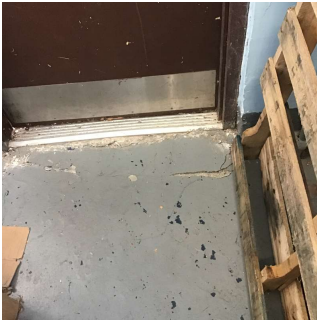
Question	Response
<b>INTERIOR</b>	
<b>AUDITORIUM</b>	
<b>Fixed Seating</b>	
Deficiency Photo1	 
	Seat A/2
Violations	No violations recorded.
<b>Floor Finish</b>	
Instance on 1st Floor (Seats 562)	Inspected
Condition	2 - Between Good and Fair
Deficiency	CONCRETE: CRACKS
Deficiency Location/Instance	Exit 10
Deficiency Quantity	15
Quantity Uom	S.F.
Potential Action	REPLACE
Urgency of Action	PRIORITY 3
Purpose of Action	LEVEL 2
Deficiency Photo1

Exit 10
Violations	No violations recorded.
<b>Sliding-folding Partition</b>	
Instance on 1st Floor (Seats 562)	Does not Exist
<b>Stage</b>	
Instance on 1st Floor (Seats 562)	Inspected
<b>Stage</b>	
Instance on 1st Floor (Seats 562)	Inspected
Condition	2 - Between Good and Fair
Deficiency	DAMAGED FLOOR
Deficiency Location/Instance	Along Front Right Side
Deficiency Quantity	20
Quantity Uom	S.F.
Potential Action	REPLACE
Urgency of Action	PRIORITY 3
Purpose of Action	LEVEL 2

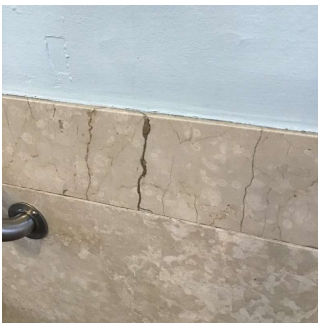
Deficiency	STONE MOLDINGS: CRACKS/SPALLING
Deficiency Location/Instance	Left Side of Stage, Along Windows Both Side, Rear
Deficiency Quantity	100
Quantity Uom	L.F.
Potential Action	REPLACE
Urgency of Action	PRIORITY 3
Purpose of Action	LEVEL 2

Left Side of Stage
Violations	No violations recorded.
<b>Window Curtains/Shades/Blinds</b>	
Instance on 1st Floor (Seats 562)	Inspected
Condition	2 - Between Good and Fair
Deficiency	No deficiencies recorded
<b>CAFETERIA</b>	
Instance on 1st Floor	Inspected
<b>Ceiling</b>	
Instance on 1st Floor	Inspected
Condition	2 - Between Good and Fair
Deficiency	ACOUSTIC TILES ON PLASTER: DAMAGED/MISSING
Deficiency Location/Instance	Near Drinking Fountain, Near Exit 5/6, Near Exit 2
Deficiency Quantity	30
Quantity Uom	S.F.
Potential Action	REPLACE
Urgency of Action	PRIORITY 3
Purpose of Action	LEVEL 2
Deficiency Photo1

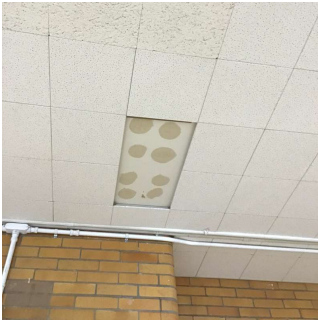
Near Drinking Fountain
Violations	No violations recorded.
<b>Door(s)</b>	
Instance on 1st Floor	Inspected
Condition	3 - Fair
Deficiency	WOOD: DETERIORATED DOOR
Deficiency Location/Instance	Near Girls Restroom
Deficiency Quantity	1

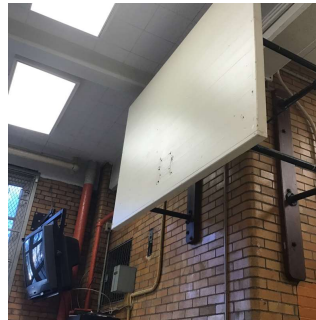
Instance on 1st Floor	Inspected
Condition	3 - Fair
Deficiency	DAMAGED/MISSING
Deficiency Location/Instance	Near Exit 2
Deficiency Quantity	1
Quantity Uom	EACH
Potential Action	MAINTENANCE
Urgency of Action	PRIORITY 3
Purpose of Action	LEVEL 2
Deficiency Photo1

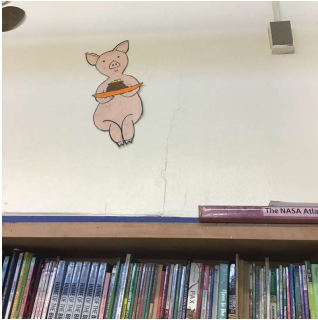
Violations	Center No violations recorded.
<b>Walls</b>	
Instance on Room 209	Inspected
Condition	2 - Between Good and Fair
Deficiency	PLASTER: CRACKS/SPALLING
Deficiency Location/Instance	Right Side
Deficiency Quantity	15
Quantity Uom	S.F.
Potential Action	REPLACE
Urgency of Action	PRIORITY 3
Purpose of Action	LEVEL 2
Deficiency Photo1

Violations	Right Side No violations recorded.
<b>LOCKER ROOM</b>	Does not Exist
<b>MULTI-PURPOSE ROOM</b>	Does not Exist
<b>SCIENCE DEMO ROOM</b>	Does not Exist
<b>SCIENCE LAB</b>	Does not Exist
<b>SCIENCE PREP ROOM</b>	Does not Exist

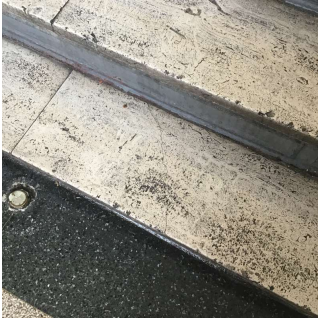
Violations	Main Entrance Vestibule No violations recorded.
<b>Stairs and Landings</b>	
Condition	Inspected 3 - Fair
Deficiency	STONE: BROKEN/MISSING
Deficiency Location/Instance	Exits 7,8 Vestibules
Deficiency Quantity	90
Quantity Uom	S.F.
Potential Action	REPLACE
Urgency of Action	PRIORITY 3
Purpose of Action	LEVEL 2
Deficiency Photo1

Violations	Exit 7 Vestibule No violations recorded.
Deficiency	STONE: WORN-OUT TREAD/NOSINGS
Deficiency Location/Instance	Stair A/2,1
Deficiency Quantity	10
Quantity Uom	S.F.
Potential Action	REPLACE
Urgency of Action	PRIORITY 3
Purpose of Action	LEVEL 2

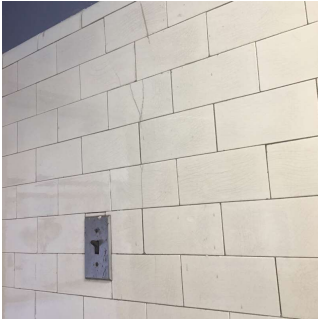
Room 357
Violations	No violations recorded.
<b>Stalls</b>	
Condition	Inspected
Deficiency	2 - Between Good and Fair
Deficiency	No deficiencies recorded
<b>Walls</b>	
Condition	Inspected
Deficiency	2 - Between Good and Fair
Deficiency	CERAMIC TILE: BROKEN/ MISSING
Deficiency Location/Instance	Rooms 360,358,357, 258
Deficiency Quantity	40
Quantity Uom	S.F.
Potential Action	REPLACE
Urgency of Action	PRIORITY 3
Purpose of Action	LEVEL 2
Deficiency Photo1

Room 357
Violations	No violations recorded.
Deficiency	PLASTER: CRACKS/SPALLING
Deficiency Location/Instance	Room 357
Deficiency Quantity	15
Quantity Uom	S.F.
Potential Action	REPLACE
Urgency of Action	PRIORITY 3
Purpose of Action	LEVEL 2

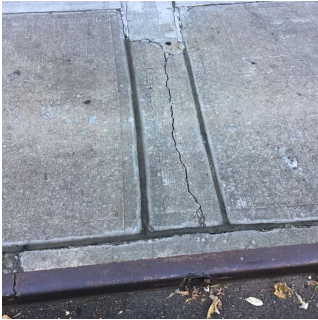
Violations	132nd Avenue No violations recorded.
<b>Drainage System for Asphalt</b>	Inspected
<b>Catch Basins/Manhole - Surrounded by asphalt</b>	Inspected
Condition	1 - Good
Deficiency	No deficiencies recorded
<b>Culverts - Asphalt Covering</b>	Does not Exist
<b>Drainage System for Concrete</b>	Inspected
<b>Catch Basins/Manhole - Surrounded by concrete</b>	Inspected
Condition	2 - Between Good and Fair
Deficiency	No deficiencies recorded
<b>Culverts - Concrete Covering</b>	Inspected
Condition	2 - Between Good and Fair
Deficiency	DAMAGED
Deficiency Location/Instance	132nd Avenue
Deficiency Quantity	25
Quantity Uom	L.F.
Potential Action	REPLACE
Urgency of Action	PRIORITY 3
Purpose of Action	LEVEL 2
Deficiency Photo1

Violations	132nd Avenue No violations recorded.
<b>Drainage System for Soil</b>	Does not Exist
<b>DRINKING FOUNTAINS</b>	Does not Exist

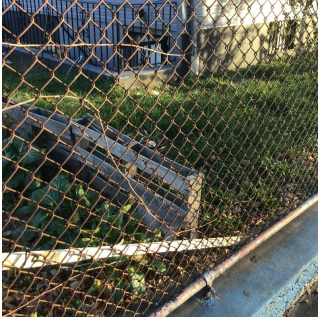
Violations	Rear Schoolyard No violations recorded.
Deficiency	CHAIN LINK: RUST - MAJOR
Deficiency Location/Instance	Rear Schoolyard
Deficiency Quantity	900
Quantity Uom	S.F.
Potential Action	REPLACE
Urgency of Action	PRIORITY 3
Purpose of Action	LEVEL 2
Deficiency Photo1

Violations	Rear Schoolyard No violations recorded.
Deficiency	CONCRETE CURB: DAMAGED/DETERIORATED
Deficiency Location/Instance	218th Street, 132nd Avenue
Deficiency Quantity	80
Quantity Uom	S.F.
Potential Action	REPLACE
Urgency of Action	PRIORITY 3
Purpose of Action	LEVEL 2

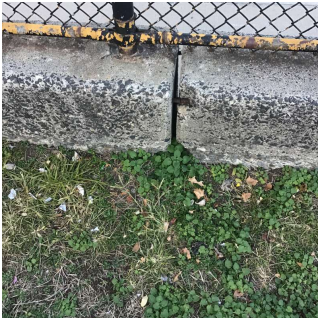
132nd Avenue
Violations	No violations recorded.
Deficiency	CAST IN PLACE CONCRETE: DETERIORATED CONTROL/EXPANSION JOINT
Deficiency Location/Instance	132nd Avenue
Deficiency Quantity	20
Quantity Uom	L.F.
Potential Action	REPLACE
Urgency of Action	PRIORITY 3
Purpose of Action	LEVEL 2
Deficiency Photo1

132nd Avenue
Violations	No violations recorded.
<b>SEATING</b>	Inspected
<b>Benches</b>	Inspected
