**NYC Department of Education**  
**Building Condition Assessment Survey 2023 - 2024**

Architectural Inspection

**Asset:** M.S. 137 - QUEENS, 109-15 98TH STREET, New York, 11417

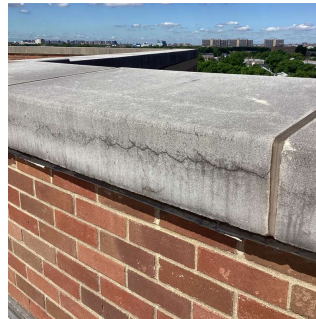
Roof 1

10  
 L.F.  
 REPLACE-IN-KIND  
 PRIORITY 4  
 LEVEL 2

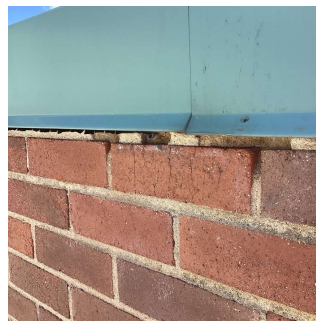
Roof 1

**METAL: DETERIORATED JOINTS**

10  
 L.F.  
 REPAIR  
 PRIORITY 3  
 LEVEL 2

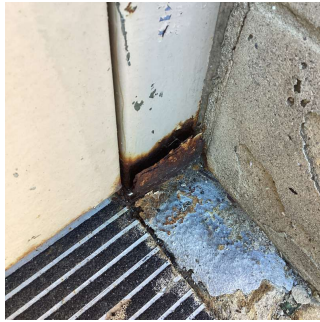
Question	Response
<b>EXTERIOR</b>	
<b>CORNICE</b>	Does not Exist
<b>DOORS</b>	Inspected
<b>DOORS AND FRAMES</b>	Inspected
Condition	5 - Poor
Deficiency	METAL: DETERIORATED DOOR AND FRAME - MAJOR DETERIORATION
Roof Plan reference	Q137

Deficiency Quantity	10
Quantity Uom	EACH
Potential Action	REPLACE
Urgency of Action	PRIORITY 4
Purpose of Action	LEVEL 2
Deficiency Photo1

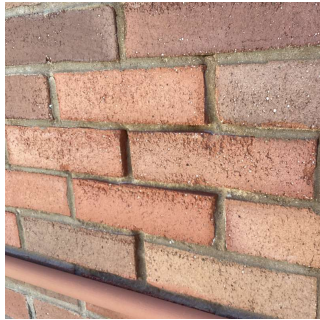
Question	Response
<b>EXTERIOR</b>	
<b>PARAPETS</b>	
Replacement Quantity	9,800
Replacement Uom	C.F.
Instance on All Facades	Inspected
Instance Condition	4 - Between Fair and Poor
Instance Quantity	9,800
Instance Quantity Uom	C.F.
Deficiency	BRICK: DETERIORATED JOINTS
Roof Plan reference	Q137

Deficiency Quantity	100
Quantity Uom	S.F.
Potential Action	REPOINT
Urgency of Action	PRIORITY 4
Purpose of Action	LEVEL 2
Deficiency Photo1

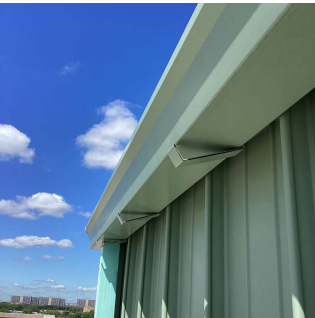
Question	Response
<b>EXTERIOR</b>	
<b>ROOF</b>	
<b>Roofing</b>	
<b>LEADERS, GUTTERS, DOWNSPOUTS, SCUPPERS</b>	
Roof Plan reference

Deficiency Quantity	20
Quantity Uom	L.F.
Potential Action	REPLACE
Urgency of Action	PRIORITY 4
Purpose of Action	LEVEL 2
Deficiency Photo1

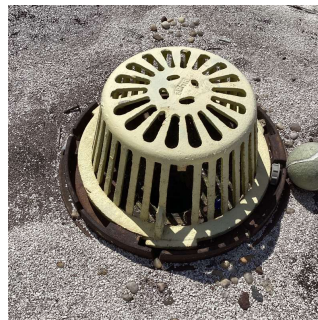
Roof 1	No violations recorded.
--------	-------------------------

Condition	Inspected
Deficiency	4 - Between Fair and Poor
Roof Plan reference	Q137

Deficiency Quantity	2
Quantity Uom	EACH
Potential Action	REPLACE
Urgency of Action	PRIORITY 4
Purpose of Action	LEVEL 2

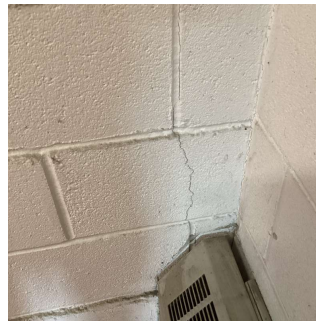
Roof 1 - Bulkhead 2

**BULKHEAD/PENTHOUSE WALLS/INTERIOR: CMU  
 CRACKS/SPALLING**

REPLACE

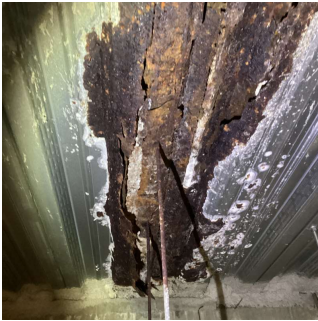
Structural Condition Type	Condition Description	Component Affected	Location Description	Person(s) Notified	Person(s) Title	PhotoImage
Deteriorated Steel	Severely deteriorated composite concrete metal deck floor structure is a potential structural hazard.	INTERIOR   STRUCTURAL   FLOOR STRUCTURE	Basement - Chiller Room Crawl Space	Rennie Heeraall	Cleaner

Question	Response
<b>EXTERIOR</b>	Inspected
<b>WINDOWS</b>	
<b>WINDOWS</b>	
Are these windows insulated	No
Installation Year	2002
Source of Installation	Custodial Staff
Deficiency	No deficiencies recorded
<b>INTERIOR</b>	Inspected
<b>POOLS</b>	Does not Exist
<b>STRUCTURAL</b>	Inspected
<b>COLUMNS/BEAMS/BEARING WALLS</b>	Inspected
Condition	2 - Between Good and Fair
Deficiency	No deficiencies recorded
<b>FLOOR STRUCTURE</b>	Inspected
Condition	4 - Between Fair and Poor
Deficiency	METAL DECK AND CONCRETE: DETERIORATED
Deficiency Location/Instance	Basement - Chiller Room Crawl Space
Deficiency Quantity	100
Quantity Uom	S.F.
Potential Action	REPAIR
Urgency of Action	PRIORITY 5
Purpose of Action	LEVEL 6
Deficiency Photo1

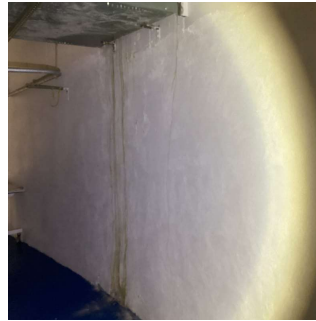
Violations	Basement - Chiller Room Crawl Space No violations recorded.
<b>FOUNDATION WALLS</b>	Inspected
Material Type(s)	Concrete
Condition	4 - Between Fair and Poor
Deficiency	CONCRETE: WATER INFILTRATION IN ELECTRICAL PANEL ROOM

Deficiency Location/Instance	Basement - Electrical Panel Room
Deficiency Quantity	100
Quantity Uom	S.F.
Potential Action	INSTALL WATERPROOFING
Urgency of Action	PRIORITY 5
Purpose of Action	LEVEL 6

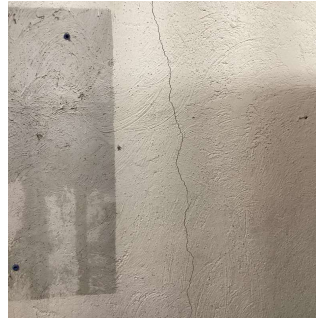
Basement - Boiler Room

CONCRETE: CRACKED/SPALLED/REINFORCEMENT EXPOSED

REPAIR

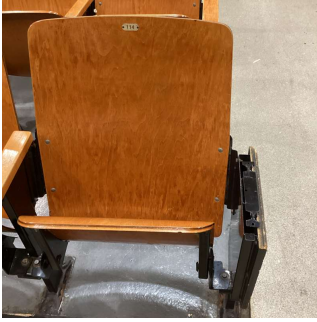
Violations	Roof 1 - Generator Room No violations recorded.
<b>VAULTS-BUNKERS</b>	Does not Exist
<b>AUDITORIUM</b>	Inspected
Instance on 1st Floor (557 Seats)	Inspected
<b>Ceiling</b>	
Instance on 1st Floor (557 Seats)	Inspected
Condition	2 - Between Good and Fair
Deficiency	No deficiencies recorded
<b>Door(s)</b>	
Instance on 1st Floor (557 Seats)	Inspected
Condition	2 - Between Good and Fair
Deficiency	No deficiencies recorded
<b>Fixed H/C Lift</b>	
Instance on 1st Floor (557 Seats)	Does not Exist
<b>Fixed Seating</b>	
Instance on 1st Floor (557 Seats)	Inspected
Condition	3 - Fair
Deficiency	DAMAGED/BROKEN/INOPERABLE
Deficiency Location/Instance	Seats B/114, C/9
Deficiency Quantity	2
Quantity Uom	EACH
Potential Action	REPLACE
Urgency of Action	PRIORITY 5
Purpose of Action	LEVEL 6
Deficiency Photo1

Violations	Seat B/114 No violations recorded.

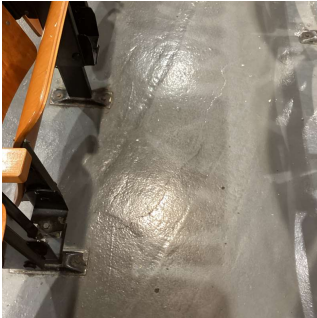
Question	Response
<b>INTERIOR</b>	
<b>AUDITORIUM</b>	
<b>Fixed Seating</b>	
Deficiency Quantity	17
Quantity Uom	EACH
Potential Action	REPLACE
Urgency of Action	PRIORITY 3
Purpose of Action	LEVEL 2
Deficiency Photo1	 
	Seat P/114
Violations	No violations recorded.
<b>Floor Finish</b>	
Instance on 1st Floor (557 Seats)	Inspected
Condition	2 - Between Good and Fair
Deficiency	CONCRETE: CRACKS
Deficiency Location/Instance	Utility Room, Near Seats F/10, P/111
Deficiency Quantity	30
Quantity Uom	S.F.
Potential Action	REPLACE
Urgency of Action	PRIORITY 3
Purpose of Action	LEVEL 2
Deficiency Photo1

Near Seat F/10
Violations	No violations recorded.
<b>Sliding-folding Partition</b>	
Instance on 1st Floor (557 Seats)	Does not Exist
<b>Stage</b>	
Instance on 1st Floor (557 Seats)	Inspected
<b>Stage</b>	
Instance on 1st Floor (557 Seats)	Inspected
Condition	2 - Between Good and Fair
Deficiency	No deficiencies recorded
<b>Stage Curtain Rigging</b>

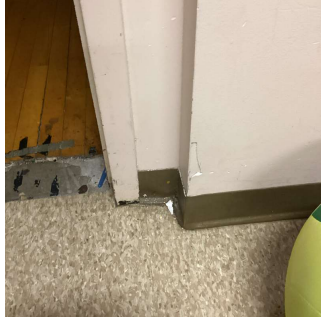
Utility Room  
 No violations recorded.

Instance on 1st Floor (557 Seats)	Inspected
Condition	2 - Between Good and Fair
Deficiency	GYPSUM BOARD: DETERIORATED
Deficiency Location/Instance	Utility Room, Stage Area
Deficiency Quantity	20
Quantity Uom	S.F.
Potential Action	REPLACE
Urgency of Action	PRIORITY 3
Purpose of Action	LEVEL 2
Deficiency Photo1

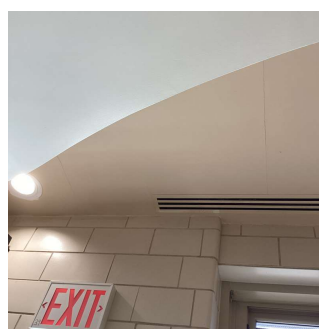
Instance on 1st Floor	Inspected
Condition	2 - Between Good and Fair
Deficiency	GYPSUM BOARD: DAMAGED/DETERIORATED
Deficiency Location/Instance	Near Windows, Serving Area
Deficiency Quantity	20
Quantity Uom	S.F.
Potential Action	REPLACE
Urgency of Action	PRIORITY 3
Purpose of Action	LEVEL 2

Near Windows No violations recorded.
Deficiency Deficiency Location/Instance Deficiency Quantity Quantity Uom Potential Action Urgency of Action Purpose of Action Deficiency Photo1            Violations	PLASTER: CRACKS/SPALLING Near Windows 10 S.F. REPLACE PRIORITY 3 LEVEL 2

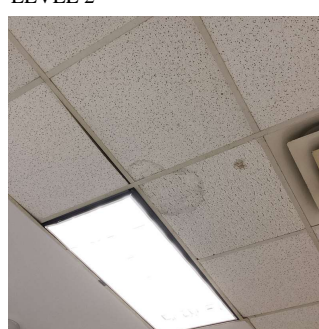
Near Windows No violations recorded.
Deficiency Deficiency Location/Instance Deficiency Quantity Quantity Uom Potential Action Urgency of Action Purpose of Action Deficiency Photo1            Violations	ACOUSTIC TILES: DAMAGED/MISSING Near Center, Entrance, Windows 60 S.F. REPLACE PRIORITY 3 LEVEL 2

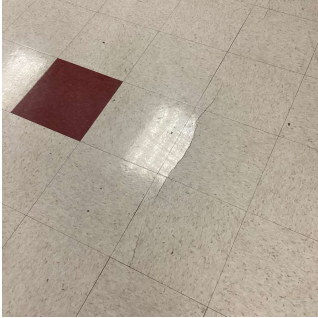
Question	Response
<b>INTERIOR</b>	
<b>CAFETERIA</b>	
<b>Door(s)</b>	
Instance on 1st Floor	Inspected
Condition	2 - Between Good and Fair
Deficiency	No deficiencies recorded
<b>Fixed Equipment</b>	
Instance on 1st Floor	Does not Exist
<b>Floor Finish</b>	
Instance on 1st Floor	Inspected
Condition	3 - Fair
Deficiency	VINYL TILES: BROKEN/DETERIORATED/MISSING TILES
Deficiency Location/Instance	Near Room 128B, Expansion Joins, Serving Area
Deficiency Quantity	130
Quantity Uom	S.F.
Potential Action	REPLACE
Urgency of Action	PRIORITY 3
Purpose of Action	LEVEL 2
Deficiency Photo1

Violations	Near Room 128B No violations recorded.
<b>Sliding-folding Partition</b>	
Instance on 1st Floor	Does not Exist
<b>Stage</b>	
Instance on 1st Floor	Does not Exist
<b>Walls</b>	
Instance on 1st Floor	Inspected
Condition	2 - Between Good and Fair
Deficiency	No deficiencies recorded
<b>Window Curtains/Shades/Blinds</b>	
Instance on 1st Floor	Does not Exist

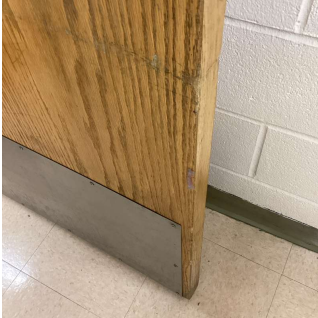
Question	Response
<b>INTERIOR</b>	
<b>CLASSROOMS/CORRIDORS/ADMIN SPACES</b>	
<b>Door(s)</b>	Inspected
Condition	5 - Poor
Deficiency	WOOD: DETERIORATED DOOR
Deficiency Location/Instance	Rooms 214, 241, 309, 414, 442, and others
Deficiency Quantity	22
Quantity Uom	EACH
Potential Action	MAINTENANCE
Urgency of Action	PRIORITY 3
Purpose of Action	LEVEL 2
Deficiency Photo1

Violations	Room 442 No violations recorded.
<b>Floor Finish</b>	Inspected
Condition	2 - Between Good and Fair
Deficiency	VINYL TILES: DETERIORATED SUBSTRATE
Deficiency Location/Instance	Room 111
Deficiency Quantity	30
Quantity Uom	S.F.
Potential Action	REPLACE
Urgency of Action	PRIORITY 3
Purpose of Action	LEVEL 2
Deficiency Photo1

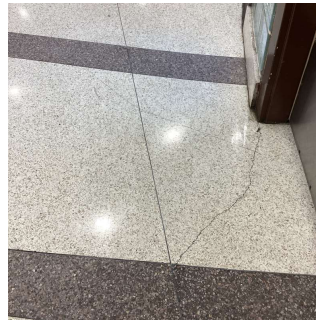
Main Entrance

**TERRAZZO: CRACKS**

REPLACE

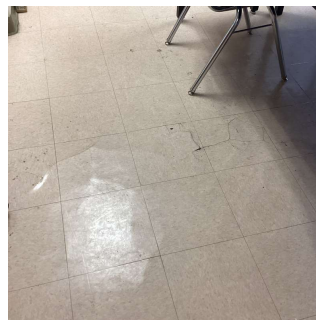
Room 318

**VINYL TILES: BROKEN/DETERIORATED/MISSING TILES**

REPLACE

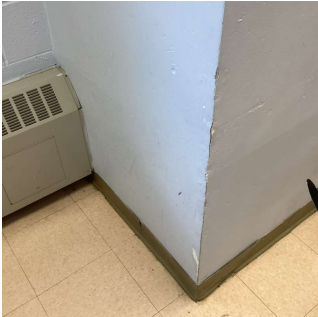
Question	Response
<b>INTERIOR</b>	
<b>CLASSROOMS/CORRIDORS/ADMIN SPACES</b>	
<b>Floor Finish</b>	Inspected
Violations	No violations recorded.
<b>Walls</b>	Inspected
Condition	2 - Between Good and Fair
Deficiency	GYPSUM BOARD: DETERIORATED
Deficiency Location/Instance	Rooms 126, 212, 313, 333, 341, and others
Deficiency Quantity	200
Quantity Uom	S.F.
Potential Action	REPLACE
Urgency of Action	PRIORITY 3
Purpose of Action	LEVEL 2
Deficiency Photo1

Violations	Room 126 No violations recorded.
<b>Specialties</b>	Inspected
<b>Classroom Locker(s)</b>	Inspected
Condition	2 - Between Good and Fair
Deficiency	No deficiencies recorded
<b>Fixed Seating</b>	Does not Exist
<b>GYMNASIUM</b>	Inspected
Instance on 2nd Floor	Inspected
<b>Ceiling</b>	Inspected
Instance on 2nd Floor	Inspected
Condition	2 - Between Good and Fair
Deficiency	No deficiencies recorded
<b>Door(s)</b>	Inspected
Instance on 2nd Floor	Inspected
Condition	3 - Fair

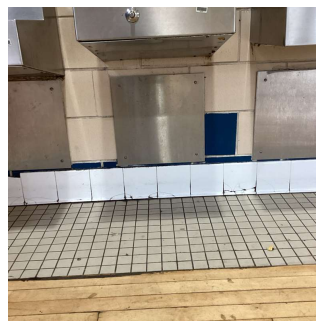
Instance on 2nd Floor	Inspected
Condition	2 - Between Good and Fair
Deficiency	CERAMIC TILE: BROKEN/ MISSING
Deficiency Location/Instance	Drinking Fountain Area
Deficiency Quantity	10
Quantity Uom	S.F.
Potential Action	REPLACE
Urgency of Action	PRIORITY 3
Purpose of Action	LEVEL 2
Deficiency Photo1

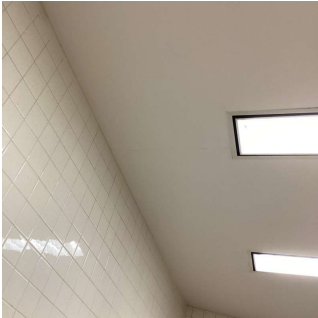
Question	Response
<b>INTERIOR</b>	
<b>GYMNASIUM</b>	Inspected
<b>Walls</b>	
Violations	No violations recorded.
<b>Window Curtains/Shades/Blinds</b>	
Instance on 2nd Floor	Does not Exist
<b>INTERIOR DOOR HARDWARE</b>	Inspected
Condition	2 - Between Good and Fair
Deficiency	No deficiencies recorded
<b>INTERIOR GUARDS</b>	Inspected
Condition	2 - Between Good and Fair
Deficiency	No deficiencies recorded
<b>KITCHEN</b>	Inspected
Instance on 1st Floor	Inspected
<b>Ceiling</b>	
Instance on 1st Floor	Inspected
Condition	2 - Between Good and Fair
Deficiency	GYPSUM BOARD: DAMAGED/DETERIORATED
Deficiency Location/Instance	Room 129I
Deficiency Quantity	10
Quantity Uom	S.F.
Potential Action	REPLACE
Urgency of Action	PRIORITY 3
Purpose of Action	LEVEL 2
Deficiency Photo1

Violations	Room 129I No violations recorded.
Deficiency	METAL PAN: DAMAGED/MISSING
Deficiency Location/Instance	Near Serving Area
Deficiency Quantity	20
Quantity Uom	S.F.

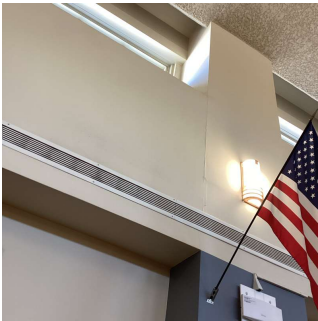
Question	Response
<b>INTERIOR</b>	
<b>LIBRARY</b>	
<b>Walls</b>	
Deficiency Photo1

Violations	Near Office No violations recorded.
<b>LOCKER ROOM</b>	Does not Exist
<b>MULTI-PURPOSE ROOM</b>	Does not Exist
<b>SCIENCE DEMO ROOM</b>	Does not Exist
<b>SCIENCE LAB</b>	Inspected
Instance on Rooms 207, 309, 409, 411, 413	Inspected
Alternative use	No
Instance on Rooms 209, 311, 313	Inspected
Alternative use	Yes
<b>Fixed Equipment</b>	
Instance on Rooms 207, 309, 409, 411, 413	Inspected
Condition	5 - Poor
Deficiency	CABINETRY: MISSING/DAMAGED
Deficiency Location/Instance	Rooms 207, 309, 409, 411, 413
Deficiency Quantity	40
Quantity Uom	L.F.
Potential Action	REPLACE
Urgency of Action	PRIORITY 3
Purpose of Action	LEVEL 2
Deficiency Photo1

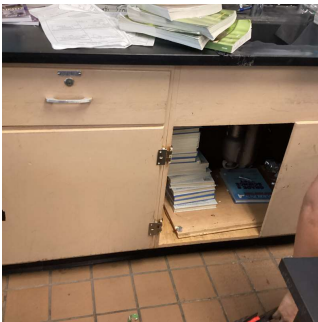
Violations	Room 411 No violations recorded.
Instance on Rooms 209, 311, 313	Inspected
Condition	3 - Fair
Deficiency	CABINETRY: MISSING/DAMAGED
Deficiency Location/Instance	Rooms 209, 311, 313

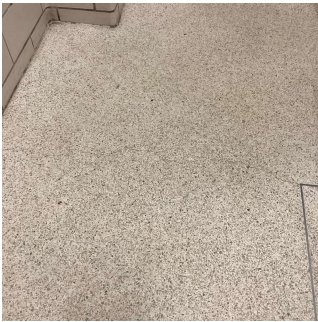
Question	Response
<b>INTERIOR</b>	
<b>STAIRS/RAMPS: INTERIOR</b>	
<b>Partition</b>	Does not Exist
<b>Railings</b>	Inspected
Condition	2 - Between Good and Fair
Deficiency	No deficiencies recorded
<b>Stairs and Landings</b>	Inspected
Condition	2 - Between Good and Fair
Deficiency	TERRAZZO: CRACKS
Deficiency Location/Instance	Stairs A/3, B/1, 2, 3
Deficiency Quantity	80
Quantity Uom	S.F.
Potential Action	REPLACE
Urgency of Action	PRIORITY 3
Purpose of Action	LEVEL 2
Deficiency Photo1

Violations	Stair A/3 No violations recorded.
Deficiency	VINYL TILES: BROKEN/DETERIORATED/MISSING TILES
Deficiency Location/Instance	Stairs A/1, 2, C/1
Deficiency Quantity	40
Quantity Uom	S.F.
Potential Action	REPLACE
Urgency of Action	PRIORITY 3
Purpose of Action	LEVEL 2
Deficiency Photo1

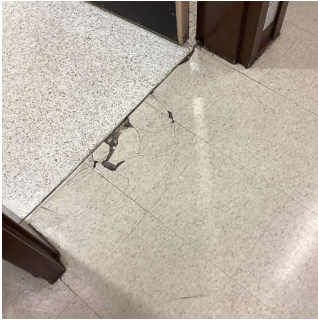
Violations	Stair A/1 No violations recorded.
<b>Walls</b>	Inspected
Condition	2 - Between Good and Fair
Deficiency	GLAZED BLOCK: CRACKS/SPALLING

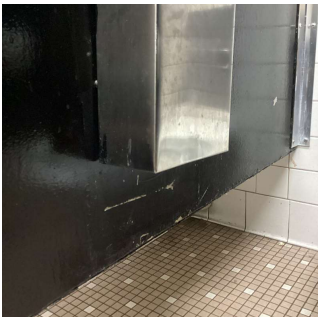
Question	Response
<b>INTERIOR</b>	
<b>TOILET ROOMS - STUDENTS</b>	
<b>Floor Finish</b>	Inspected
Deficiency	No deficiencies recorded
<b>Stalls</b>	Inspected
Condition	2 - Between Good and Fair
Deficiency	RUST - MAJOR
Deficiency Location/Instance	Room 128B
Deficiency Quantity	1
Quantity Uom	EACH
Potential Action	REPLACE
Urgency of Action	PRIORITY 3
Purpose of Action	LEVEL 2
Deficiency Photo1

Room 128B
Violations	No violations recorded.
<b>Walls</b>	Inspected
Condition	2 - Between Good and Fair
Deficiency	CERAMIC TILE: BROKEN/ MISSING
Deficiency Location/Instance	Rooms 119, 128A, 128B, 415
Deficiency Quantity	30
Quantity Uom	S.F.
Potential Action	REPLACE
Urgency of Action	PRIORITY 3
Purpose of Action	LEVEL 2
Deficiency Photo1

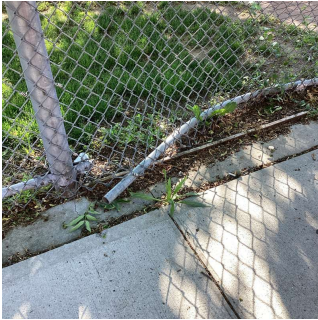
Deficiency Quantity	10
Quantity Uom	L.F.
Potential Action	REPLACE
Urgency of Action	PRIORITY 3
Purpose of Action	LEVEL 2
Deficiency Photo1

Violations	98th Street No violations recorded.
Deficiency	CHAIN LINK: DAMAGED/DETERIORATED
Deficiency Location/Instance	98th Street
Deficiency Quantity	150
Quantity Uom	S.F.
Potential Action	REPLACE
Urgency of Action	PRIORITY 3
Purpose of Action	LEVEL 2

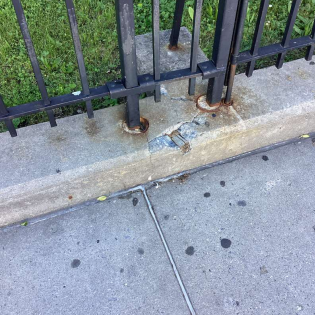
Question	Response
<b>SITE</b>	
<b>FENCES</b>	
Deficiency Photo1	 
Violations	98th Street No violations recorded.
Deficiency	<b>WROUGHT IRON: DAMAGED/DETERIORATED</b>
Deficiency Location/Instance	98th Street
Deficiency Quantity	80
Quantity Uom	S.F.
Potential Action	REPLACE
Urgency of Action	PRIORITY 3
Purpose of Action	LEVEL 2
Deficiency Photo1	 
Violations	98th Street No violations recorded.
Deficiency	<b>CONCRETE CURB: DAMAGED/DETERIORATED</b>
Deficiency Location/Instance	98th Street
Deficiency Quantity	130
Quantity Uom	S.F.
Potential Action	REPLACE
Urgency of Action	PRIORITY 3
Purpose of Action	LEVEL 2
Deficiency Photo1

Violations	98th Street No violations recorded.
<b>IRRIGATION SYSTEM</b>	
	Does not Exist

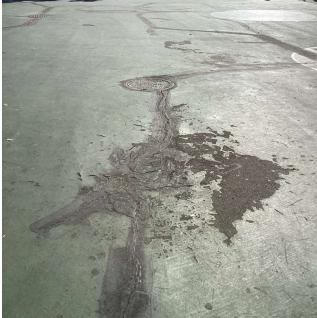
98th Street
Violations	No violations recorded.
<b>Pavers</b>	Does not Exist
<b>Student Use</b>	Inspected
Gravel Exists?	No
<b>Asphalt</b>	Inspected
Condition	4 - Between Fair and Poor
Deficiency	CRACKS - MAJOR
Deficiency Location/Instance	Near Exit 8, Center, Seating Area, Running Track
Deficiency Quantity	1,200
Quantity Uom	S.F.
Potential Action	REPLACE
Urgency of Action	PRIORITY 3
Purpose of Action	LEVEL 2
Deficiency Photo1

Near Exit 8
Violations	No violations recorded.

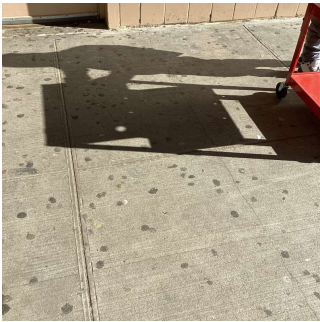
Running Track Area
Violations	No violations recorded.
<b>Site Sidewalks &amp; Walkways</b>	Inspected
<b>Asphalt</b>	Does not Exist
<b>Concrete</b>	Inspected
Condition	3 - Fair
Deficiency	DAMAGED/DETERIORATED/MISSING SECTIONS
Deficiency Location/Instance	Near Exit 8
Deficiency Quantity	200
Quantity Uom	S.F.
Potential Action	REPLACE
Urgency of Action	PRIORITY 3
Purpose of Action	LEVEL 2
Deficiency Photo1

Near Exit 8
Violations	No violations recorded.
<b>Pavers</b>	Inspected
Condition	2 - Between Good and Fair
Deficiency	No deficiencies recorded
<b>DOT Sidewalk</b>	Inspected

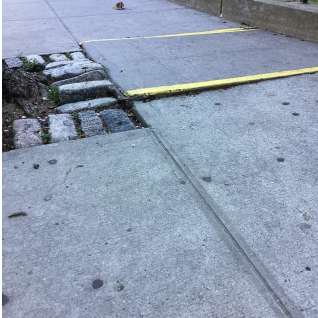
98th Street
Violations	No violations recorded.
Deficiency	DAMAGED/DETERIORATED/MISSING SECTIONS
Deficiency Location/Instance	98th Street, 99th Street
Deficiency Quantity	1,000
Quantity Uom	S.F.
Potential Action	REPLACE
Urgency of Action	PRIORITY 3
Purpose of Action	LEVEL 2
Deficiency Photo1

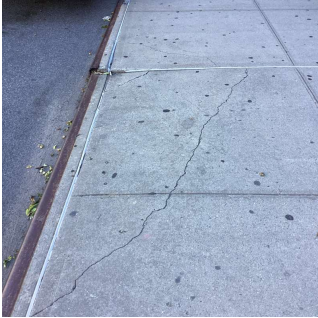
98th Street
Violations	No violations recorded.
Deficiency	DAMAGED CURBS
Deficiency Location/Instance	98th Street, 99th Street
Deficiency Quantity	105
Quantity Uom	L.F.
Potential Action	REPLACE
Urgency of Action	PRIORITY 3
Purpose of Action	LEVEL 2
