NYC Department of Education
Building Condition Assessment Survey 2023 - 2024

Architectural Inspection

Asset: P.S. 752 (OLD J142) - QUEENS, 142-10 LINDEN BLVD, New York, 11436

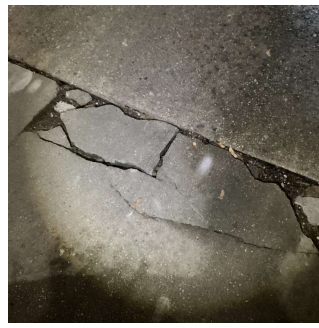
| Question | Response |
|--|--|
| Violations | Facade B - AW5 No violations recorded. |

| Question | Response |
|--|--|
| Deficiency | AREAWAY SLAB: CRACKS AND SPALLING |

| Question | Response |
|--|--|
| Potential Action | REPLACE |

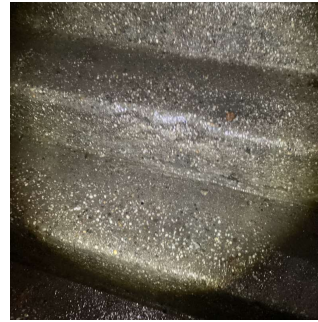
Facade B - AW5

| Question | Response |
|--|--|
| Deficiency | AREAWAY STAIRS: DETERIORATED TREADS/RISERS/NOSINGS |

| Question | Response |
|--|--|
| Potential Action | REPAIR |

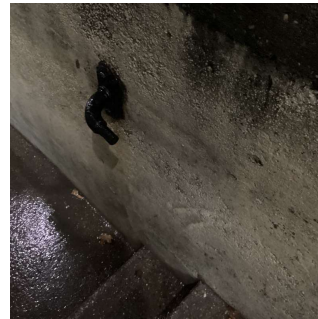
Facade B - AW5

AREAWAY STAIRS: MISSING RAILINGS

REPLACE

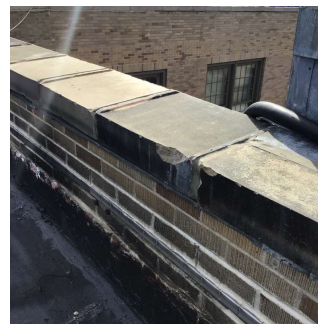
Roof 1
No violations recorded.

TERRA COTTA: CRACKED/BROKEN PIECES

30
L.F.
REPLACE-IN-KIND
PRIORITY 4
LEVEL 2

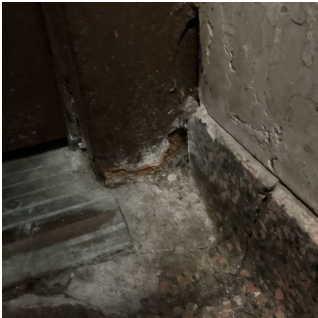
| Question | Response |
|---|--|
| | Facade A |

METAL: DETERIORATED DOOR AND FRAME - MAJOR DETERIORATION

8
EACH
REPLACE
PRIORITY 4

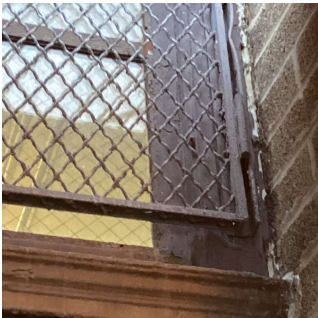
| Question | Response |
|---|--|
| | Facade H |

| Question | Response |
|---|--|
| Deficiency | METAL: DENTED, MAJOR RUSTING |

| Question | Response |
|---|--|
| Potential Action | REPLACE |

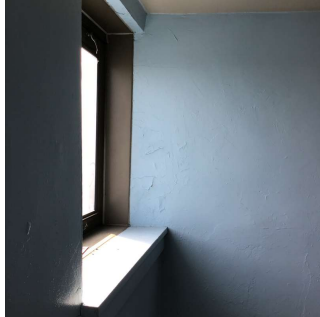
| Question | Response |
|---|--|
| Violations | Roof 1 No violations recorded. |

| Question | Response |
|---|--|
| Deficiency | BULKHEAD/PENTHOUSE WALLS/INTERIOR: PLASTER CRACKS/SPALLING |

| Question | Response |
|---|--|
| Potential Action | REPLACE |

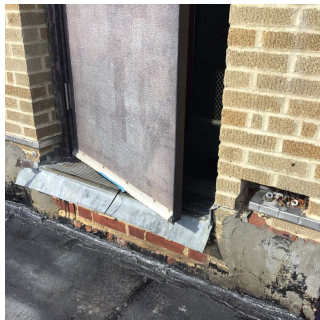
| Question | Response |
|---|--|
| Violations | Roof 1 No violations recorded. |

| Question | Response |
|---|--|
| Deficiency | BULKHEAD/PENTHOUSE DOORS: DETERIORATED DOOR |

| Question | Response |
|---|--|
| Potential Action | REPLACE DOOR |

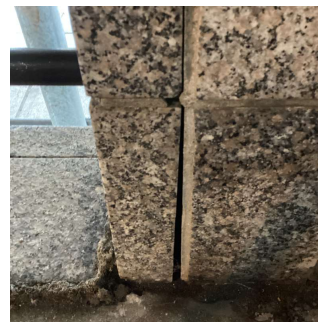
Facade A

STONE: DETERIORATED JOINTS

20
S.F.
REPOINT
PRIORITY 4
LEVEL 2

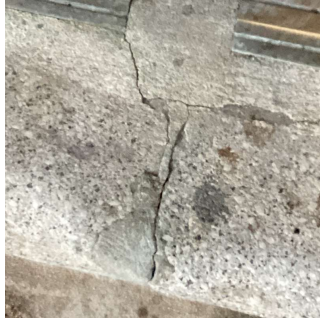
| Question | Response |
|---|--|
| Violations | Facade A No violations recorded. |

| Question | Response |
|---|--|
| Deficiency | STONE: CRACKS/SPALLING - MINOR |

| Question | Response |
|---|--|
| Potential Action | REPAIR |

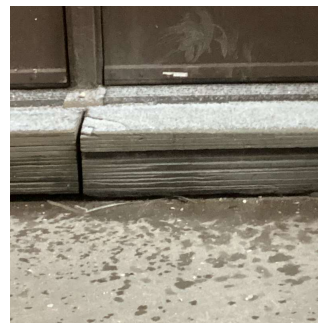
Facade D

| Question | Response |
|---|--|
| Deficiency | STONE: WORN-OUT TREAD/RISER/NOSING |

10
S.F.
REPLACE
PRIORITY 4
LEVEL 2

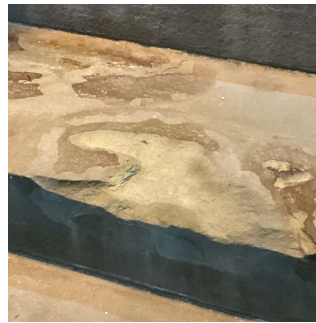
Facade E - Exit5

| Priority Condition Exist Last Year? | Priority Category | Condition Description | Component Affected | Location Description | Person(s) Notified | Person(s) Title | PhotoImage |
|---|---|--|--|---|---|---|--|
| Yes | Tripping Hazard | Deteriorated stair tread is a potential tripping hazard. | EXTERIOR STAIRS/RAMP S: EXTERIOR STAIRS/RAMP S | Exit 5 facing inner courtyard. | Jose Ramos | Fireman | |

STONE: WORN-OUT TREAD/RISER/NOSING

10
S.F.
REPLACE
PRIORITY 5
LEVEL 6

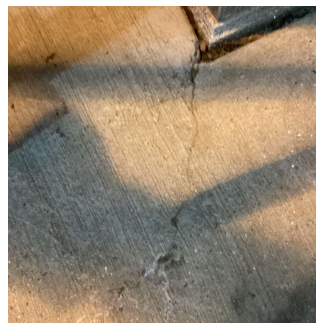
Facade H

CONCRETE: CRACKS/SPALLING - MINOR

REPAIR

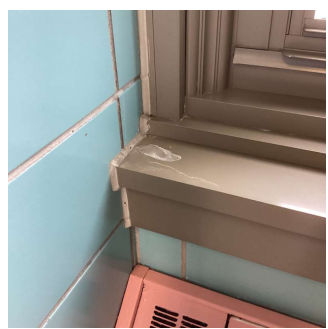
| Question | Response |
|---|--|
| Violations | Facade B - 4th Floor, also 3rd, 2nd and 1st Floor, Facade E - 3rd and 2nd Floor No violations recorded. |

| Question | Response |
|---|---|
| Deficiency | ALUMINUM - DOUBLE HUNG: AIR/WATER INFILTRATION |

| Question | Response |
|---|--|
| Potential Action | REPLACE TRIM, SILLS OR WEATHERSTRIPPING |

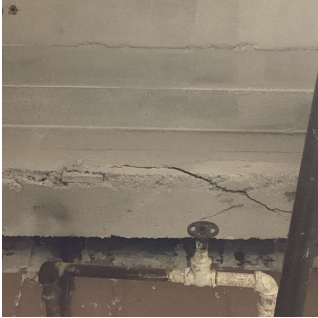
| Question | Response |
|---|--|
| | Basement - Storage Room |

| Question | Response |
|---|--|
| Deficiency | STEEL COLUMNS/BEAMS: DETERIORATED CONCRETE FIREPROOFING |

| Question | Response |
|---|--|
| Potential Action | REPLACE |

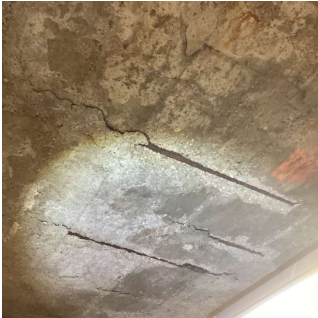
| Question | Response |
|---|--|
| | Basement - Storage Room |

| Question | Response |
|---|--|
| Deficiency | CONCRETE: CRACKS/SPALLED/REINFORCEMENT EXPOSED |

| Question | Response |
|---|--|
| Potential Action | REPAIR |

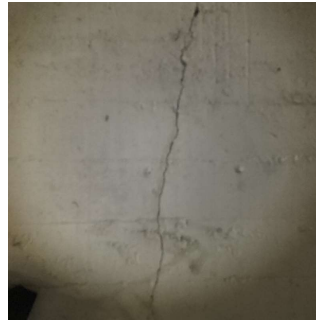
Basement - Back Room

| Question | Response |
|---|--|
| Deficiency | CONCRETE: CRACKED/SPALLED/REINFORCEMENT EXPOSED |

| Question | Response |
|---|--|
| Potential Action | REPAIR |

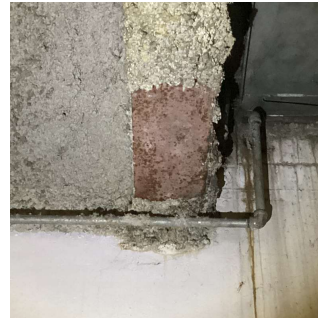
Basement - Ash Hoist Vault

STEEL COLUMNS/BEAMS: DETERIORATED/MISSING SPRAY-ON FIREPROOFING

REPLACE

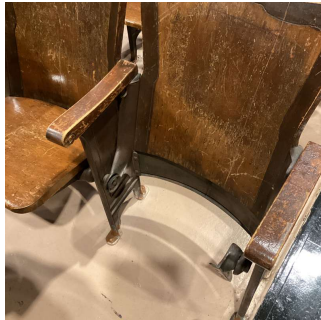
| Question | Response |
|--|--|
| Violations | Seat N/2 No violations recorded. |

| Question | Response |
|--|--|
| Deficiency | DAMAGED/BROKEN/INOPERABLE |

| Question | Response |
|--|--|
| Potential Action | REPLACE |

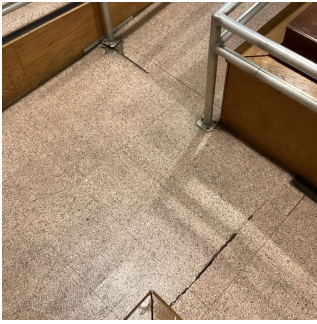
| Question | Response |
|---|--|
| Violations | Stage Ramp No violations recorded. |

| Question | Response |
|---|--|
| Deficiency | VINYL TILES: DETERIORATED SUBSTRATE |

| Question | Response |
|---|--|
| Potential Action | REPLACE |

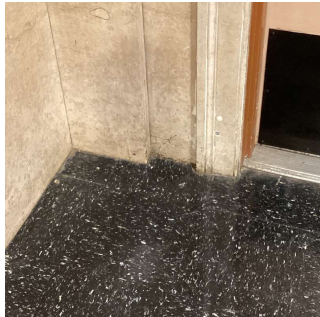
| Question | Response |
|---|--|
| | Near Stair G |

| Question | Response |
|---|--|
| Deficiency | STONE: CRACKS/SPALLING |

| Question | Response |
|---|--|
| Potential Action | REPLACE |

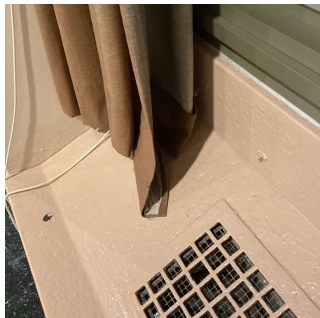
| Question | Response |
|---|--|
| | Rear Left |

| Question | Response |
|---|--|
| Deficiency | WORN/DAMAGED CURTAINS |
