NYC Department of Education
Building Condition Assessment Survey 2023 - 2024

Architectural Inspection

Asset: P.S. 146 - QUEENS, 98-01 159 AVENUE, New York, 11414

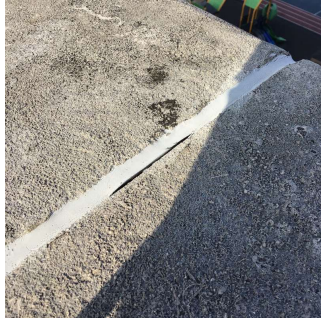
Deficiency	CAST STONE: DETERIORATED TRANSVERSE JOINTS
Roof Plan reference

Question	Response
EXTERIOR	
COPING	
Potential Action	MAINTENANCE
Urgency of Action	PRIORITY 3
Purpose of Action	LEVEL 2
Deficiency Photo1

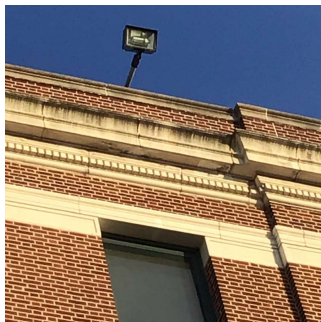
Violations	Roof 3 No violations recorded.
CORNICE	
Condition	Inspected 3 - Fair
Deficiency	STONE: MAJOR CRACKS, SPALLING
Roof Plan reference

Deficiency Quantity	50
Quantity Uom	S.F.
Potential Action	REPLACE
Urgency of Action	PRIORITY 4
Purpose of Action	LEVEL 2
Deficiency Photo1

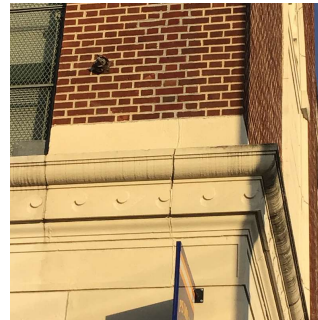
Violations	Facade B No violations recorded.
Deficiency	STONE: DETERIORATED JOINTS

10
 L.F.
 REPOINT
 PRIORITY 3
 LEVEL 2

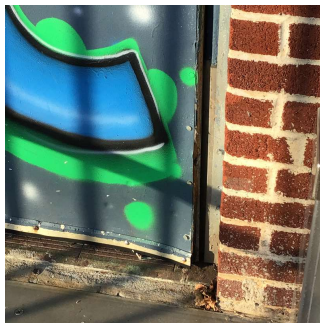
METAL CLAD: DETERIORATED DOOR AND FRAME - MAJOR DETERIORATION

1
 EACH
 REPLACE
 PRIORITY 4
 LEVEL 2

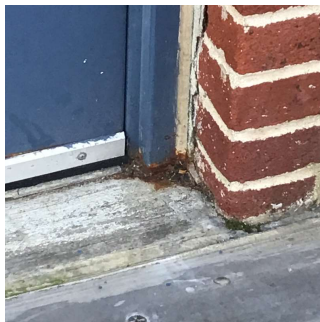
Violations	Facade A No violations recorded.
Deficiency	METAL: DETERIORATED DOOR AND FRAME - MINOR DETERIORATION
Roof Plan reference

Deficiency Quantity	9
Quantity Uom	EACH
Potential Action	MAINTENANCE
Urgency of Action	PRIORITY 3
Purpose of Action	LEVEL 2
Deficiency Photo1

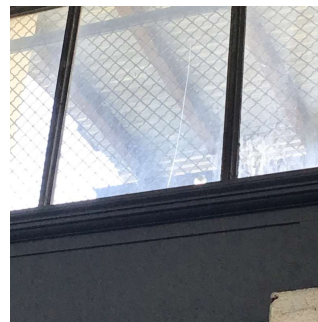
Facade A
 No violations recorded.

METAL: BROKEN GLASS

10
 S.F.
 MAINTENANCE
 PRIORITY 3
 LEVEL 2

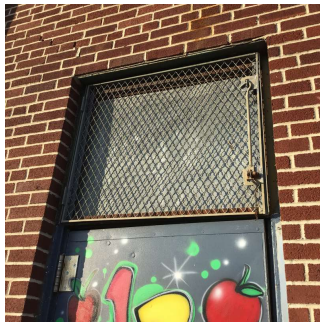
METAL: DENTED, MAJOR RUSTING

10
 S.F.
 REPLACE
 PRIORITY 4
 LEVEL 2

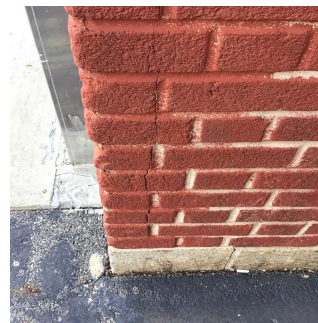
Facade F

BRICK: CRACKS/DISPLACED/SPALLED BRICK AT BUILDING CORNERS

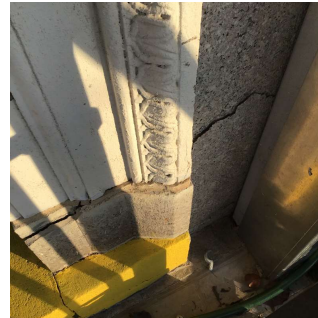
Facade C

STONE: CHIPPED/SPALLED/BROKEN PIECES - MAJOR

REPLACE

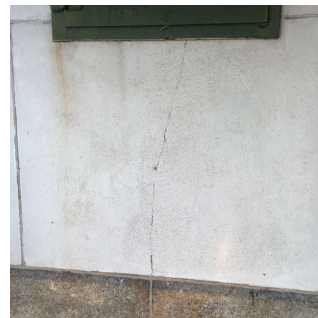
Facade C

STONE: CHIPPED/SPALLED/BROKEN PIECES - MINOR

REPAIR

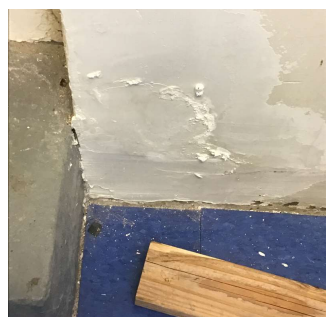
BULKHEAD/PENTHOUSE WALLS/INTERIOR: PLASTER CRACKS/SPALLING

Question	Response
EXTERIOR	
ROOF	
Specialties	
BULKHEAD/PENTHOUSE	
Quantity Uom	S.F.
Potential Action	REPLACE
Urgency of Action	PRIORITY 3
Purpose of Action	LEVEL 2
Deficiency Photo1

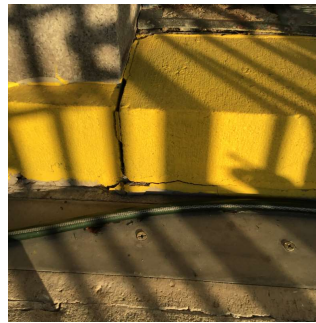
Facade C

STONE: CRACKS/SPALLING - MINOR

40
S.F.
REPAIR
PRIORITY 3
LEVEL 2

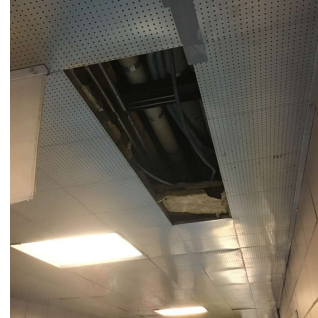
Corridor near room B14

METAL PAN: DAMAGED/MISSING - ACTIVE LEAK

REPLACE

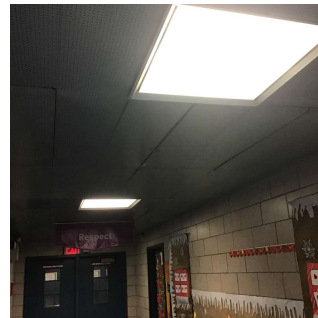
Corridor near room B18

METAL PAN: DAMAGED/MISSING

REPLACE
