**NYC Department of Education**  
**Building Condition Assessment Survey 2023 - 2024**

Architectural Inspection

Q147

**Asset:** P.S. 147 - QUEENS, 218-01 116 AVENUE, New York, 11411

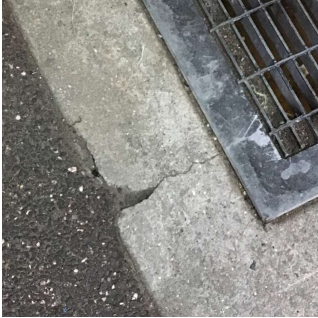
Violations	Facade D - AW9 No violations recorded.
Deficiency	AREAWAY GRATINGS: MAJOR RUSTING / OR BROKEN
Roof Plan reference

Question	Response
<b>Architectural</b>	
<b>EXTERIOR</b>	Inspected
<b>AREAWAY</b>	Inspected
Instance on AW1-AW18	Inspected
Instance Condition	3 - Fair
Instance Quantity	18
Instance Quantity Uom	EACH
Deficiency	AREAWAY WALLS: CRACKS AND SPALLING
Roof Plan reference

Question	Response
<b>EXTERIOR</b>	
<b>AREAWAY</b>	
Quantity Uom	S.F.
Potential Action	REPAIR
Urgency of Action	PRIORITY 3
Purpose of Action	LEVEL 2
Deficiency Photo1

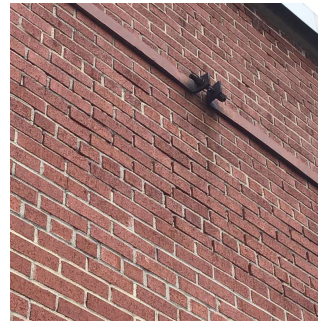
Roof 1  
No violations recorded.

Violations	Facade D - AW6 No violations recorded.
<b>AWNINGS AND CANOPIES</b>	Does not Exist
<b>CHIMNEY</b>	Inspected
Material Type(s)	Masonry
Condition	3 - Fair
Deficiency	BRICK: DETERIORATED JOINTS

50  
S.F.  
REPOINT  
PRIORITY 4  
LEVEL 2

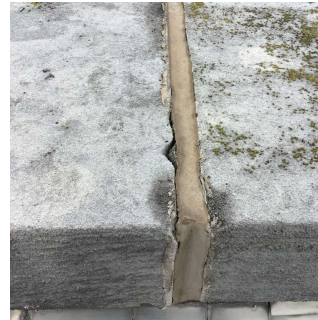
Roof 1

CAST STONE: DETERIORATED TRANSVERSE JOINTS

50  
L.F.  
MAINTENANCE  
PRIORITY 3  
LEVEL 2

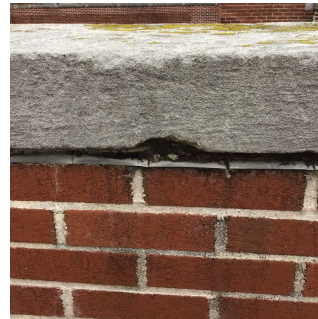
Roof 1

**CAST STONE: CRACKED/BROKEN PIECES**

REPLACE-IN-KIND

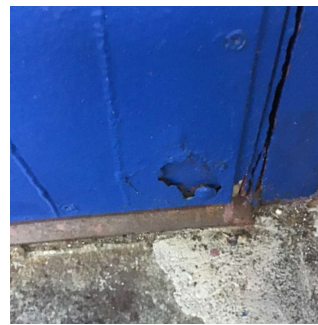
Facade C

METAL CLAD: DETERIORATED DOOR AND FRAME - MAJOR DETERIORATION

10  
EACH  
REPLACE  
PRIORITY 4  
LEVEL 2

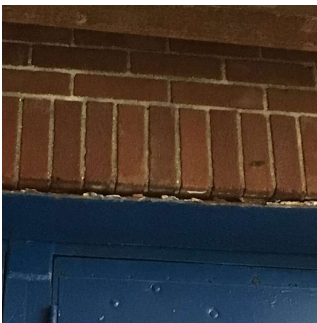
STEEL: MAJOR RUSTING

20  
L.F.  
REPLACE  
PRIORITY 4  
LEVEL 2

Violations	Facade E No violations recorded.
<b>TRANSOM/SIDE LIGHT</b>	Does not Exist
<b>EXTERIOR WALLS</b>	Inspected
Material Type(s)	Masonry
Replacement Quantity	14,000
Replacement Uom	S.F.
Instance on All Facades	Inspected
Instance Condition	3 - Fair
Instance Quantity	14,000
Instance Quantity Uom	S.F.
Deficiency	STONE: CHIPPED/SPALLED/BROKEN PIECES - MINOR
Roof Plan reference

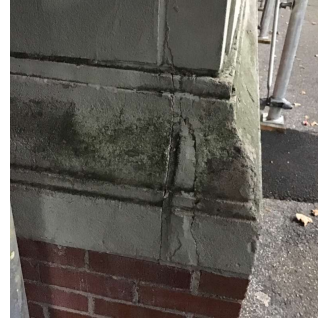
Facade G

Deficiency Quantity	10
Quantity Uom	S.F.
Potential Action	REPAIR
Urgency of Action	PRIORITY 3
Purpose of Action	LEVEL 2

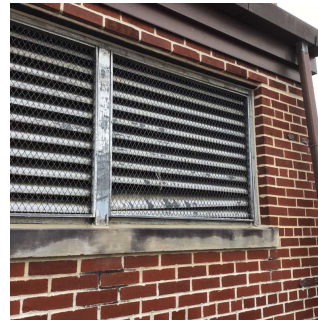
Roof 2

BROKEN/ DENTED BLADES

REPLACE

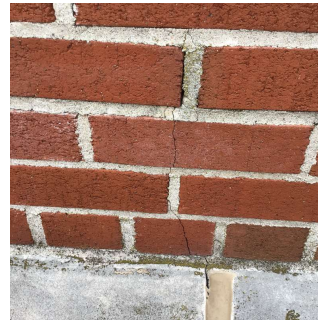
Roof 5

BRICK: MINOR CRACKS, SPALLING

REPAIR

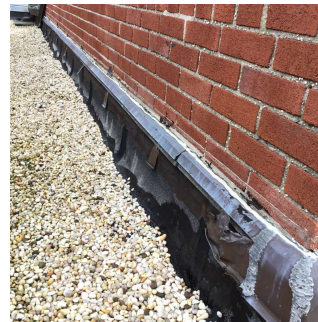
Roof 5

**BUILT-UP: FLASHING: CAP FLASHING MISSING**

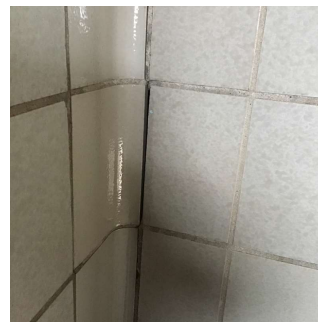
Roof 5 - Bulkhead 2

**BULKHEAD/PENTHOUSE WALLS/INTERIOR: GLAZED BLOCK DETERIORATED JOINTS**

30  
S.F.  
REPOINT  
PRIORITY 3  
LEVEL 2

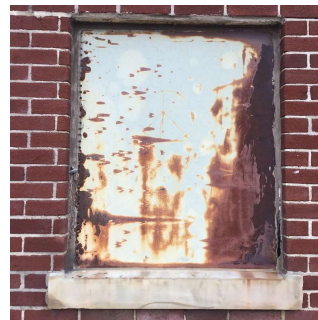
Roof 1 - Bulkhead 1

**BULKHEAD/PENTHOUSE WINDOWS: DAMAGED, DETERIORATED WINDOWS**

REPLACE

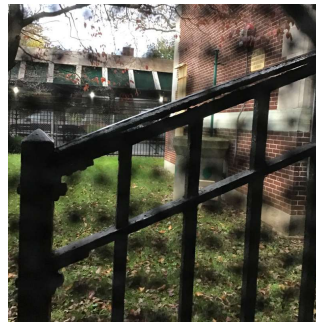
Facade A

RUST - MAJOR

REPLACE

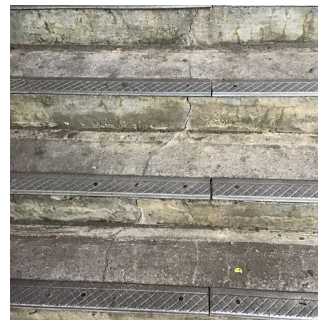
Facade E

**CONCRETE: CRACKS/SPALLING - MINOR**

REPAIR

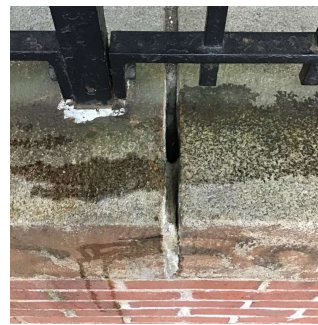
Facade C  
No violations recorded.

**STONE: DETERIORATED JOINTS**

20  
L.F.  
REPOINT  
PRIORITY 4  
LEVEL 2

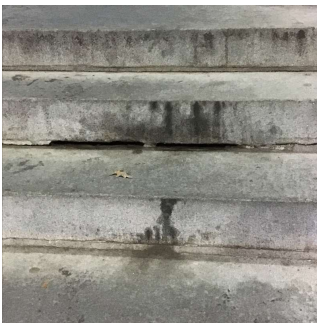
**STONE: DETERIORATED SUBSTRATE**

50  
S.F.  
REPLACE SUBSTRATE AND RESET  
PRIORITY 4  
LEVEL 2

Violations	Facade A No violations recorded.
<b>WINDOWS</b>	Inspected
Replacement Quantity	14,060
Replacement Uom	S.F.
<b>EXTERIOR GUARDS</b>	Inspected
Condition	4 - Between Fair and Poor
Deficiency	DETERIORATED/TORN-OUT/MISSING
Roof Plan reference

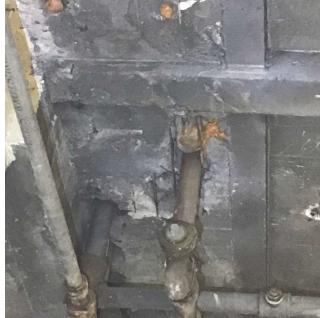
Basement - Storage
Violations	No violations recorded.
<b>FLOOR STRUCTURE</b>	Inspected
Condition	3 - Fair
Deficiency	CONCRETE: CRACKS/SPALLED/REINFORCEMENT EXPOSED
Deficiency Location/Instance	Basement - Boiler Room

Deficiency Quantity	30
Quantity Uom	S.F.
Potential Action	REPAIR

Basement - Boiler Room
Violations	No violations recorded.
<b>FOUNDATION WALLS</b>	
	Inspected
Material Type(s)	Concrete
Condition	4 - Between Fair and Poor
Deficiency	CONCRETE: WATER INFILTRATION IN NON- INSTRUCTIONAL SPACE
Deficiency Location/Instance	Basement - Storage
Deficiency Quantity	100
Quantity Uom	S.F.
Potential Action	INSTALL WATERPROOFING
Urgency of Action	PRIORITY 5
Purpose of Action	LEVEL 5
Deficiency Photo1

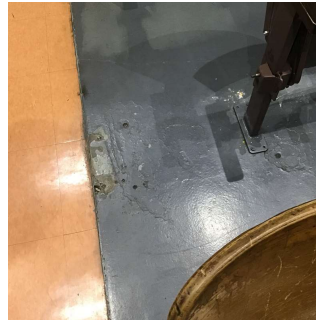
Seat R/101

DAMAGED/BROKEN/INOPERABLE

REPLACE

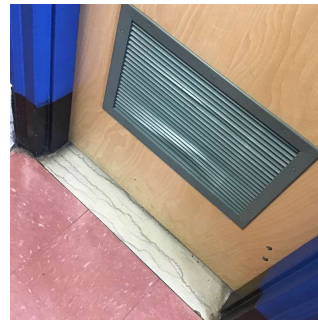
WOOD: DAMAGED LOUVER  
Room 229  
1  
EACH  
MAINTENANCE  
PRIORITY 3  
LEVEL 2

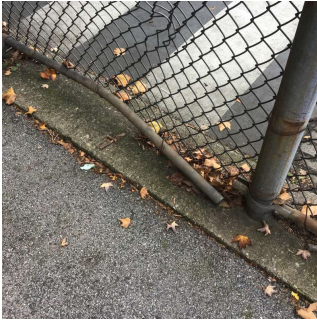
Violations	Along Exit 1 of Mini School No violations recorded.
Deficiency	<b>CHAIN LINK: RUST - MAJOR</b>
Deficiency Location/Instance	Along Exit 1 of Mini School
Deficiency Quantity	950
Quantity Uom	S.F.
Potential Action	REPLACE
Urgency of Action	PRIORITY 3
Purpose of Action	LEVEL 2
Deficiency Photo1	 
Violations	Along Exit 1 of Mini School No violations recorded.
<b>IRRIGATION SYSTEM</b>	Does not Exist
<b>PAVING</b>	Inspected
<b>Student Non-Use</b>	Inspected
Gravel Exists?	No
<b>Asphalt</b>	Does not Exist
<b>Concrete</b>	Inaccessible
<b>Pavers</b>	Does not Exist
<b>Student Use</b>	Inspected
Gravel Exists?	No
<b>Asphalt</b>	Inaccessible
<b>Concrete</b>	Does not Exist
<b>Pavers</b>	Does not Exist
<b>Site Sidewalks &amp; Walkways</b>	Inspected
<b>Asphalt</b>	Inspected
Condition	4 - Between Fair and Poor
Deficiency	<b>CRACKS - MAJOR</b>
Deficiency Location/Instance	Near Exit 10, Along Mini School Exits 3,2,1, 219st
