NYC Department of Education
Building Condition Assessment Survey 2023 - 2024

Architectural Inspection

Asset: P.S. 148 - QUEENS, 89-02 32 AVENUE, New York, 11369

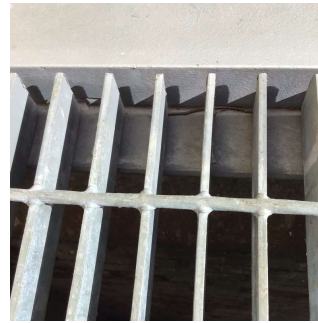
AW5

Question	Response
Architectural	
EXTERIOR	Inspected
AREAWAY	Inspected
Instance on AW1 - AW11	Inspected
Instance Condition	3 - Fair
Instance Quantity	11
Instance Quantity Uom	EACH
Deficiency	AREAWAY WALLS: DETERIORATED JOINTS
Roof Plan reference

S.F.
 REPAIR
 PRIORITY 3
 LEVEL 2

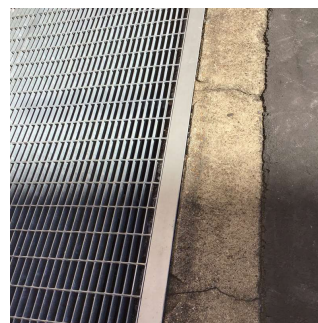
AW5

AREAWAY WALLS: DETERIORATED COPING STONE

30
 S.F.
 REPLACE
 PRIORITY 4
 LEVEL 2

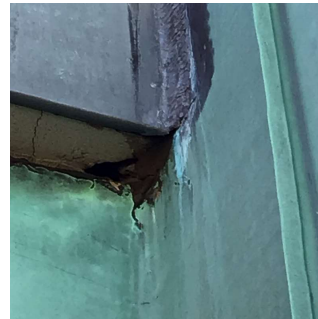
Roof 1 and 2

CAST STONE: CRACKED/BROKEN PIECES

REPLACE-IN-KIND

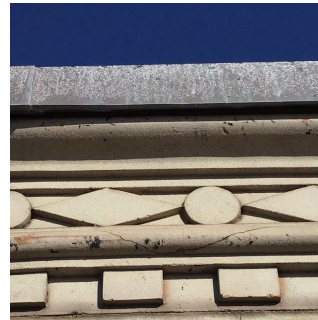
Roof 3
 No violations recorded.

STONE: MINOR CRACKS, SPALLING

10
 S.F.
 REPAIR
 PRIORITY 3
 LEVEL 2

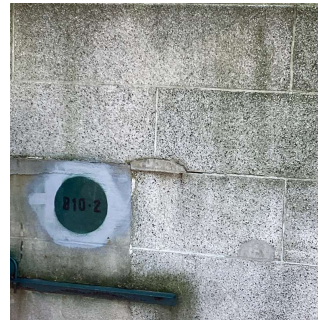
Facade B

STONE: CHIPPED/SPALLED/BROKEN PIECES - MAJOR

REPLACE

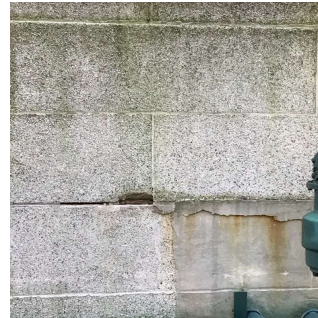
Facade B

STONE: DETERIORATED JOINTS

PRIORITY 4
LEVEL 2

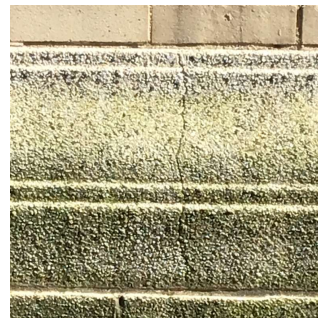
Facade H

STONE: CHIPPED/SPALLED/BROKEN PIECES - MINOR

REPAIR

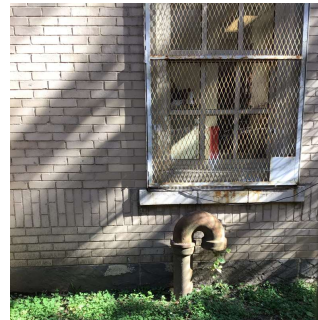
Facade H

BRICK: DETERIORATED MASONRY SILLS - MINOR

REPAIR

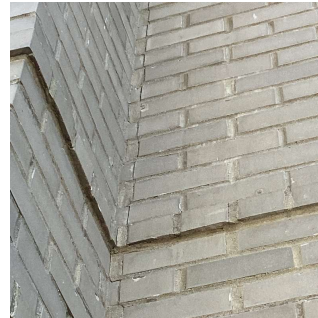
Facade B

BRICK: MINOR CRACKS AND SPALLING

PRIORITY 3
LEVEL 2

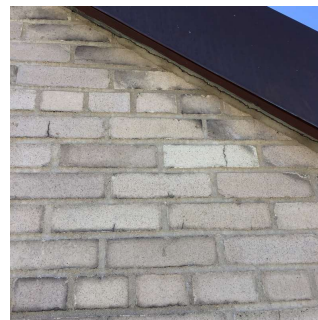
BH1
No violations recorded.

BULKHEAD/PENTHOUSE WALLS/EXTERIOR: CRACKS/SPALLING - MINOR

10
S.F.
REPAIR
PRIORITY 3
LEVEL 2

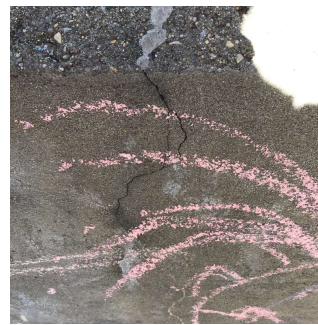
Facade D, E, B

Question	Response
EXTERIOR	
ROOF	
Specialties	
DORMER	Does not Exist
DUNNAGE STEEL	Inspected
Condition	3 - Fair
Deficiency	HEIGHT LESS THAN 18"
Roof Plan reference	
Deficiency Quantity	80
Quantity Uom	L.F.
Potential Action	REPLACE
Urgency of Action	PRIORITY 3
Purpose of Action	LEVEL 2
Deficiency Photo1	
Violations	Roof 8 No violations recorded.
SKYLIGHT/ROOF VENT	Inspected
Material Type(s)	Glass
Condition	2 - Between Good and Fair
Deficiency	No deficiencies recorded
ROOF/GRAVITY TANK	Does not Exist
STAIRS/RAMPS: EXTERIOR	Inspected
BUILDING CHEEK/FLANK WALLS	Inspected
Condition	5 - Poor
Deficiency	CAST IN PLACE CONCRETE: CRACKS/SPALLING - MINOR

150
S.F.
REPAIR
PRIORITY 3
LEVEL 2

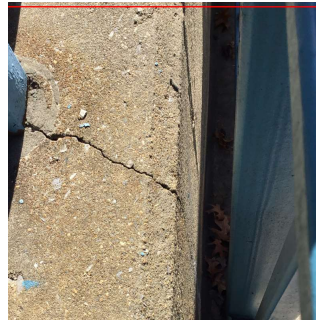
Facade D, B

CAST IN PLACE CONCRETE: CRACKS/SPALLING - MAJOR

100
S.F.
REPLACE
PRIORITY 4
LEVEL 2

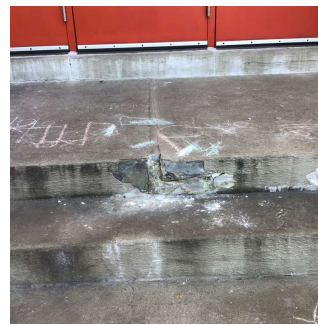
Facade E

CONCRETE: CRACKS/SPALLING - MAJOR

10
S.F.
REPLACE
PRIORITY 4
LEVEL 2

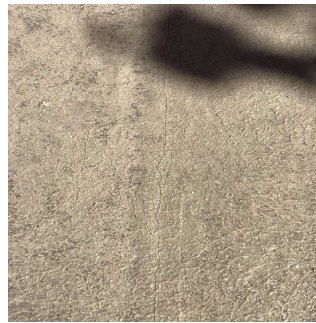
Facade H, Facade D

CONCRETE: CRACKS/SPALLING - MINOR

90
S.F.
REPAIR
PRIORITY 3
LEVEL 2

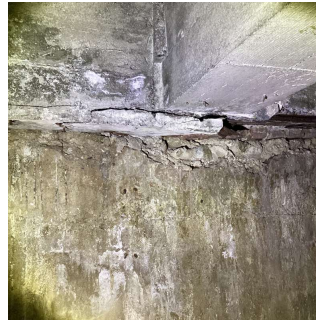
Are these windows insulated	No
Installation Year	2005
Source of Installation	Custodial Staff
Deficiency	No deficiencies recorded
INTERIOR	Inspected
POOLS	Does not Exist
STRUCTURAL	Inspected
COLUMNS/BEAMS/BEARING WALLS	Inspected
Condition	3 - Fair
Deficiency	STEEL COLUMNS/BEAMS: MAJOR RUSTING

Question	Response
INTERIOR	
STRUCTURAL	
COLUMNS/BEAMS/BEARING WALLS	
Deficiency Location/Instance	Basement - Crawlspace West
Deficiency Quantity	20
Quantity Uom	S.F.
Potential Action	REPLACE
Urgency of Action	PRIORITY 4
Purpose of Action	LEVEL 5
Deficiency Photo1	 
Violations	Crawlspace West No violations recorded.
Deficiency	STEEL COLUMNS/BEAMS: DETERIORATED MASONRY FIREPROOFING
Deficiency Location/Instance	Basement - Circular Staircase, Oil Tank Room
Deficiency Quantity	20
Quantity Uom	S.F.
Potential Action	REPLACE
Urgency of Action	PRIORITY 3
Purpose of Action	LEVEL 5
Deficiency Photo1	 
Violations	Basement - Circular Staircase No violations recorded.
Deficiency	STEEL COLUMNS/BEAMS: DETERIORATED CONCRETE FIREPROOFING
Deficiency Location/Instance	Basement - Boiler Room, Crawlspace West
Deficiency Quantity	50
Quantity Uom	S.F.
Potential Action	REPLACE
Urgency of Action	PRIORITY 4
Purpose of Action	LEVEL 5

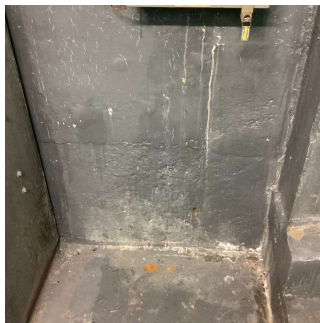
Circular Staircase No violations recorded.
Violations	
Deficiency	CONCRETE: WATER INFILTRATION IN ELECTRICAL PANEL ROOM
Deficiency Location/Instance	Basement - Electrical Panel Room
Deficiency Quantity	100
Quantity Uom	S.F.
Potential Action	INSTALL WATERPROOFING
Urgency of Action	PRIORITY 5
Purpose of Action	LEVEL 6

Violations	Electrical Panel Room No violations recorded.
Deficiency	BRICK: WATER INFILTRATION IN NON- INSTRUCTIONAL SPACE
Deficiency Location/Instance	Basement - Gas Meter Room, Oil Tank Room, Boiler Room, Storage Room, Main Area Along Facade H, Facade A- Basement
Deficiency Quantity	600
Quantity Uom	S.F.
Potential Action	INSTALL WATERPROOFING
Urgency of Action	PRIORITY 5
Purpose of Action	LEVEL 5
Deficiency Photo1

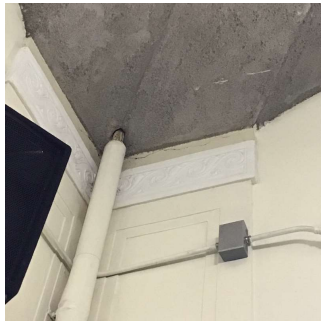
Question	Response
INTERIOR	
AUDITORIUM	
Walls	
Deficiency Photo1	 
Violations	Near Windows No violations recorded.
Deficiency	PLASTER: CRACKS/SPALLING
Deficiency Location/Instance	Near Windows, Entrance
Deficiency Quantity	30
Quantity Uom	S.F.
Potential Action	REPLACE
Urgency of Action	PRIORITY 3
Purpose of Action	LEVEL 2
Deficiency Photo1
