NYC Department of Education
Building Condition Assessment Survey 2023 - 2024

Architectural Inspection

Asset: P.S. 150 - QUEENS, 40-01 43 AVENUE, New York, 11104

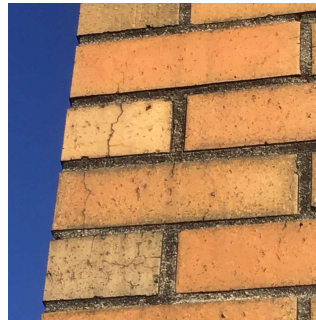
BH2
No violations recorded.

ROOFING DRAINS	Under Construction
Specialties	Inspected
BULKHEAD/PENTHOUSE	Inspected
Condition	3 - Fair
Deficiency	BULKHEAD/PENTHOUSE WALLS/EXTERIOR: CRACKS/SPALLING - MINOR
Roof Plan reference

Quantity Uom	S.F.
Potential Action	REPAIR
Urgency of Action	PRIORITY 3
Purpose of Action	LEVEL 2
Deficiency Photo1

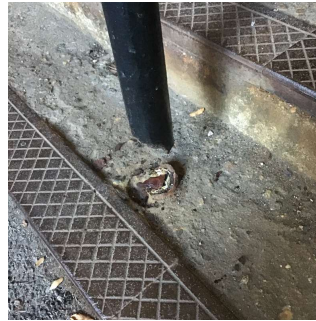
Facade E

Condition 3 - Fair

Deficiency RUST - MAJOR

Deficiency Quantity	10
Quantity Uom	L.F.
Potential Action	REPLACE
Urgency of Action	PRIORITY 5
Purpose of Action	LEVEL 2

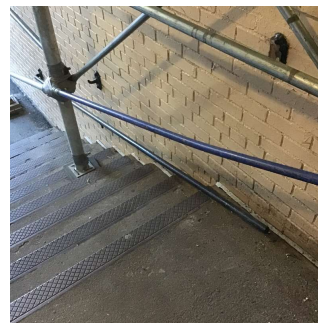
Exit 5-6 Stairs

Deficiency

BROKEN BRACKET

REPLACE

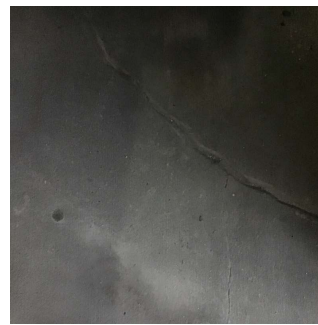
Facade D

Deficiency

CONCRETE: CRACKS/SPALLING - MAJOR

30
S.F.
REPLACE
PRIORITY 4
LEVEL 2

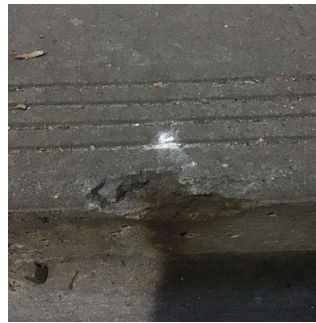
Facade D

Deficiency

CONCRETE: WORN-OUT TREAD/RISER/NOSING

20
S.F.
REPLACE
PRIORITY 4
LEVEL 2

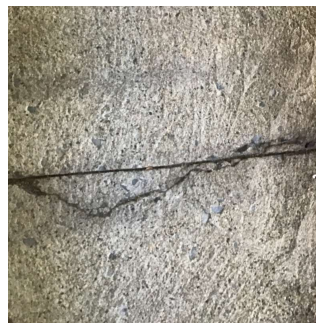
Facade B

Deficiency

CONCRETE: CRACKS/SPALLING - MINOR

REPAIR

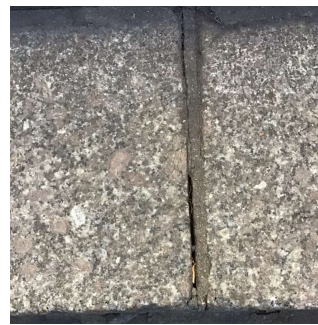
Facade A

Deficiency

STONE: DETERIORATED JOINTS

25
L.F.
REPOINT
PRIORITY 3
LEVEL 2

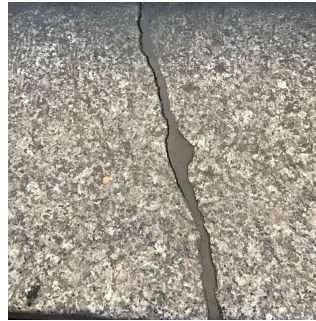
Facade A

Deficiency

STONE: CRACKS/SPALLING - MAJOR

15
S.F.
REPLACE
PRIORITY 4
LEVEL 2

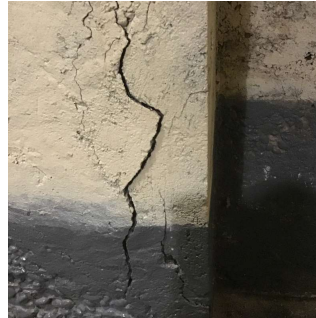
Basement - Oil Tank Room, Boiler Room, Workshop Room

Deficiency

CONCRETE: CRACKED/SPALLED/REINFORCEMENT EXPOSED

REPAIR

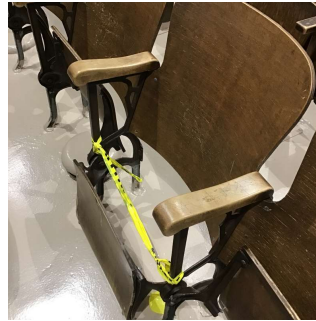
Seat K/4

Instance on 1st Floor (559 Seats)	Inspected
Condition	5 - Poor
Deficiency	DAMAGED/BROKEN/INOPERABLE
Deficiency Location/Instance	Seats A/2, C/13, F/11, 12, 14, 17, 21, 23, K/4, 24, 26, T/22
Deficiency Quantity	12
Quantity Uom	EACH
Potential Action	REPLACE
Urgency of Action	PRIORITY 5
Purpose of Action	LEVEL 6

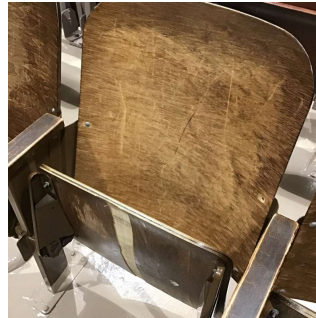
Seat L/4

Deficiency

DAMAGED/BROKEN/INOPERABLE

REPLACE

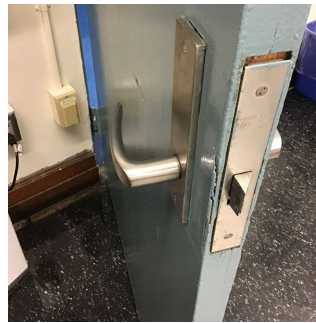
Room 202

Room 369
Violations	No violations recorded.
Deficiency	WOOD: DETERIORATED DOOR
Deficiency Location/Instance	Rooms 150, 202, 215, 303, 317, and others.
Deficiency Quantity	8
Quantity Uom	EACH
Potential Action	MAINTENANCE
Urgency of Action	PRIORITY 3
Purpose of Action	LEVEL 2

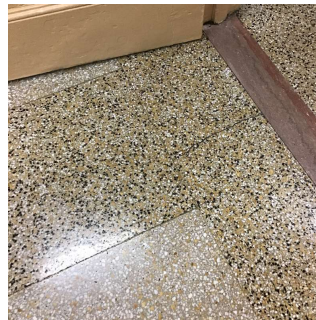
Corridor near Room 101

Deficiency

TERRAZZO: CRACKS

REPLACE

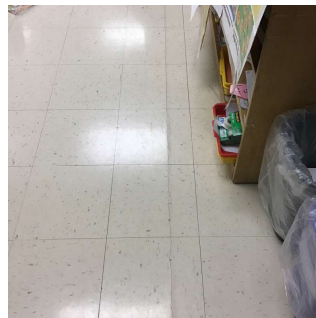
Deficiency

VINYL TILES: DETERIORATED SUBSTRATE

REPLACE
