NYC Department of Education
Building Condition Assessment Survey 2023 - 2024

Architectural Inspection

Asset: P.S. 155 - QUEENS, 130-02 115 AVENUE, New York, 11420

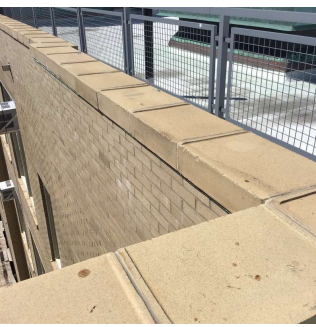
Question	Response
EXTERIOR	
AWNINGS AND CANOPIES	Does not Exist
CHIMNEY	Inspected
Material Type(s)	Masonry
Condition	1 - Good
Deficiency	No deficiencies recorded
COPING	Inspected
Condition	3 - Fair
Deficiency	TERRA COTTA: CRACKED/BROKEN PIECES
Roof Plan reference

Deficiency Quantity	20
Quantity Uom	L.F.
Potential Action	REPLACE-IN-KIND
Urgency of Action	PRIORITY 4
Purpose of Action	LEVEL 2
Deficiency Photo1

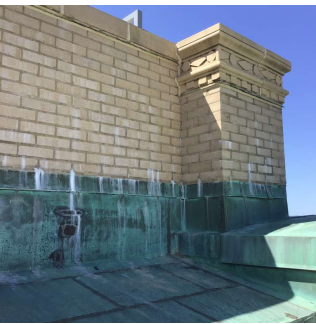
Question	Response
EXTERIOR	
PARAPETS	Inspected
Material Type(s)	Masonry
Replacement Quantity	6,000
Replacement Uom	C.F.
Instance on All Facades	Inspected
Instance Condition	2 - Between Good and Fair
Instance Quantity	6,000
Instance Quantity Uom	C.F.
Deficiency	BRICK: EFFLORESCENCE
Roof Plan reference

Deficiency Quantity	50
Quantity Uom	S.F.
Potential Action	MAINTENANCE
Urgency of Action	PRIORITY 1
Purpose of Action	LEVEL 1
Deficiency Photo1

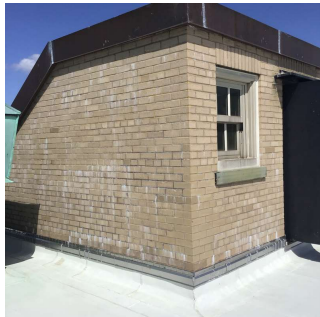
Violations	Roof 1 No violations recorded.
Deficiency	BULKHEAD/PENTHOUSE WALLS/EXTERIOR: EFFLORESCENCE
Roof Plan reference

Deficiency Quantity	50
Quantity Uom	S.F.
Potential Action	MAINTENANCE
Urgency of Action	PRIORITY 1
Purpose of Action	LEVEL 1
Deficiency Photo1

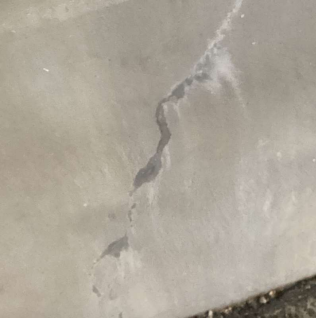
Violations	<p>Facade C</p> <p>No violations recorded.</p>

Condition	3 - Fair
Deficiency	CAST IN PLACE CONCRETE: CRACKS/SPALLING - MINOR
Roof Plan reference

Deficiency Quantity	20
Quantity Uom	S.F.
Potential Action	REPAIR
Urgency of Action	PRIORITY 3
Purpose of Action	LEVEL 2
Deficiency Photo1

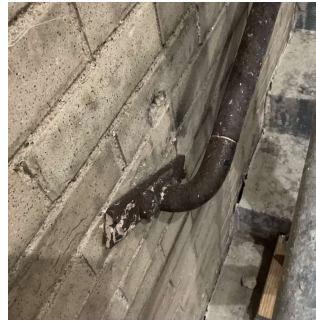
Facade C

Condition	Inspected
Condition	3 - Fair
Deficiency	RUST - MAJOR
Roof Plan reference

Deficiency Quantity	10
Quantity Uom	L.F.
Potential Action	REPLACE
Urgency of Action	PRIORITY 4
Purpose of Action	LEVEL 2

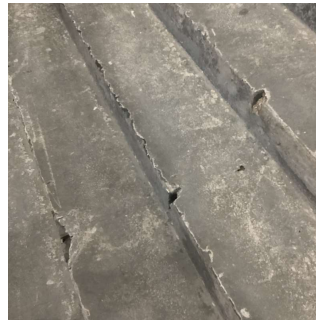
Facade C

STONE: WORN-OUT TREAD/RISER/NOSING

REPLACE

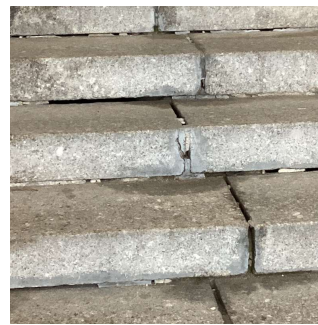
Facade F
No violations recorded.

STONE: DETERIORATED SUBSTRATE

30
S.F.
REPLACE SUBSTRATE AND RESET
PRIORITY 4
LEVEL 2

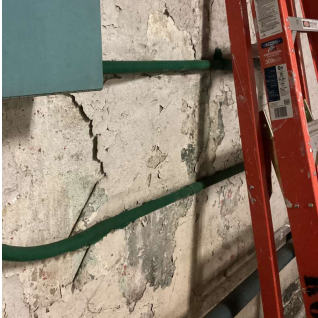
Violations	Basement - Old Coal Chute No violations recorded.
FLOOR STRUCTURE	
Condition	Inspected 2 - Between Good and Fair
Deficiency	CONCRETE: CRACKS/SPALLED/REINFORCEMENT EXPOSED
Deficiency Location/Instance	Basement - Boiler Room
Deficiency Quantity	10
Quantity Uom	S.F.
Potential Action	REPAIR
Urgency of Action	PRIORITY 3
Purpose of Action	LEVEL 5
Deficiency Photo1	 
Violations	Basement - Boiler Room No violations recorded.
FOUNDATION WALLS	
Material Type(s)	Inspected Concrete
Condition	4 - Between Fair and Poor
Deficiency	CONCRETE: WATER INFILTRATION IN NON- INSTRUCTIONAL SPACE

Deficiency Location/Instance	Basement - Boiler Room
Deficiency Quantity	100

Question	Response
INTERIOR	
STRUCTURAL	
FOUNDATION WALLS	
Quantity Uom	S.F.
Potential Action	INSTALL WATERPROOFING
Urgency of Action	PRIORITY 5
Purpose of Action	LEVEL 5
Deficiency Photo1

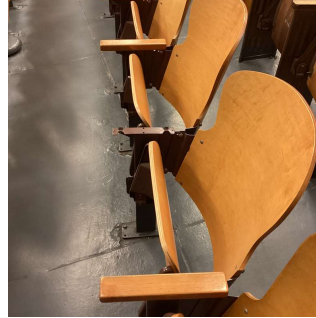
Seat M/19
No violations recorded.

Question	Response
INTERIOR	
STRUCTURAL	
VAULTS-BUNKERS	
Vault/Ash Hoist Doors and Framing	
Deficiency Photo1	 
Violations	Basement - Ash Hoist Vault No violations recorded.
AUDITORIUM	
Instance on 1st Floor (549 Seats)	Inspected
Ceiling	Inspected
Instance on 1st Floor (549 Seats)	Inspected
Condition	2 - Between Good and Fair
Deficiency	No deficiencies recorded
Door(s)	
Instance on 1st Floor (549 Seats)	Inspected
Condition	3 - Fair
Deficiency	WOOD: DETERIORATED DOOR
Deficiency Location/Instance	Storage Room - 2nd Floor
Deficiency Quantity	1
Quantity Uom	EACH
Potential Action	MAINTENANCE
Urgency of Action	PRIORITY 3
Purpose of Action	LEVEL 2
Deficiency Photo1	 
Violations	Storage Room - 2nd Floor No violations recorded.
Fixed H/C Lift	
Instance on 1st Floor (549 Seats)	Does not Exist
Fixed Seating	
Instance on 1st Floor (549 Seats)	Inspected
Condition	5 - Poor
Deficiency	DAMAGED/BROKEN/INOPERABLE
Deficiency Location/Instance	Seats F/11, M/19

Quantity Uom	EACH
Potential Action	REPLACE
Urgency of Action	PRIORITY 5
Purpose of Action	LEVEL 6
Deficiency Photo1

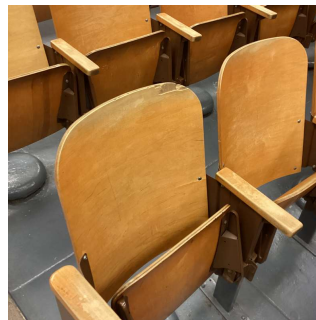
Seat K/1
No violations recorded.

Deficiency	DAMAGED/BROKEN/INOPERABLE
Deficiency Location/Instance	Seats K/1, M/2, 4, 20, O/17, and others.
Deficiency Quantity	70
Quantity Uom	EACH
Potential Action	REPLACE
Urgency of Action	PRIORITY 3
Purpose of Action	LEVEL 2
Deficiency Photo1

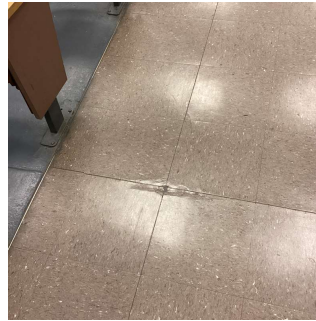
Instance on 1st Floor (549 Seats)	Inspected
Condition	2 - Between Good and Fair
Deficiency	VINYL TILES: BROKEN/DETERIORATED/MISSING TILES
Deficiency Location/Instance	Near Seat C/2
Deficiency Quantity	10
Quantity Uom	S.F.
Potential Action	REPLACE
Urgency of Action	PRIORITY 3
Purpose of Action	LEVEL 2

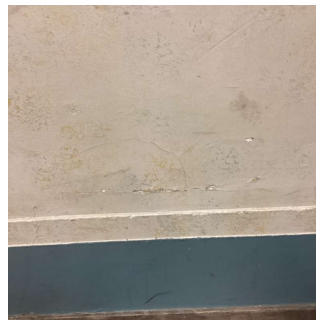
Near Main Entrance

PLASTER: CRACKS/SPALLING

REPLACE

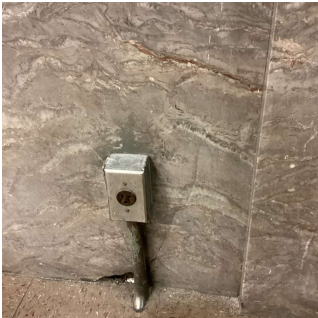
Question	Response
INTERIOR	
AUDITORIUM	
Walls	
Violations	No violations recorded.
Deficiency	STONE: CRACKS/SPALLING
Deficiency Location/Instance	Near Exit 8
Deficiency Quantity	30
Quantity Uom	S.F.
Potential Action	REPLACE
Urgency of Action	PRIORITY 3
Purpose of Action	LEVEL 2
Deficiency Photo1

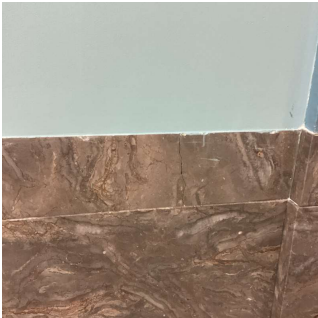
Violations	Near Exit 8
Violations	No violations recorded.
Deficiency	STONE MOLDINGS: CRACKS/SPALLING
Deficiency Location/Instance	Near Exit 8
Deficiency Quantity	10
Quantity Uom	L.F.
Potential Action	REPLACE
Urgency of Action	PRIORITY 3
Purpose of Action	LEVEL 2
Deficiency Photo1

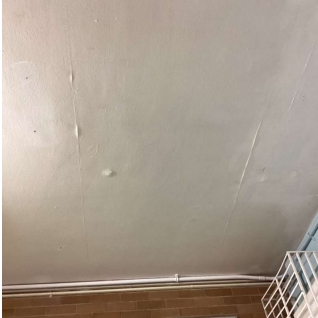
Question	Response
INTERIOR	
CAFETERIA	
Ceiling	
Deficiency Location/Instance	Near Entrance, Stair CD
Deficiency Quantity	80
Quantity Uom	S.F.
Potential Action	REPLACE
Urgency of Action	PRIORITY 3
Purpose of Action	LEVEL 2
Deficiency Photo1

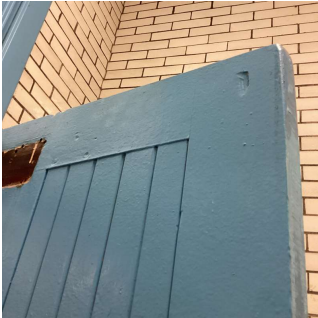
Violations	Near Entrance No violations recorded.
Door(s)	
Instance on 1st Floor	Inspected
Condition	4 - Between Fair and Poor
Deficiency	WOOD: DETERIORATED DOOR
Deficiency Location/Instance	Lobby Exit 1
Deficiency Quantity	2
Quantity Uom	EACH
Potential Action	MAINTENANCE
Urgency of Action	PRIORITY 3
Purpose of Action	LEVEL 2
Deficiency Photo1

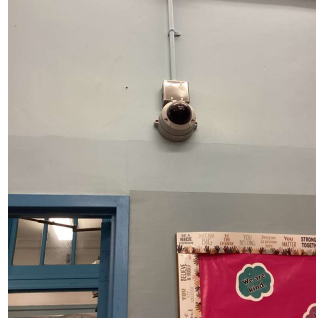
Near Entrance

PLASTER: CRACKS/SPALLING

REPLACE

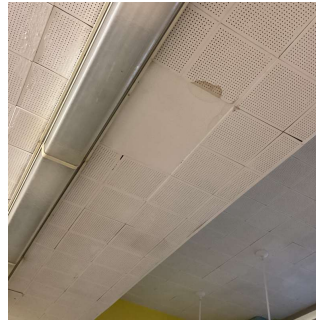
Room 101

ACOUSTIC TILES ON PLASTER: DAMAGED/MISSING

REPLACE

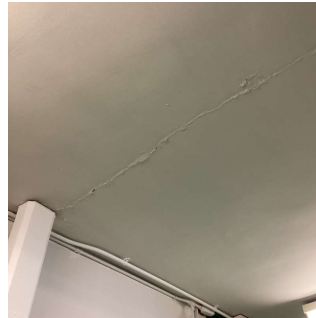
Corridor near Room 206

PLASTER: CRACKS/SPALLING

REPLACE

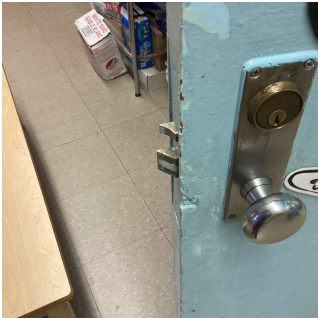
Question	Response
INTERIOR	
CLASSROOMS/CORRIDORS/ADMIN SPACES	
Door(s)	
	Room 419
Violations	No violations recorded.
Deficiency	WOOD: DETERIORATED DOOR
Deficiency Location/Instance	Rooms 101, 213, 403, 408, 5W4, and others.
Deficiency Quantity	18
Quantity Uom	EACH
Potential Action	MAINTENANCE
Urgency of Action	PRIORITY 3
Purpose of Action	LEVEL 2
Deficiency Photo1

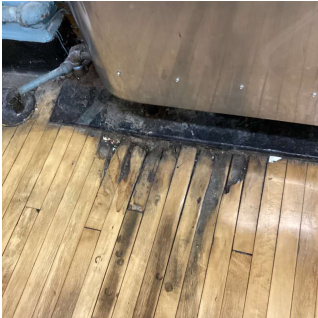
Room 101
Violations	No violations recorded.
Floor Finish	Inspected
Condition	3 - Fair
Deficiency	WOOD: DAMAGED/DETERIORATED
Deficiency Location/Instance	Rooms 301, 307, 405, 5W1, 5W4, and others.
Deficiency Quantity	250
Quantity Uom	S.F.
Potential Action	REPLACE
Urgency of Action	PRIORITY 3
Purpose of Action	LEVEL 2
Deficiency Photo1

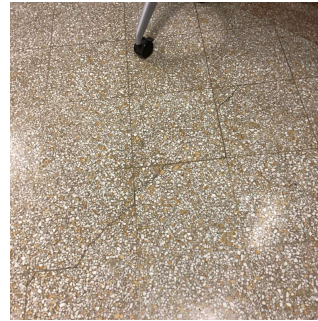
Corridor near Room 103

Room 405
Violations	No violations recorded.
Deficiency	TERRAZZO: CRACKS
Deficiency Location/Instance	Corridor near Rooms 101, 103
Deficiency Quantity	30
Quantity Uom	S.F.
Potential Action	REPLACE
Urgency of Action	PRIORITY 3

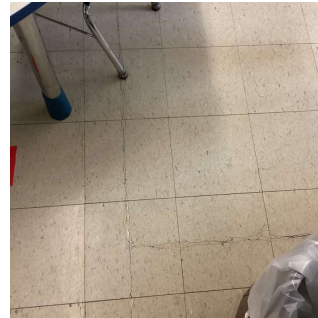
Room 213

VINYL TILES: DETERIORATED SUBSTRATE

REPLACE

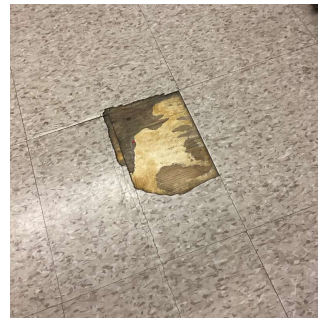
Room 415

VINYL TILES: BROKEN/DETERIORATED/MISSING TILES

REPLACE

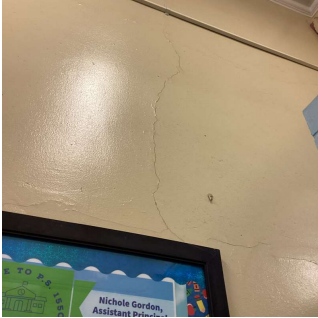
Question	Response
INTERIOR	
CLASSROOMS/CORRIDORS/ADMIN SPACES	
Walls	Inspected
Condition	2 - Between Good and Fair
Deficiency	PLASTER: CRACKS/SPALLING
Deficiency Location/Instance	Main Entrance, 307, 403, Corridor near Rooms 413, 5W3, and others
Deficiency Quantity	150
Quantity Uom	S.F.
Potential Action	REPLACE
Urgency of Action	PRIORITY 3
Purpose of Action	LEVEL 2
Deficiency Photo1

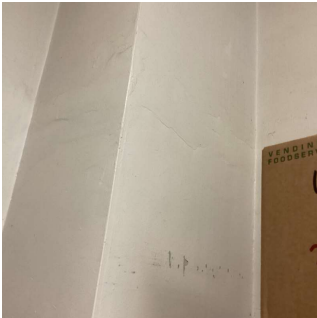
Question	Response
INTERIOR	
KITCHEN	Inspected
Floor Finish	
Violations	Near Storage Room /Office No violations recorded.
Walls	
Instance on 1st Floor	Inspected
Condition	2 - Between Good and Fair
Deficiency	PLASTER: CRACKS/SPALLING
Deficiency Location/Instance	Storage Room /Office, Locker Room
Deficiency Quantity	20
Quantity Uom	S.F.
Potential Action	REPLACE
Urgency of Action	PRIORITY 3
Purpose of Action	LEVEL 2
Deficiency Photo1

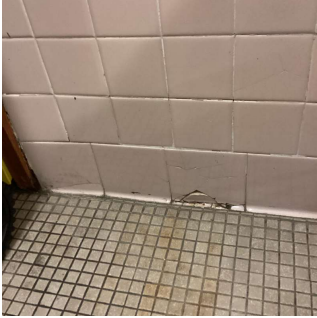
Violations	Storage Room /Office No violations recorded.
Deficiency	CERAMIC TILE: BROKEN/ MISSING
Deficiency Location/Instance	Mopp Room
Deficiency Quantity	10
Quantity Uom	S.F.
Potential Action	REPLACE
Urgency of Action	PRIORITY 3
Purpose of Action	LEVEL 2
Deficiency Photo1

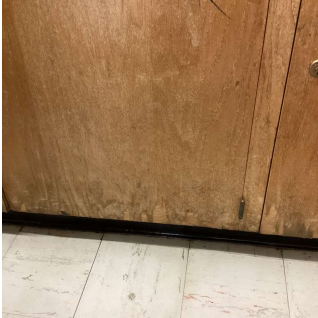
Violations	Mopp Room No violations recorded.
LIBRARY	Inspected
Instance on Room 309	Inspected
Built-in Furnishing	
Instance on Room 309	Inspected
Condition	2 - Between Good and Fair
Deficiency	MISSING/DAMAGED

Question	Response
INTERIOR	
LIBRARY	
Built-in Furnishing	
Deficiency Location/Instance	Near Librarian Desk
Deficiency Quantity	10
Quantity Uom	L.F.
Potential Action	REPLACE
Urgency of Action	PRIORITY 3
Purpose of Action	LEVEL 2
Deficiency Photo1

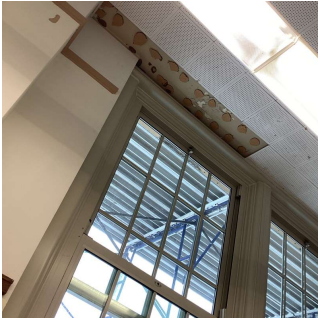
Violations	Near Librarian Desk No violations recorded.
Ceiling	
Instance on Room 309	Inspected
Condition	2 - Between Good and Fair
Deficiency	ACOUSTIC TILES ON PLASTER: DAMAGED/MISSING
Deficiency Location/Instance	Near Windows
Deficiency Quantity	20
Quantity Uom	S.F.
Potential Action	REPLACE
Urgency of Action	PRIORITY 3
Purpose of Action	LEVEL 2
Deficiency Photo1

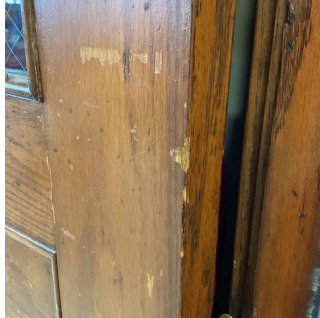
Violations	Near Windows No violations recorded.
Door(s)	
Instance on Room 309	Inspected
Condition	3 - Fair
Deficiency	WOOD: DETERIORATED DOOR
Deficiency Location/Instance	Entrance
Deficiency Quantity	1
Quantity Uom	EACH
Potential Action	MAINTENANCE
Urgency of Action	PRIORITY 3

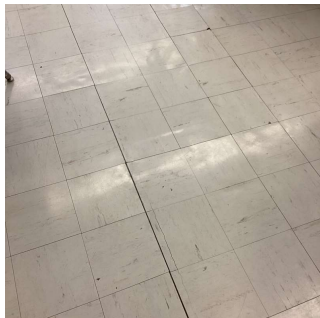
Entrance
Violations	No violations recorded.
Floor Finish	
Instance on Room 309	Inspected
Condition	5 - Poor
Deficiency	VINYL TILES: BROKEN/DETERIORATED/MISSING TILES
Deficiency Location/Instance	Near Entrance, Center
Deficiency Quantity	600
Quantity Uom	S.F.
Potential Action	REPLACE
Urgency of Action	PRIORITY 3
Purpose of Action	LEVEL 2
Deficiency Photo1

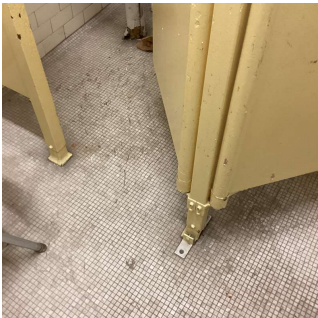
Room 103
Violations	No violations recorded.
Floor Finish	Inspected
Condition	4 - Between Fair and Poor
Deficiency	CERAMIC TILE: BROKEN/MISSING TILES
Deficiency Location/Instance	Rooms 351, 361, 451
Deficiency Quantity	40
Quantity Uom	S.F.
Potential Action	REPLACE
Urgency of Action	PRIORITY 3
Purpose of Action	LEVEL 2
Deficiency Photo1

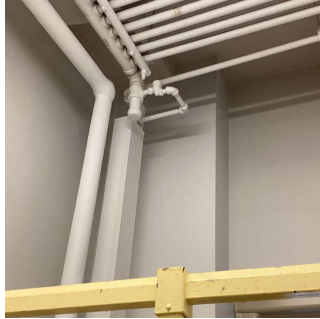
Room 451
Violations	No violations recorded.
Stalls	Inspected
Condition	2 - Between Good and Fair
Deficiency	No deficiencies recorded
Walls	Inspected
Condition	2 - Between Good and Fair
Deficiency	PLASTER: CRACKS/SPALLING
Deficiency Location/Instance	Rooms 258, 451
Deficiency Quantity	20
Quantity Uom	S.F.
Potential Action	REPLACE
Urgency of Action	PRIORITY 3
