NYC Department of Education
Building Condition Assessment Survey 2023 - 2024

Architectural Inspection

Asset: P.S. 159 - QUEENS, 205-01 33 AVENUE, New York, 11361

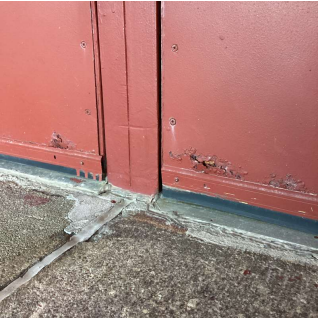
Question	Response
Architectural	
EXTERIOR	Inspected
AREAWAY	Inspected
Instance on AW1-AW13	Inspected
Instance Condition	2 - Between Good and Fair
Instance Quantity	13
Instance Quantity Uom	EACH
Deficiency	No deficiencies recorded
AWNINGS AND CANOPIES	Inspected
Condition	2 - Between Good and Fair
Deficiency	No deficiencies recorded
CHIMNEY	Under Construction
COPING	Under Construction
CORNICE	Does not Exist
DOORS	Inspected
DOORS AND FRAMES	Inspected
Condition	5 - Poor
Deficiency	METAL CLAD: DETERIORATED DOOR - MAJOR DETERIORATION
Roof Plan reference

Deficiency Quantity	6
Quantity Uom	EACH
Potential Action	REPLACE
Urgency of Action	PRIORITY 4
Purpose of Action	LEVEL 2
Deficiency Photo1

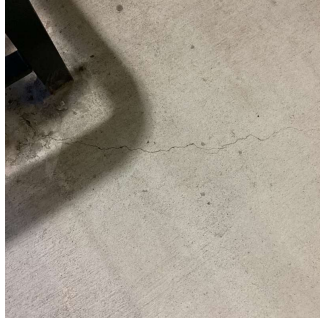
Violations	Facade F No violations recorded.
Deficiency	STONE: DETERIORATED JOINTS

Deficiency Quantity	10
Quantity Uom	S.F.
Potential Action	REPAIR
Urgency of Action	PRIORITY 3
Purpose of Action	LEVEL 2
Deficiency Photo1

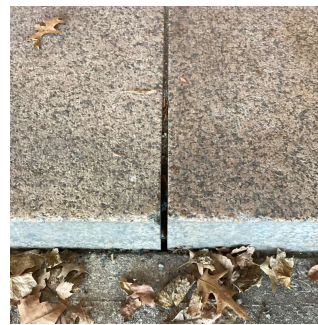
Facade H

20
L.F.
REPOINT
PRIORITY 4
LEVEL 2

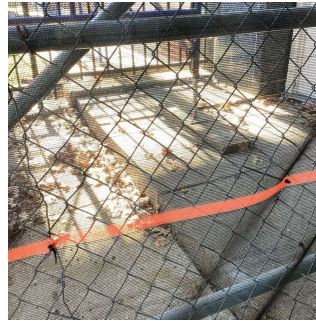
Facade H

STONE: DETERIORATED SUBSTRATE

10
S.F.
REPLACE SUBSTRATE AND RESET
PRIORITY 4
LEVEL 2

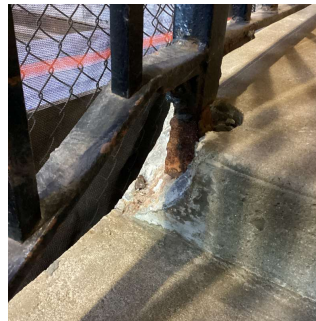
Facade E

CONCRETE: CRACKS/SPALLING - MAJOR

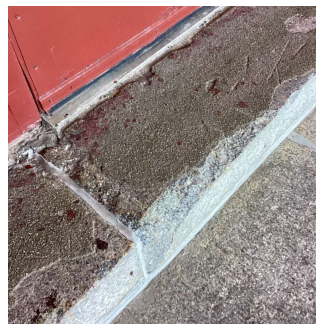
Facade C

STONE: WORN-OUT TREAD/RISER/NOSING

10
S.F.
REPLACE
PRIORITY 4
LEVEL 2

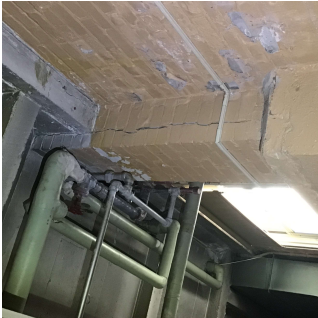
Question	Response
EXTERIOR	Inspected
WINDOWS	Inspected
WINDOWS	
Instance Quantity Uom	S.F.
INTERIOR	Inspected
POOLS	Does not Exist
STRUCTURAL	Inspected
COLUMNS/BEAMS/BEARING WALLS	Inspected
Condition	4 - Between Fair and Poor
Deficiency	STEEL COLUMNS/BEAMS: DETERIORATED MASONRY FIREPROOFING
Deficiency Location/Instance	Basement Boiler Room Shop, Storage Room
Deficiency Quantity	80
Quantity Uom	S.F.
Potential Action	REPLACE
Urgency of Action	PRIORITY 4
Purpose of Action	LEVEL 5
Deficiency Photo1

Violations	Boiler Room Shop No violations recorded.
Deficiency	CONCRETE COLUMNS/BEAMS: CRACKED/SPALLED/REINFORCEMENT EXPOSED
Deficiency Location/Instance	Boiler Room
Deficiency Quantity	10
Quantity Uom	S.F.
Potential Action	REPLACE
Urgency of Action	PRIORITY 4
Purpose of Action	LEVEL 5
Deficiency Photo1

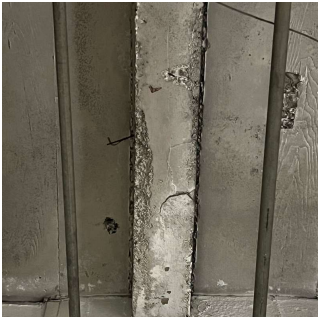
Violations	Boiler Room No violations recorded.
Deficiency	STEEL COLUMNS/BEAMS: DETERIORATED CONCRETE FIREPROOFING
Deficiency Location/Instance	Basement - Boiler Room, Shop

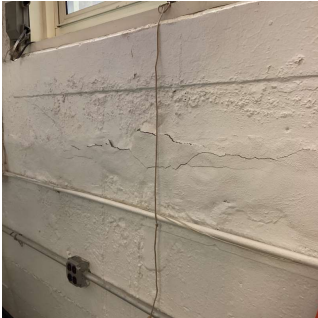
Question	Response
INTERIOR	
STRUCTURAL	
FOUNDATION WALLS	
Violations	No violations recorded.
Deficiency	CONCRETE: CRACKED/SPALLED/REINFORCEMENT EXPOSED
Deficiency Location/Instance	Basement - Boiler Room, Storage Area
Deficiency Quantity	50
Quantity Uom	S.F.
Potential Action	REPAIR
Urgency of Action	PRIORITY 3
Purpose of Action	LEVEL 5
Deficiency Photo1

Boiler Room
Violations	No violations recorded.
Deficiency	BRICK: CRACKED/SPALLED
Deficiency Location/Instance	Basement - Boiler Room, Storage Area, Oil Tank Room
Deficiency Quantity	60
Quantity Uom	S.F.
Potential Action	RESTITCH
Urgency of Action	PRIORITY 3
Purpose of Action	LEVEL 5
Deficiency Photo1

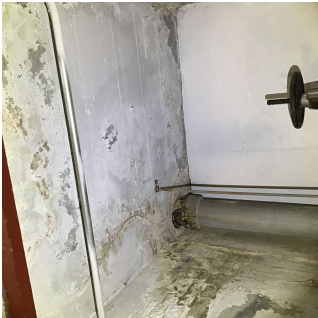
Question	Response
INTERIOR	
STRUCTURAL	
VAULTS-BUNKERS	
Slab Structure	
Deficiency	CONCRETE: CRACKS/SPALLED/REINFORCEMENT EXPOSED
Deficiency Location/Instance	Basement
Deficiency Quantity	20
Quantity Uom	S.F.
Potential Action	REPAIR
Urgency of Action	PRIORITY 3
Purpose of Action	LEVEL 5
Deficiency Photo1

Violations	Ash Hoist Vault No violations recorded.
Vault/Ash Hoist Doors and Framing	Inspected
Condition	5 - Poor
Deficiency	WATER INFILTRATION
Deficiency Location/Instance	Ash Hoist Vault
Deficiency Quantity	10
Quantity Uom	S.F.
Potential Action	REPAIR
Urgency of Action	PRIORITY 5
Purpose of Action	LEVEL 2
Deficiency Photo1

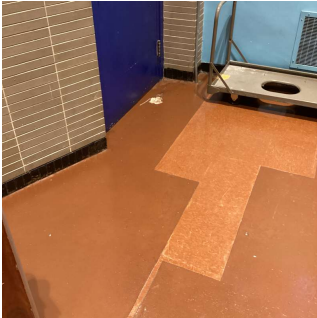
Question	Response
INTERIOR	
AUDITORIUM	
Door(s)	
Condition	2 - Between Good and Fair
Deficiency	No deficiencies recorded
Fixed H/C Lift	
Instance on 1st Floor (380 Seats)	Does not Exist
Fixed Seating	
Instance on 1st Floor (380 Seats)	Inspected
Condition	2 - Between Good and Fair
Deficiency	DAMAGED/BROKEN/INOPERABLE
Deficiency Location/Instance	Seats A/1, 2, 6, 114, C/5 and others
Deficiency Quantity	9
Quantity Uom	EACH
Potential Action	REPLACE
Urgency of Action	PRIORITY 3
Purpose of Action	LEVEL 2
Deficiency Photo1	 
Violations	Seat A/2 No violations recorded.
Floor Finish	
Instance on 1st Floor (380 Seats)	Inspected
Condition	2 - Between Good and Fair
Deficiency	SHEET VINYL: BROKEN/DETERIORATED
Deficiency Location/Instance	Left Side near Stage, Center
Deficiency Quantity	20
Quantity Uom	S.F.
Potential Action	REPLACE
Urgency of Action	PRIORITY 3
Purpose of Action	LEVEL 2
Deficiency Photo1

Violations	Left Side near Stage No violations recorded.

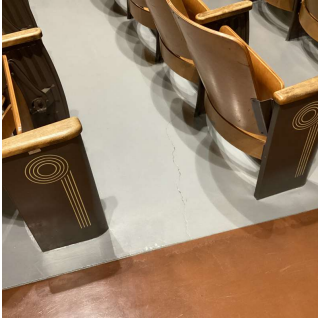
Question	Response
INTERIOR	
AUDITORIUM	
Floor Finish	
Deficiency Location/Instance	Near seats B/1, 3, 5, 7, C/101 and others
Deficiency Quantity	80
Quantity Uom	S.F.
Potential Action	REPLACE
Urgency of Action	PRIORITY 3
Purpose of Action	LEVEL 2
Deficiency Photo1

Near seat C/101
Violations	No violations recorded.
Sliding-folding Partition	
Instance on 1st Floor (380 Seats)	Does not Exist
Stage	
Instance on 1st Floor (380 Seats)	Inspected
Stage	Inspected
Instance on 1st Floor (380 Seats)	Inspected
Condition	3 - Fair
Deficiency	DAMAGED FASCIA
Deficiency Location/Instance	Front, left and Right Side
Deficiency Quantity	40
Quantity Uom	S.F.
Potential Action	REPLACE
Urgency of Action	PRIORITY 3
Purpose of Action	LEVEL 2
Deficiency Photo1

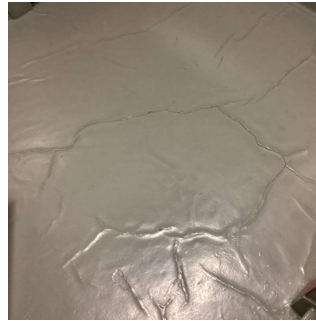
Stair CD/3

TERRAZZO: CRACKS

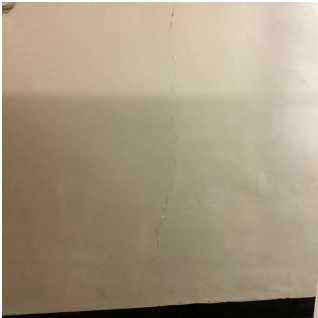
Question	Response
INTERIOR	
STAIRS/RAMPS: INTERIOR	
Walls	
Violations	Stair AB/2 No violations recorded.
Deficiency	PLASTER: CRACKS/SPALLING
Deficiency Location/Instance	Stairs AB/3, 1, CD/1
Deficiency Quantity	40
Quantity Uom	S.F.
Potential Action	REPLACE
Urgency of Action	PRIORITY 3
Purpose of Action	LEVEL 2
Deficiency Photo1

Violations	Stair CD/1 No violations recorded.
Deficiency	GLAZED BLOCK: CRACKS/SPALLING
Deficiency Location/Instance	Stair EF/1 Vestibule, 1, 2, 3
Deficiency Quantity	80
Quantity Uom	S.F.
Potential Action	REPLACE
Urgency of Action	PRIORITY 3
Purpose of Action	LEVEL 2
Deficiency Photo1
