**NYC Department of Education**  
**Building Condition Assessment Survey 2023 - 2024**

Architectural Inspection

**Asset:** P.S. 160 - QUEENS, 109-59 INWOOD STREET, New York, 11435

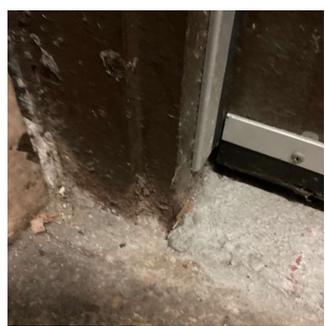
Violations	Facade F No violations recorded.
Deficiency	METAL CLAD: DETERIORATED DOOR AND FRAME - MAJOR DETERIORATION

Deficiency Quantity	2
Quantity Uom	EACH
Potential Action	REPLACE
Urgency of Action	PRIORITY 4
Purpose of Action	LEVEL 2
Deficiency Photo1

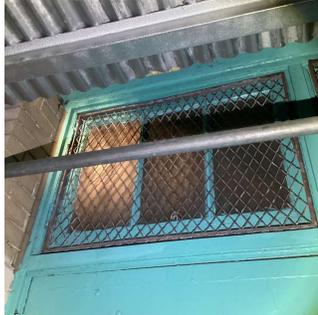
Facade F
Violations	No violations recorded.
<b>EXTERIOR WALLS</b>	
Material Type(s)	Inspected Masonry
Replacement Quantity	32,000
Replacement Uom	S.F.
Instance on All Facades except Facades C, D, E, F	Inspected
Instance Condition	3 - Fair
Instance Quantity	22,000
Instance Quantity Uom	S.F.
Deficiency	BRICK: WATER INFILTRATION IN INSTRUCTIONAL SPACE
Roof Plan reference	Q160

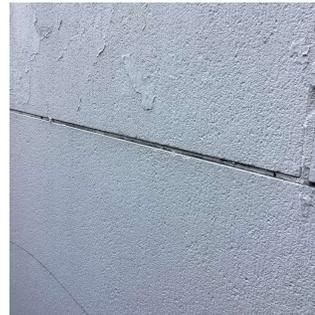
Facade G

STONE: CRACKS AT BUILDING CORNERS

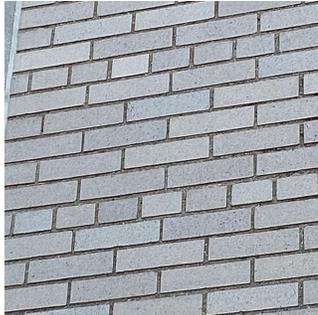
Facade B
Violations	No violations recorded.
Instance on Facades C, D, E, F	Inaccessible
Instance Quantity	10,000
Instance Quantity Uom	S.F.
<b>EXTERIOR SOFFITS</b>	
Condition	Inspected
Deficiency	2 - Between Good and Fair
	No deficiencies recorded
<b>LOADING DOCK</b>	
	Does not Exist
<b>LOUVER</b>	
Condition	Inspected
Deficiency	2 - Between Good and Fair
	No deficiencies recorded
<b>PARAPETS</b>	
Material Type(s)	Inspected
Replacement Quantity	Masonry
Replacement Uom	6,000
	C.F.
Instance on All Facades	Inspected
Instance Condition	3 - Fair
Instance Quantity	6,000
Instance Quantity Uom	C.F.
Deficiency	BRICK: EFFLORESCENCE
Roof Plan reference	Q160

Question	Response
<b>EXTERIOR</b>	
<b>EXTERIOR WALLS</b>	
Urgency of Action	PRIORITY 3
Purpose of Action	LEVEL 2
Deficiency Photo1

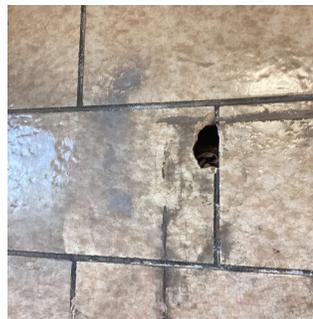
Roof 1 - Bulkhead 2

**BULKHEAD/PENTHOUSE WALLS/INTERIOR: SALT GLAZED BRICK DETERIORATED JOINTS**

10  
 S.F.  
 REPLACE  
 PRIORITY 3  
 LEVEL 2

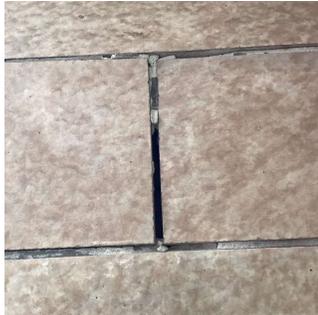
Violations	Roof 1 - Bulkhead 2 No violations recorded.
Deficiency	<b>BULKHEAD/PENTHOUSE WALLS/EXTERIOR: EFFLORESCENCE</b>
Roof Plan reference	Q160

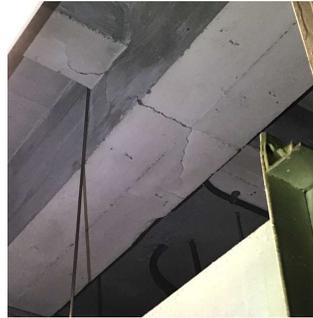
Fan Room

**MASONRY BEARING WALL: CRACKED/SPALLED**

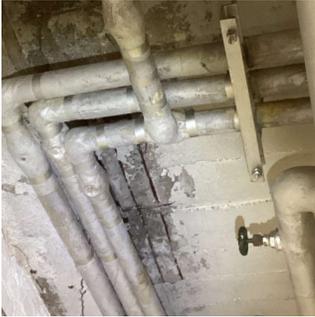
Question	Response
<b>INTERIOR</b>	
<b>STRUCTURAL</b>	
<b>COLUMNS/BEAMS/BEARING WALLS</b>	Inspected
Violations	No violations recorded.
<b>FLOOR STRUCTURE</b>	Inspected
Condition	3 - Fair
Deficiency	CONCRETE: CRACKS/SPALLED/REINFORCEMENT EXPOSED
Deficiency Location/Instance	Basement - Storage
Deficiency Quantity	10
Quantity Uom	S.F.
Potential Action	REPAIR
Urgency of Action	PRIORITY 4
Purpose of Action	LEVEL 5
Deficiency Photo1

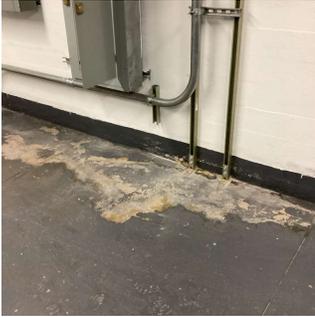
Violations	Basement- Electrical Panel Room No violations recorded.
<b>FOUNDATION WALLS</b>	Inspected
Material Type(s)	Concrete
Condition	4 - Between Fair and Poor
Deficiency	CONCRETE: WATER INFILTRATION IN ELECTRICAL PANEL ROOM
Deficiency Location/Instance	Basement- Electrical Panel Room
Deficiency Quantity	100
Quantity Uom	S.F.
Potential Action	INSTALL WATERPROOFING
Urgency of Action	PRIORITY 5
Purpose of Action	LEVEL 6
Deficiency Photo1

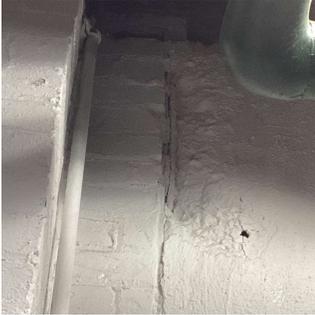
Deficiency	CONCRETE: CRACKED/SPALLED/REINFORCEMENT EXPOSED
Deficiency Location/Instance	Basement - Boiler Room, Fan Area
Deficiency Quantity	20

Question	Response
<b>INTERIOR</b>	
<b>STRUCTURAL</b>	
<b>FOUNDATION WALLS</b>	
Quantity Uom	S.F.
Potential Action	REPAIR
Urgency of Action	PRIORITY 3
Purpose of Action	LEVEL 5
Deficiency Photo1

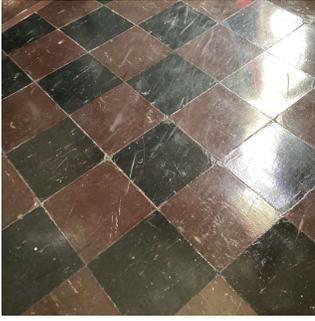
Near Seat T/2
Violations	No violations recorded.
Deficiency	VINYL TILES: BROKEN/DETERIORATED/MISSING TILES
Deficiency Location/Instance	Near Windows , Entrance, Corridors, stage.
Deficiency Quantity	2,500
Quantity Uom	S.F.
Potential Action	REPLACE
Urgency of Action	PRIORITY 3
Purpose of Action	LEVEL 2
Deficiency Photo1

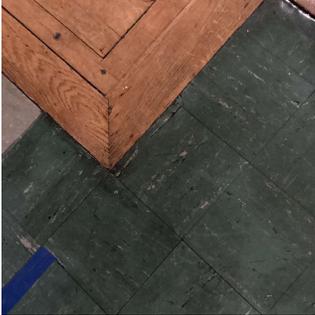
Violations	Near Step Right Side No violations recorded.
Deficiency	DAMAGED STEPS
Deficiency Location/Instance	Right and Left Side
Deficiency Quantity	20
Quantity Uom	S.F.
Potential Action	REPLACE
Urgency of Action	PRIORITY 3
Purpose of Action	LEVEL 2
Deficiency Photo1

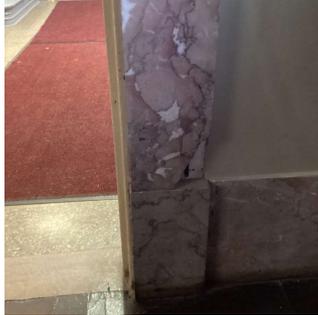
Near Stair Exit 9
Violations	No violations recorded.
Deficiency	PLASTER: CRACKS/SPALLING
Deficiency Location/Instance	Near Windows, Stage
Deficiency Quantity	30
Quantity Uom	S.F.
Potential Action	REPLACE
Urgency of Action	PRIORITY 3
Purpose of Action	LEVEL 2
Deficiency Photo1

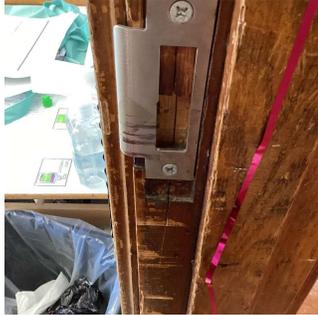
Room 217
Violations	No violations recorded.
<b>Deficiency</b>	<b>METAL: DETERIORATED DOOR</b>
Deficiency Location/Instance	Rooms 225, 228, 328, 425, 428, and others.
Deficiency Quantity	8
Quantity Uom	EACH
Potential Action	MAINTENANCE
Urgency of Action	PRIORITY 3
Purpose of Action	LEVEL 2
Deficiency Photo1

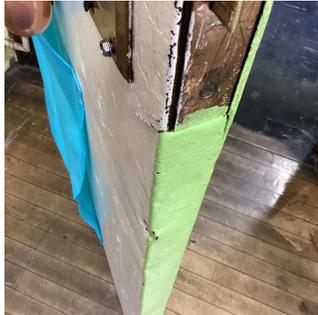
Room 428
Violations	No violations recorded.
<b>Deficiency</b>	<b>WOOD: DETERIORATED DOOR</b>
Deficiency Location/Instance	Rooms 111, 128, 221, 319, 423, and others.
Deficiency Quantity	12
Quantity Uom	EACH
Potential Action	MAINTENANCE
Urgency of Action	PRIORITY 3
Purpose of Action	LEVEL 2

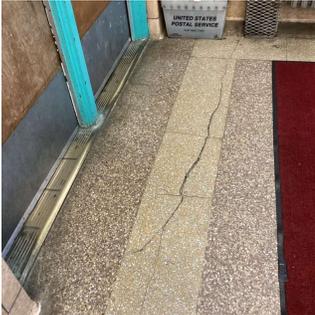
Violations	Main Entrance - Vestibule No violations recorded.
Deficiency	VINYL TILES: DETERIORATED SUBSTRATE
Deficiency Location/Instance	Rooms 121, 202, 221, 321, 323, and others.
Deficiency Quantity	2,000
Quantity Uom	S.F.
Potential Action	REPLACE
Urgency of Action	PRIORITY 3
Purpose of Action	LEVEL 2
Deficiency Photo1

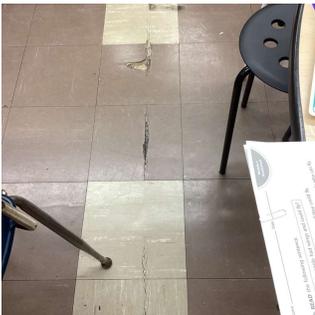
Violations	Room 328 No violations recorded.
Deficiency	VINYL TILES: BROKEN/DETERIORATED/MISSING TILES
Deficiency Location/Instance	Rooms 127, 128, 415, Corridor near Rooms 319, 415, and others.
Deficiency Quantity	4,000

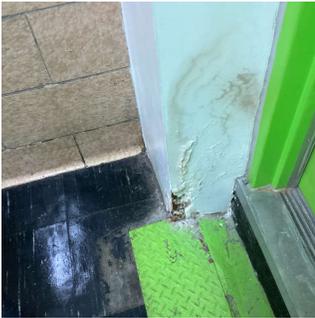
Violations	Corridor near Room 402 No violations recorded.
Deficiency	PLASTER: CRACKS/SPALLING
Deficiency Location/Instance	Rooms 111, 128, 409, 413, 428, and others.
Deficiency Quantity	100
Quantity Uom	S.F.
Potential Action	REPLACE

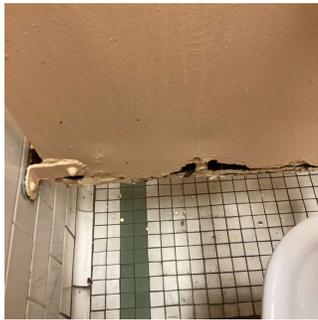
Room 106
Violations	No violations recorded.
<b>Walls</b>	
Condition	Inspected
	3 - Fair
Deficiency	PLASTER: CRACKS/SPALLING
Deficiency Location/Instance	Rooms 104, 106, 2nd Floor, 3rd Floor, 4th Floor
Deficiency Quantity	50
Quantity Uom	S.F.
Potential Action	REPLACE
Urgency of Action	PRIORITY 3
Purpose of Action	LEVEL 2
Deficiency Photo1

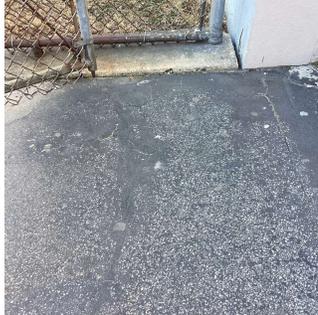
Violations	Near Exit 9 No violations recorded.
<b>Concrete</b>	Inspected
Condition	2 - Between Good and Fair
Deficiency	DAMAGED/DETERIORATED/MISSING SECTIONS
Deficiency Location/Instance	Near Exit 7
Deficiency Quantity	25
Quantity Uom	S.F.
Potential Action	REPLACE
Urgency of Action	PRIORITY 3
Purpose of Action	LEVEL 2
Deficiency Photo1
