NYC Department of Education
Building Condition Assessment Survey 2023 - 2024

Architectural Inspection

Asset: P.S. 161 - QUEENS, 101-33 124TH STREET, New York, 11419

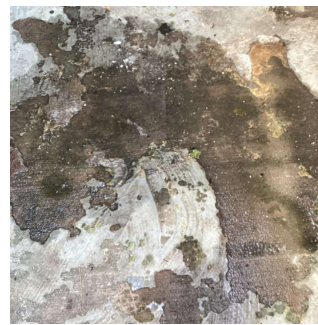
Facade F - AW1

AREAWAY SLAB: CRACKS AND SPALLING

30
 S.F.
 REPAIR
 PRIORITY 3
 LEVEL 2

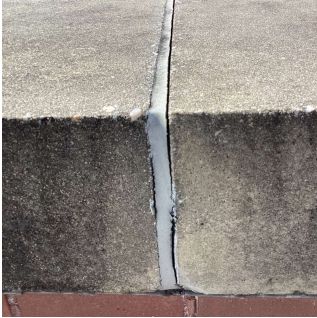
CAST STONE: DETERIORATED TRANSVERSE JOINTS

Question	Response
EXTERIOR	
COPING	
Quantity Uom	L.F.
Potential Action	MAINTENANCE
Urgency of Action	PRIORITY 3
Purpose of Action	LEVEL 2
Deficiency Photo1

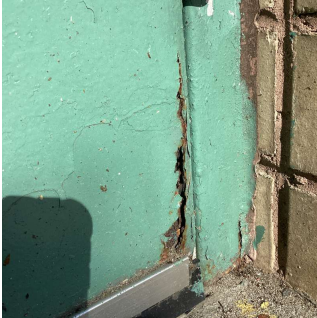
Violations	Roof 1 No violations recorded.
CORNICE	Does not Exist
DOORS	Inspected
DOORS AND FRAMES	Inspected
Condition	4 - Between Fair and Poor
Deficiency	METAL: DETERIORATED DOOR AND FRAME - MAJOR DETERIORATION
Roof Plan reference	Q161 125TH STREET

Deficiency Quantity	4
Quantity Uom	EACH
Potential Action	REPLACE
Urgency of Action	PRIORITY 4
Purpose of Action	LEVEL 2
Deficiency Photo1

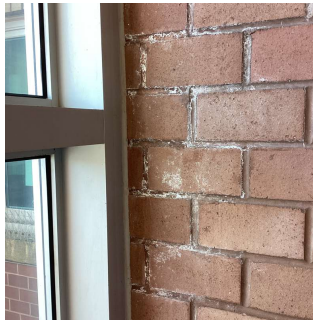
Facade C - 3rd Floor Corridor

BRICK: WATER INFILTRATION IN INSTRUCTIONAL SPACE

REPAIR

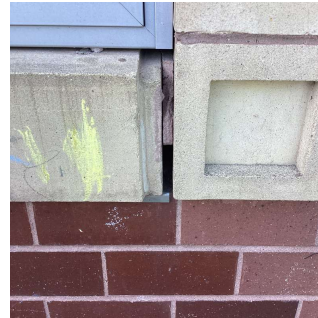
Facade B

BRICK: MASONRY SILLS - DETERIORATED JOINTS

PRIORITY 3
LEVEL 2

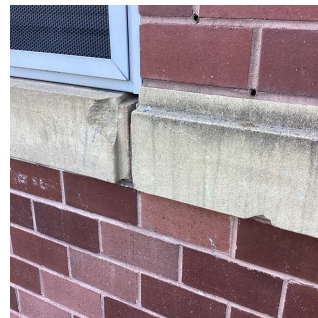
Facade B

BRICK: DETERIORATED MASONRY SILLS - MINOR

REPAIR

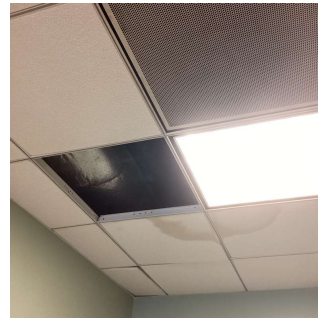
Roof 1 - Room 411 Library, also Corridor near Room 428

MODIFIED BITUMEN: ROOFING: MAJOR ACTIVE ROOF
LEAKS IN INSTRUCTIONAL SPACE

REPLACE ROOFING WITHOUT MAJOR EQUIPMENT
REMOVAL

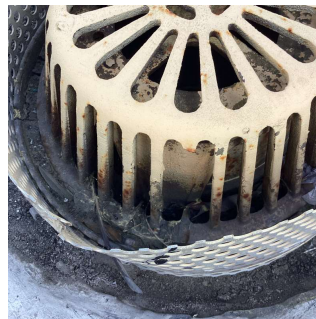
Roof 1

DETERIORATED

REPLACE

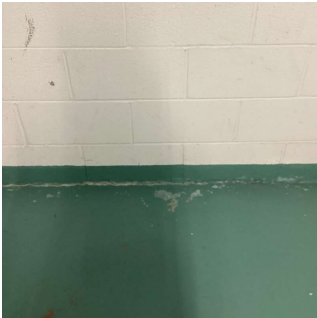
BULKHEAD/PENTHOUSE WALLS/EXTERIOR: WATER INFILTRATION

Question	Response
EXTERIOR	
ROOF	
Specialties	
BULKHEAD/PENTHOUSE	
Quantity Uom	S.F.
Potential Action	REPAIR
Urgency of Action	PRIORITY 5
Purpose of Action	LEVEL 2
Deficiency Photo1

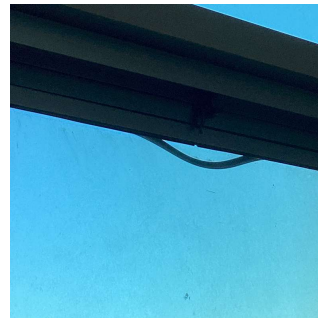
Deficiency	ALUMINUM - DOUBLE HUNG: DETERIORATED

120
S.F.
REPLACE WINDOW
PRIORITY 4
LEVEL 2

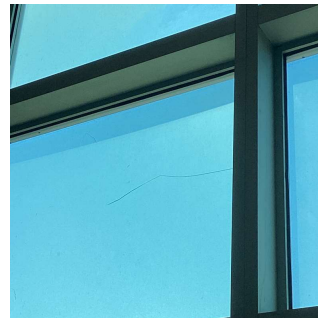
Facade A

Instance on Aluminum - Other: All Facades	Inspected
Instance Condition	4 - Between Fair and Poor
Instance Quantity	2,000
Instance Quantity Uom	S.F.
Are these windows insulated	Yes
Installation Year	2000
Source of Installation	Custodial Staff
Deficiency	ALUMINUM - OTHER: BROKEN PANE

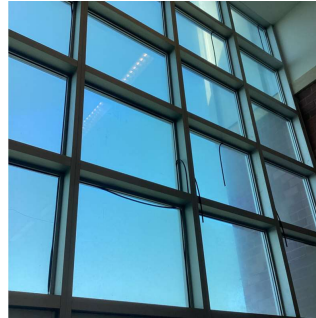
ALUMINUM - OTHER: DETERIORATED

400
S.F.
REPLACE WINDOW
PRIORITY 4
LEVEL 2

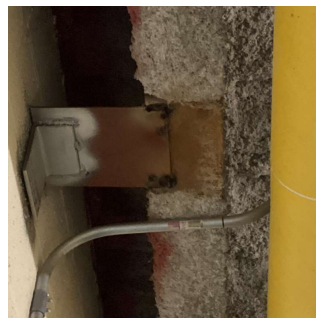
STEEL COLUMNS/BEAMS: DETERIORATED/MISSING SPRAY-ON FIREPROOFING

REPLACE

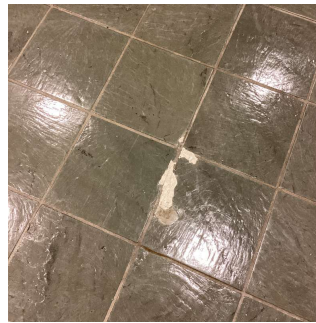
Violations	Room 433 No violations recorded.
Floor Finish	Inspected
Condition	2 - Between Good and Fair
Deficiency	CERAMIC TILE: BROKEN/MISSING TILES
Deficiency Location/Instance	Corridor near the Gymnasium
Deficiency Quantity	10
Quantity Uom	S.F.
Potential Action	REPLACE
Urgency of Action	PRIORITY 3
Purpose of Action	LEVEL 2

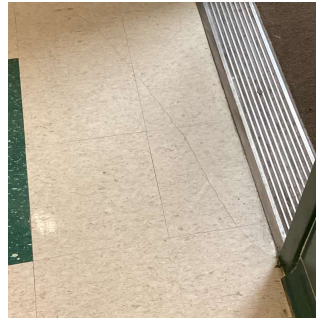
Corridor near Room 130

VINYL TILES: BROKEN/DETERIORATED/MISSING TILES

REPLACE

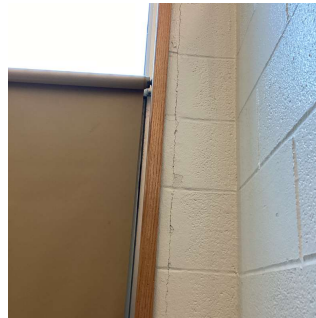
MASONRY: CRACKS/SPALLING

REPLACE

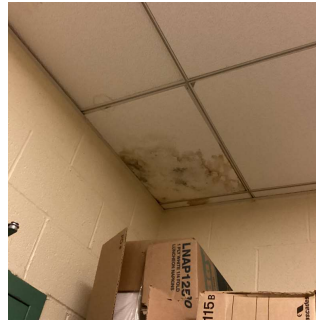
Deficiency	ACOUSTIC TILES: DAMAGED/MISSING
Deficiency Location/Instance	Storage Room
Deficiency Quantity	10
Quantity Uom	S.F.
Potential Action	REPLACE
Urgency of Action	PRIORITY 3
Purpose of Action	LEVEL 2

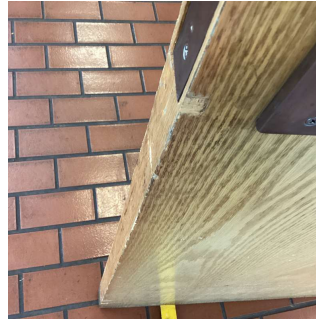
Instance on 2nd Floor	Inspected
Condition	3 - Fair
Deficiency	WOOD: DETERIORATED DOOR
Deficiency Location/Instance	Servery Entrance
Deficiency Quantity	1
Quantity Uom	EACH
Potential Action	MAINTENANCE
Urgency of Action	PRIORITY 3
Purpose of Action	LEVEL 2
Deficiency Photo1

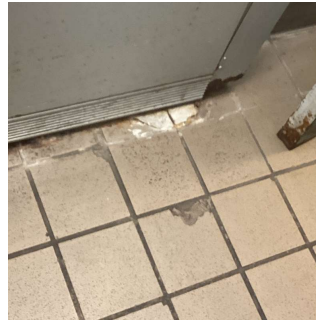
Food preparation area

Instance on 2nd Floor	Inspected
Condition	2 - Between Good and Fair
Deficiency	QUARRY TILE: BROKEN/MISSING TILES
Deficiency Location/Instance	Food preparation area, servery
Deficiency Quantity	10
Quantity Uom	S.F.
Potential Action	REPLACE
Urgency of Action	PRIORITY 3
Purpose of Action	LEVEL 2

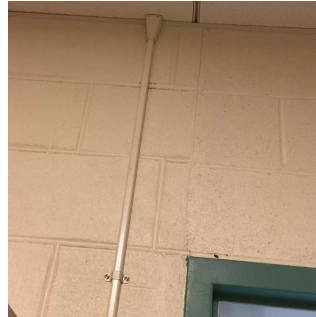
Office

Deficiency MASONRY: CRACKS/SPALLING

Potential Action REPLACE

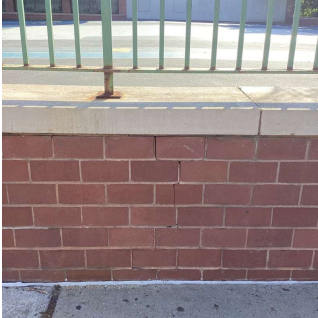
Question	Response
SITE	
RETAINING WALLS	
Deficiency	BRICK: CRACKS/SPALLING - MAJOR
Deficiency Location/Instance	124th Street
Deficiency Quantity	10
Quantity Uom	S.F.
Potential Action	REPLACE
Urgency of Action	PRIORITY 3
Purpose of Action	LEVEL 2
Deficiency Photo1
