**NYC Department of Education**  
**Building Condition Assessment Survey 2023 - 2024**

Architectural Inspection

**Asset:** P.S. 162 - QUEENS, 201-02 53 AVENUE, New York, 11364

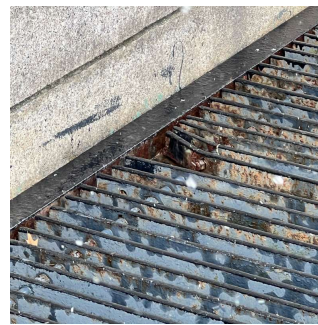
AW1  
No violations recorded.

AREAWAY GRATINGS: MAJOR RUSTING / OR BROKEN

10  
S.F.  
REPLACE  
PRIORITY 4  
LEVEL 2

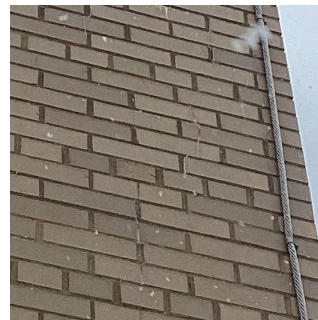
CH

BRICK: MINOR CRACKS AND SPALLING

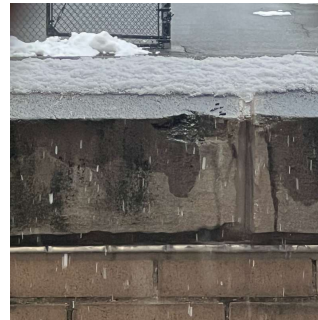
Roof 3 - Facade E

CAST STONE: CRACKED/BROKEN PIECES

REPLACE-IN-KIND

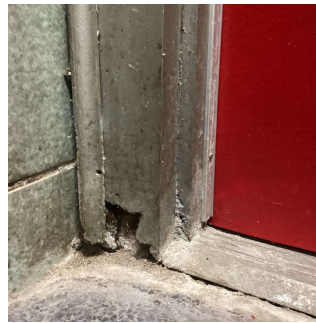
Facade C - Exit 8(6j)

METAL CLAD: DETERIORATED DOOR AND FRAME - MAJOR DETERIORATION

REPLACE

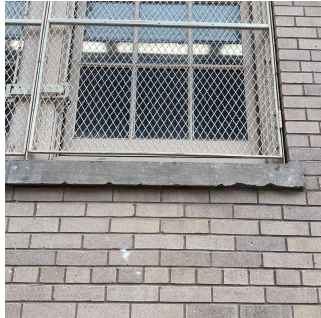
BRICK: DETERIORATED MASONRY SILLS - MINOR

REPAIR

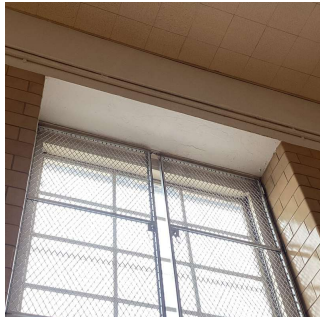
MODIFIED BITUMEN; ROOFING; MAJOR ACTIVE ROOF  
LEAKS IN INSTRUCTIONAL SPACE

Violations	Roof 2 - Gymnasium (Roof 2 - Room 341) No violations recorded.
<b>ROOFING DRAINS</b>	Inspected
Condition	1 - Good
Deficiency	No deficiencies recorded
<b>Specialties</b>	Inspected
<b>BULKHEAD/PENTHOUSE</b>	Inspected
Condition	4 - Between Fair and Poor
Deficiency	BULKHEAD/PENTHOUSE WINDOWS: DAMAGED, DETERIORATED WINDOWS
Roof Plan reference

300  
S.F.  
REPLACE ROOFING WITHOUT MAJOR EQUIPMENT  
REMOVAL  
PRIORITY 5  
LEVEL 2

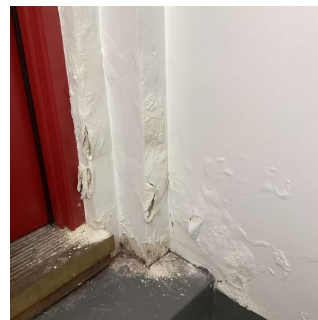
BH3  
No violations recorded.

**BULKHEAD/PENTHOUSE WALLS/INTERIOR: PLASTER CRACKS/SPALLING**

20  
S.F.  
REPLACE  
PRIORITY 4  
LEVEL 2

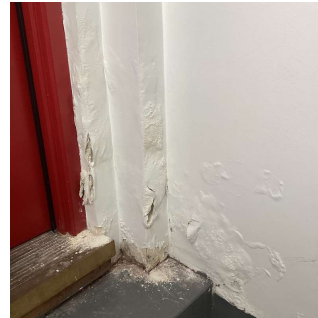
BH3

**BULKHEAD/PENTHOUSE WALLS/EXTERIOR: WATER INFILTRATION**

100  
S.F.  
REPAIR  
PRIORITY 5  
LEVEL 2

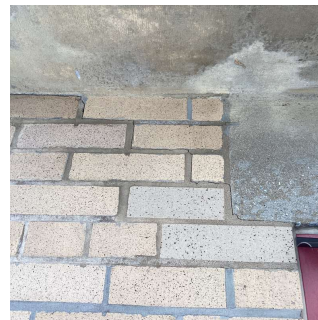
BH3

**BULKHEAD/PENTHOUSE WALLS/EXTERIOR:  
CRACKS/SPALLING - MINOR**

REPAIR

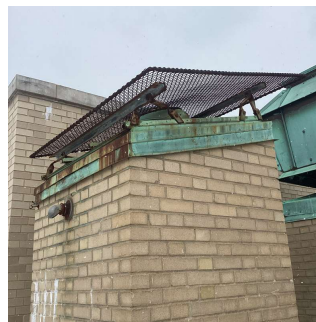
SK1  
 No violations recorded.

Deficiency **DAMAGED GUARDS**

25  
 S.F.  
 MAINTENANCE  
 PRIORITY 3  
 LEVEL 2

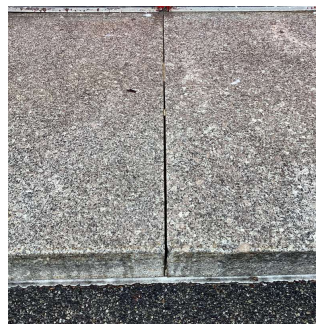
Facade C - Exit 8  
 No violations recorded.

STONE: DETERIORATED JOINTS

20  
 L.F.  
 REPOINT  
 PRIORITY 4  
 LEVEL 2

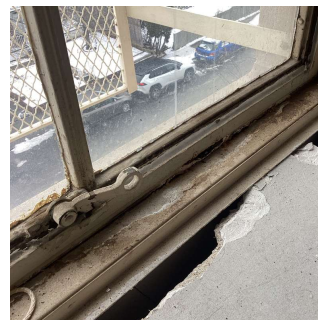
Facade H - Stair A-B/2 (similar throughout Auditorium, Gymnasium, Stair A-B)

Question	Response
<b>EXTERIOR</b>	
<b>WINDOWS</b>	
<b>EXTERIOR GUARDS</b>	
Elevation	 
Deficiency Quantity	90
Quantity Uom	S.F.
Potential Action	REPLACE
Urgency of Action	PRIORITY 4
Purpose of Action	LEVEL 2
Deficiency Photo1	 
Violations	Facade F No violations recorded.
<b>LINTELS</b>	Inspected
Condition	2 - Between Good and Fair
Deficiency	No deficiencies recorded
<b>WINDOWS</b>	Inspected
Material Type(s)	Solid Wood, Steel
Instance on Steel: All Facades	Inspected
Instance Condition	4 - Between Fair and Poor
Instance Quantity	2,100
Instance Quantity Uom	S.F.
Are these windows insulated	No
Installation Year	1954
Source of Installation	Custodial Staff
Deficiency	STEEL: DETERIORATED

600  
S.F.  
REPLACE WINDOW  
PRIORITY 4  
LEVEL 2

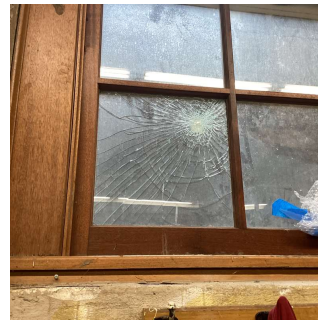
Facade E - Firemans Shop (similar throughout)  
No violations recorded.

Instance on Wood: All Facades	Inspected
Instance Condition	4 - Between Fair and Poor
Instance Quantity	4,900
Instance Quantity Uom	S.F.
Are these windows insulated	No
Installation Year	2004
Source of Installation	Custodial Staff
Deficiency	WOOD: BROKEN PANE

50  
S.F.  
MAINTENANCE  
PRIORITY 3  
LEVEL 2

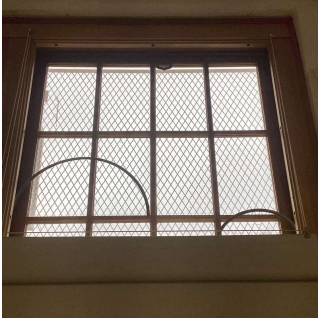
WOOD: DETERIORATED

Violations	Facade H - Room 211 (similar throughout) No violations recorded.
<b>INTERIOR</b>	Inspected
<b>POOLS</b>	Does not Exist
<b>STRUCTURAL</b>	Inspected
<b>COLUMNS/BEAMS/BEARING WALLS</b>	
Condition	3 - Fair
Deficiency	STEEL COLUMNS/BEAMS: MAJOR RUSTING
Deficiency Location/Instance	Basement - East Crawlspace
Deficiency Quantity	20
Quantity Uom	S.F.
Potential Action	REPLACE
Urgency of Action	PRIORITY 4
Purpose of Action	LEVEL 5
Deficiency Photo1

Question	Response
<b>EXTERIOR</b>	
<b>WINDOWS</b>	
<b>WINDOWS</b>	
Quantity Uom	S.F.
Potential Action	REPLACE WINDOW
Urgency of Action	PRIORITY 4
Purpose of Action	LEVEL 2
Deficiency Photo1

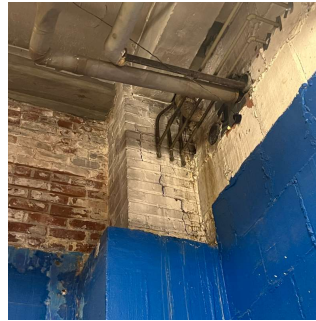
Violations	Basement - East Crawlspace No violations recorded.
Deficiency	STEEL COLUMNS/BEAMS: DETERIORATED MASONRY FIREPROOFING
Deficiency Location/Instance	Basement - Paint Room
Deficiency Quantity	10
Quantity Uom	S.F.
Potential Action	REPLACE
Urgency of Action	PRIORITY 3
Purpose of Action	LEVEL 5

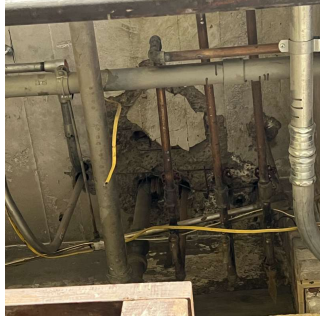
Violations	Basement - East Crawlspace No violations recorded.
Deficiency	CONCRETE: CRACKS/SPALLED/REINFORCEMENT EXPOSED
Deficiency Location/Instance	Basement - Firemans Shop, East and West Crawlspace

Basement - Firemans Shop
Violations	No violations recorded.
<b>FOUNDATION WALLS</b>	
Material Type(s)	Inspected Concrete, Masonry
Condition	5 - Poor
Deficiency	BRICK: CRACKED/SPALLED
Deficiency Location/Instance	Basement - Firemans Shop
Deficiency Quantity	20
Quantity Uom	S.F.
Potential Action	RESTITCH
Urgency of Action	PRIORITY 4
Purpose of Action	LEVEL 5
Deficiency Photo1

Deficiency Quantity	100
Quantity Uom	S.F.
Potential Action	REPAIR
Urgency of Action	PRIORITY 4

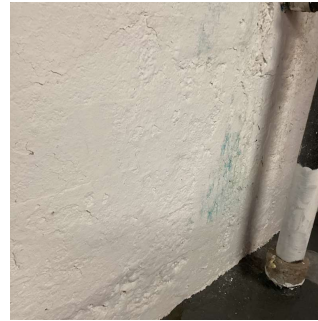
Firemans Shop
Violations	No violations recorded.
Deficiency	CONCRETE: CRACKED/SPALLED/REINFORCEMENT EXPOSED
Deficiency Location/Instance	Basement - Storage area, Boiler Room
Deficiency Quantity	10
Quantity Uom	S.F.
Potential Action	REPAIR
Urgency of Action	PRIORITY 4
Purpose of Action	LEVEL 5

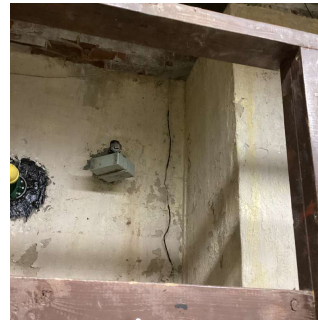
Basement - Firemans Shop

**CONCRETE: WATER INFILTRATION IN NON- INSTRUCTIONAL SPACE**

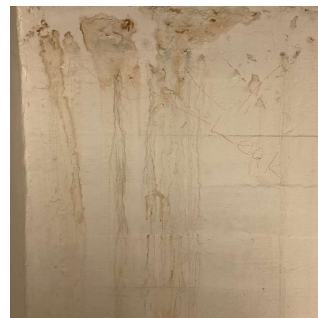
Boiler Room

**CONCRETE: WATER INFILTRATION IN NON- INSTRUCTIONAL SPACE**

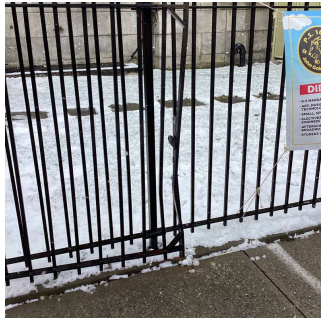
Priority Condition Exist Last Year?	Priority Category	Condition Description	Component Affected	Location Description	Person(s) Notified	Person(s) Title	PhotoImage
No	Potential Falling Debris	Leaning fence is a potential safety hazard.	SITE   FENCES	Schoolyard	Anthony DiDonna	Fireman

Question	Response
<b>SITE</b>	
<b>FENCES</b>	
Deficiency Location/Instance	53rd Avenue
Deficiency Quantity	320
Quantity Uom	S.F.
Potential Action	REPLACE
Urgency of Action	PRIORITY 3
Purpose of Action	LEVEL 2
Deficiency Photo1

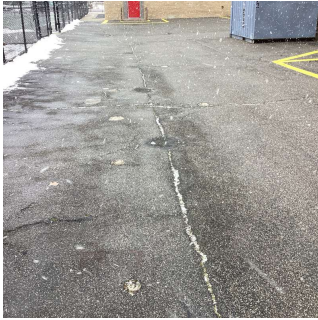
Question	Response
<b>SITE</b>	
<b>PAVING</b>	
<b>Student Use</b>	
<b>Asphalt</b>	
Deficiency	CRACKS - MAJOR
Deficiency Location/Instance	Schoolyard
Deficiency Quantity	800
Quantity Uom	S.F.
Potential Action	REPLACE
Urgency of Action	PRIORITY 3
Purpose of Action	LEVEL 2
Deficiency Photo1

Violations	Schoolyard No violations recorded.
<b>Concrete</b>	Does not Exist
<b>Pavers</b>	Does not Exist
<b>Site Sidewalks &amp; Walkways</b>	Inspected
<b>Asphalt</b>	Inspected
Condition	3 - Fair
Deficiency	CRACKS - MAJOR
Deficiency Location/Instance	Near Exits 4, 3
Deficiency Quantity	100
Quantity Uom	S.F.
Potential Action	REPLACE
Urgency of Action	PRIORITY 3
Purpose of Action	LEVEL 2
Deficiency Photo1
