NYC Department of Education
Building Condition Assessment Survey 2023 - 2024

Architectural Inspection

Asset: P.S. 163 - QUEENS, 159-01 59 AVENUE, New York, 11365

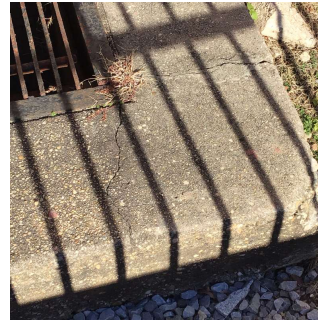
AW2

AREAWAY WALLS: CRACKS AND SPALLING

REPLACE

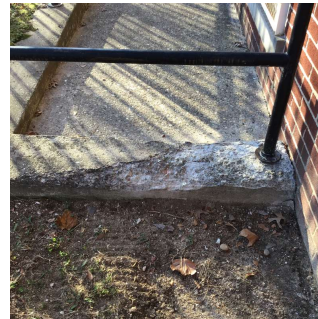
AW4

AREAWAY SLAB: CRACKS AND SPALLING

20
S.F.
REPLACE
PRIORITY 4
LEVEL 2

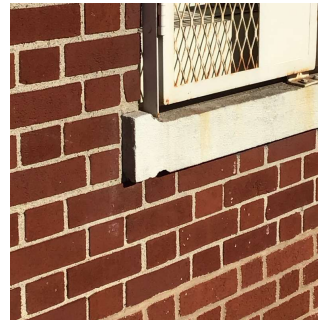
Facade A

BRICK: DETERIORATED MASONRY SILLS - MINOR

REPAIR

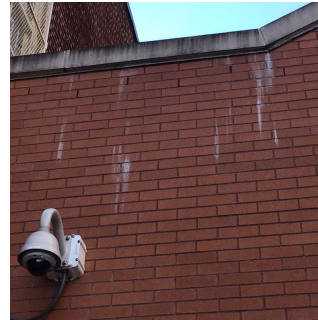
Roof 6

BRICK: MAJOR DETERIORATION/CRACKS

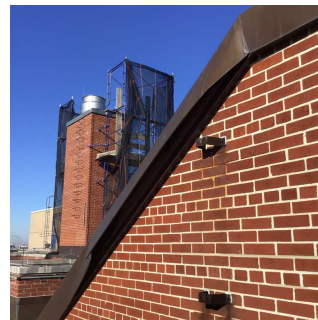
Roof 1 - BH2

BUILT-UP: FLASHING: DRIP EDGE/GRAVEL STOP DAMAGED

REPLACE

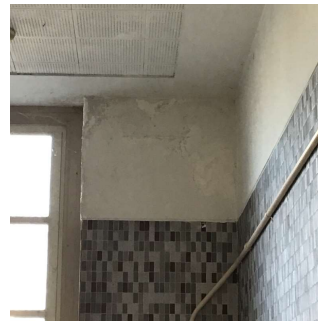
BUILT-UP: ROOFING: MAJOR ACTIVE ROOF LEAKS IN INSTRUCTIONAL SPACE

Roof 4 - Stair H/1
 No violations recorded.

100
 S.F.
 REPLACE ROOFING WITHOUT MAJOR EQUIPMENT
 REMOVAL
 PRIORITY 5
 LEVEL 2

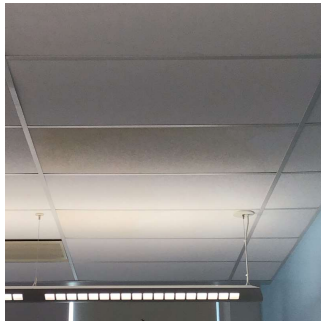
Roof 5
Instance Quantity	9,600
Instance Quantity Uom	S.F.
Does the roof have major mechanical equipment sitting on Dunnage Steel less than 18" above the Roofing?	No
Does this roof instance have a Sustainable Roof System?	No
Do solar panels exist on these roofs?	No
Is/Are the roof(s) suitable for Solar Panel installation?	No
Installation Year	2016
Source of Installation	Custodial Staff
Deficiency	IRMA: ROOFING: MAJOR ACTIVE ROOF LEAKS IN INSTRUCTIONAL SPACE
Roof Plan reference

Roof 5 - Room 440 (Roof 5 - Corridor near Elevator A/4)
Violations	No violations recorded.
ROOFING DRAINS	
Condition	4 - Between Fair and Poor

<p>Q163 4 N</p>
Deficiency Quantity	200
Quantity Uom	S.F.
Potential Action	REPLACE ROOFING WITHOUT MAJOR EQUIPMENT REMOVAL
Urgency of Action	PRIORITY 5
Purpose of Action	LEVEL 2
Deficiency Photo1

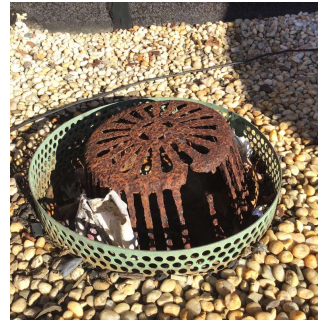
Roof 1

DETERIORATED

REPLACE

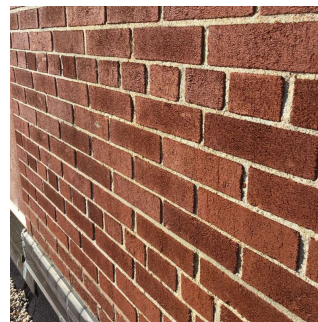
BH2
 No violations recorded.

BULKHEAD/PENTHOUSE WALLS/EXTERIOR: DETERIORATED JOINTS

160
 S.F.
 REPOINT
 PRIORITY 3
 LEVEL 2

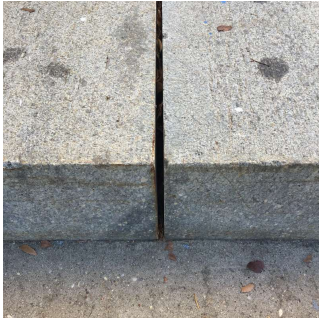
Violations	Facade H No violations recorded.
RAILINGS	Inspected
Condition	2 - Between Good and Fair
Deficiency	No deficiencies recorded
STAIRS/RAMPS	Inspected
Condition	3 - Fair
Deficiency	STONE: DETERIORATED JOINTS
RooF Plan reference

Violations	Facade F - Exit 4 No violations recorded.
WINDOWS	Inspected
Replacement Quantity	12,800
Replacement Uom	S.F.
EXTERIOR GUARDS	Inspected

Deficiency Quantity	15
Quantity Uom	L.F.
Potential Action	REPOINT
Urgency of Action	PRIORITY 4
Purpose of Action	LEVEL 2
Deficiency Photo1

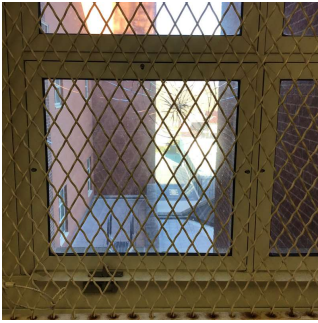
Inspected	
Material Type(s)	Aluminum
Instance on Aluminum - Other: 2016 Addition	Inspected
Instance Condition	1 - Good
Instance Quantity	4,400
Instance Quantity Uom	S.F.
Are these windows insulated	Yes
Installation Year	2016
Source of Installation	Custodial Staff
Deficiency	No deficiencies recorded
Instance on Aluminum - Double Hung: Original Building and 1964 Addition	Inspected
Instance Condition	2 - Between Good and Fair
Instance Quantity	8,400
Instance Quantity Uom	S.F.
Are these windows insulated	Yes
Installation Year	2016
Source of Installation	Custodial Staff
Deficiency	ALUMINUM - DOUBLE HUNG: BROKEN PANE
Roof Plan reference

Violations	Facade C - Corridor near Room 359A (throughout Original and 1964 Addition similar) No violations recorded.
INTERIOR	
POOLS	
STRUCTURAL	
COLUMNS/BEAMS/BEARING WALLS	
Condition	3 - Fair
Deficiency	STEEL COLUMNS/BEAMS: DETERIORATED CONCRETE FIREPROOFING
Deficiency Location/Instance	Basement - Firemans Shop, Boiler Room
Deficiency Quantity	80
Quantity Uom	S.F.
Potential Action	REPLACE
Urgency of Action	PRIORITY 3
Purpose of Action	LEVEL 5
Deficiency Photo1	 
Violations	Basement - Firemans Shop No violations recorded.
FLOOR STRUCTURE	
Condition	3 - Fair
Deficiency	CONCRETE: CRACKS/SPALLED/REINFORCEMENT EXPOSED
Deficiency Location/Instance	Room 134, Gymnasium Mechanical Room
Deficiency Quantity	40
Quantity Uom	S.F.
Potential Action	REPAIR
Urgency of Action	PRIORITY 3
Purpose of Action	LEVEL 5

Deficiency Quantity	50
Quantity Uom	S.F.
Potential Action	MAINTENANCE
Urgency of Action	PRIORITY 3
Purpose of Action	LEVEL 2

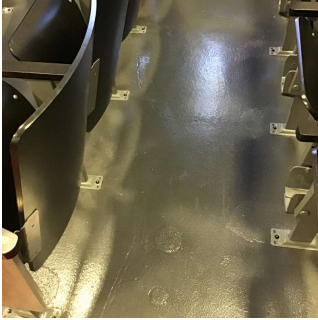
Question	Response
INTERIOR	
AUDITORIUM	
Door(s)	
Instance on Basement (382 Seats)	Inspected
Condition	2 - Between Good and Fair
Deficiency	No deficiencies recorded
Fixed H/C Lift	
Instance on Basement (382 Seats)	Does not Exist
Fixed Seating	
Instance on Basement (382 Seats)	Inspected
Condition	1 - Good
Deficiency	No deficiencies recorded
Floor Finish	
Instance on Basement (382 Seats)	Inspected
Condition	2 - Between Good and Fair
Deficiency	CONCRETE: CRACKS
Deficiency Location/Instance	Along Row R Left Side
Deficiency Quantity	50
Quantity Uom	S.F.
Potential Action	REPLACE
Urgency of Action	PRIORITY 3
Purpose of Action	LEVEL 2
Deficiency Photo1

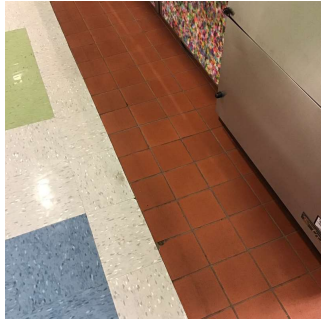
Serving area
No violations recorded.

Instance on Basement	Inspected
Condition	2 - Between Good and Fair
Deficiency	QUARRY TILE: BROKEN/MISSING TILES
Deficiency Location/Instance	Serving area
Deficiency Quantity	10
Quantity Uom	S.F.
Potential Action	REPLACE
Urgency of Action	PRIORITY 3
Purpose of Action	LEVEL 2
Deficiency Photo1

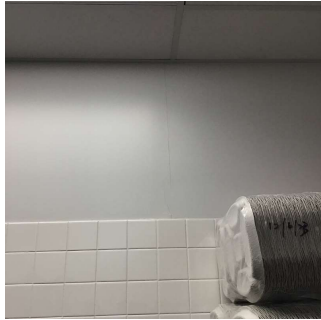
Room C006
No violations recorded.

Instance on Basement	Inspected
Condition	2 - Between Good and Fair
Deficiency	GYPSUM BOARD: DETERIORATED
Deficiency Location/Instance	Rooms C006, C004F
Deficiency Quantity	10
Quantity Uom	S.F.
Potential Action	REPLACE
Urgency of Action	PRIORITY 3
Purpose of Action	LEVEL 2
Deficiency Photo1

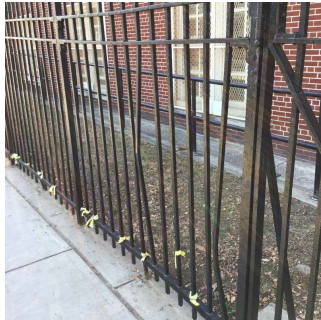
Deficiency	WROUGHT IRON: DAMAGED/DETERIORATED
Deficiency Location/Instance	160th Street
Deficiency Quantity	400
Quantity Uom	S.F.
Potential Action	REPLACE
Urgency of Action	PRIORITY 3
Purpose of Action	LEVEL 2
Deficiency Photo1

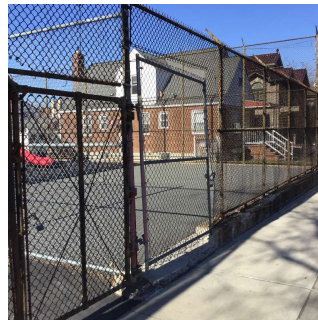
Priority Condition Exist Last Year?	Priority Category	Condition Description	Component Affected	Location Description	Person(s) Notified	Person(s) Title	PhotoImage
Yes	Potential Falling Debris	Unsecured gate with severely damaged posts is a potential safety hazard	SITE FENCES	160th Street gate to playground	Michael Leto	Fireman

CHAIN LINK: DAMAGED/DETERIORATED
160th Street gate to playground
50
S.F.
REPLACE
PRIORITY 5
LEVEL 6

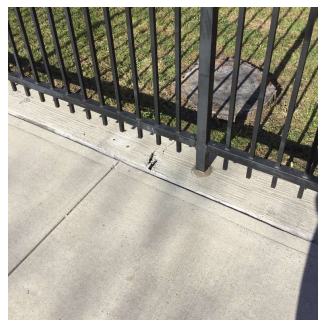
CONCRETE CURB: DAMAGED/DETERIORATED
59th Avenue, 160th Street
30
S.F.
REPLACE
PRIORITY 3
LEVEL 2
