NYC Department of Education
Building Condition Assessment Survey 2023 - 2024

Architectural Inspection

Q175

Asset: P.S. 175 - QUEENS, 64-35 102 STREET, New York, 11374

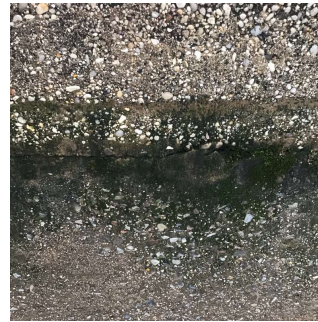
AW2
 No violations recorded.

Question	Response
Architectural	
EXTERIOR	Inspected
AREAWAY	Inspected
Instance on AW1 - AW2	Inspected
Instance Condition	4 - Between Fair and Poor
Instance Quantity	2
Instance Quantity Uom	EACH
Deficiency	AREAWAY WALLS: CRACKS AND SPALLING

10
 S.F.
 REPLACE
 PRIORITY 4
 LEVEL 2

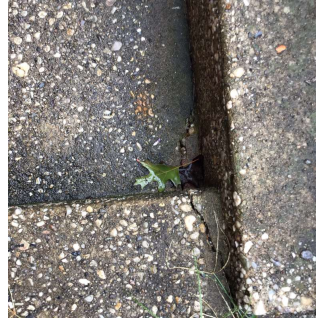
AW2

AREAWAY STAIRS: DETERIORATED
 TREADS/RISERS/NOSINGS

10
 S.F.
 REPAIR
 PRIORITY 3
 LEVEL 2

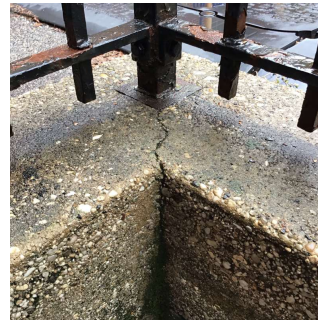
AW2
No violations recorded.

AREAWAY WALLS: CRACKS AND SPALLING

40
S.F.
REPAIR
PRIORITY 3
LEVEL 2

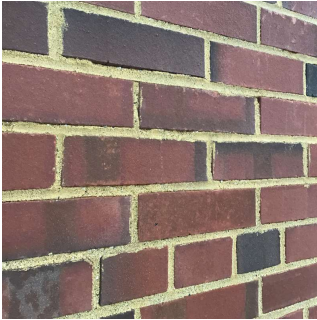
Violations	Facade B No violations recorded.
CHIMNEY	
Material Type(s)	Inspected Masonry
Condition	2 - Between Good and Fair
Deficiency	BRICK: DETERIORATED JOINTS
Roof Plan reference

Deficiency Quantity	10
Quantity Uom	S.F.
Potential Action	REPOINT
Urgency of Action	PRIORITY 3
Purpose of Action	LEVEL 2
Deficiency Photo1

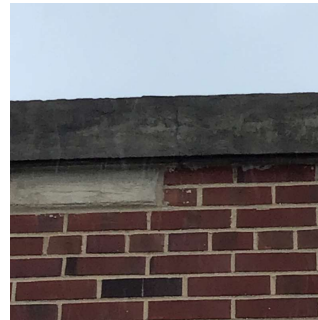
Violations	CH No violations recorded.
Deficiency	BRICK: DETERIORATED CAP

10
L.F.
REPLACE
PRIORITY 3
LEVEL 2

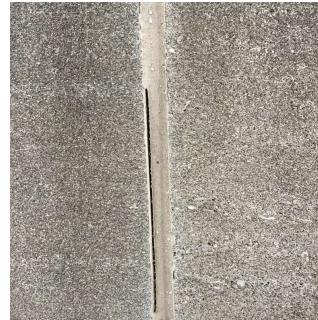
Roof 1

CAST STONE: DETERIORATED TRANSVERSE JOINTS

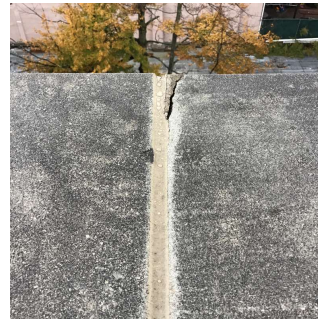
Roof 1

CAST STONE: CRACKED/BROKEN PIECES

REPLACE-IN-KIND

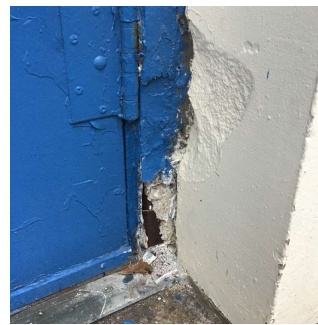
Facade G - Exit 7

METAL CLAD: DETERIORATED DOOR AND FRAME - MAJOR DETERIORATION

9
EACH
REPLACE
PRIORITY 4
LEVEL 2

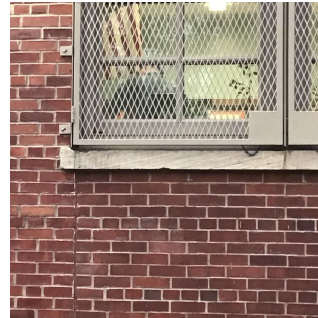
Facade A

BRICK: DETERIORATED MASONRY SILLS - MINOR

REPAIR

PRIORITY 3
LEVEL 2

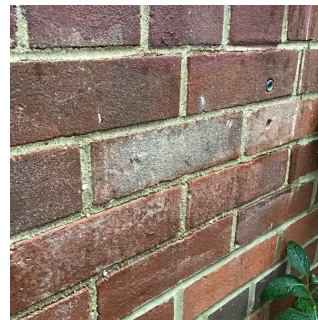
Facade A

BRICK: DETERIORATED JOINTS

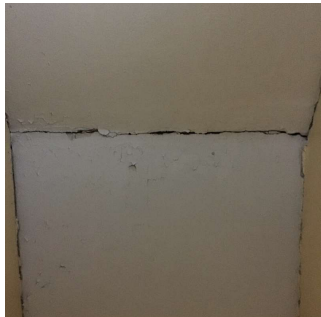
Violations	PH No violations recorded.
Deficiency	BULKHEAD/PENTHOUSE CEILING: PLASTER DAMAGED/DETERIORATED
Roof Plan reference

Deficiency Quantity	20
Quantity Uom	S.F.
Potential Action	REPLACE
Urgency of Action	PRIORITY 4
Purpose of Action	LEVEL 2
Deficiency Photo1

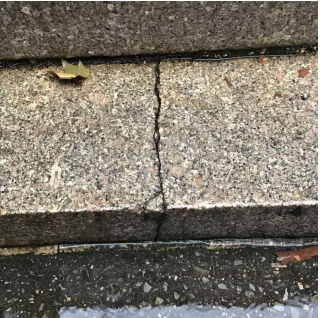
Question	Response
EXTERIOR	
ROOF	Inspected
Specialties	Inspected
ROOF/GRAVITY TANK	Does not Exist
STAIRS/RAMPS: EXTERIOR	Inspected
BUILDING CHEEK/FLANK WALLS	Inspected
Condition	2 - Between Good and Fair
Deficiency	No deficiencies recorded
RAILINGS	Inspected
Condition	2 - Between Good and Fair
Deficiency	No deficiencies recorded
STAIRS/RAMPS	Inspected
Condition	4 - Between Fair and Poor
Deficiency	STONE: CRACKS/SPALLING - MAJOR
Roof Plan reference	<p>Q175</p>

Deficiency Quantity	10
Quantity Uom	S.F.
Potential Action	REPLACE
Urgency of Action	PRIORITY 4
Purpose of Action	LEVEL 2
Deficiency Photo1

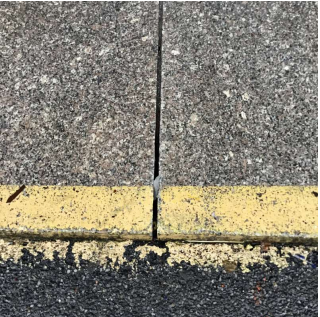
Violations	Facade L No violations recorded.
Deficiency	STONE: DETERIORATED JOINTS

Deficiency Quantity	10
Quantity Uom	L.F.
Potential Action	REPOINT
Urgency of Action	PRIORITY 4
Purpose of Action	LEVEL 2
Deficiency Photo1

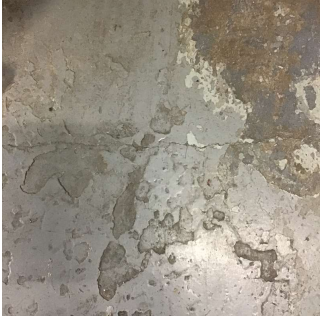
Violations	Subbasement - Crawlspace No violations recorded.
FLOOR STRUCTURE	
Condition	Inspected 3 - Fair
Deficiency	CONCRETE SLAB ON GRADE: THRU CRACKS
Deficiency Location/Instance	Boiler Room
Deficiency Quantity	80
Quantity Uom	S.F.
Potential Action	REPAIR
Urgency of Action	PRIORITY 3
Purpose of Action	LEVEL 5
Deficiency Photo1

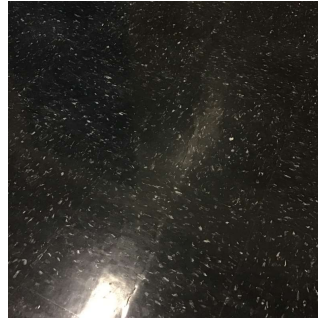
Corridor Near 217

Violations	Room 306 No violations recorded.
Floor Finish	
Condition	Inspected 4 - Between Fair and Poor
Deficiency	SHEET VINYL: DETERIORATED SUBSTRATE
Deficiency Location/Instance	Near Room 217

Deficiency Quantity	30
Quantity Uom	S.F.
Potential Action	REPLACE
Urgency of Action	PRIORITY 3
Purpose of Action	LEVEL 2
Deficiency Photo1

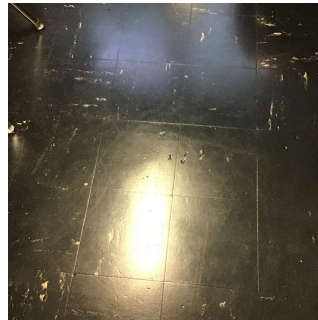
Room 325

Deficiency	VINYL TILES: BROKEN/DETERIORATED/MISSING TILES
Deficiency Location/Instance	Rooms 324,323,322,303, 202 and others
Deficiency Quantity	2,800
Quantity Uom	S.F.
Potential Action	REPLACE
Urgency of Action	PRIORITY 3
Purpose of Action	LEVEL 2
Deficiency Photo1
