NYC Department of Education
Building Condition Assessment Survey 2023 - 2024

Architectural Inspection

Asset: P.S. 176 - QUEENS, 120-45 235 STREET, New York, 11411

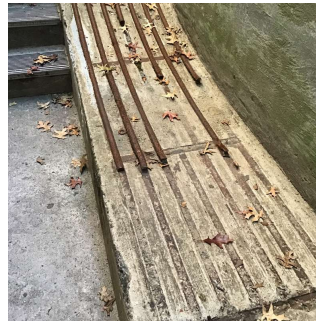
Facade C - AW4

Question	Response
Architectural	
EXTERIOR	Inspected
AREAWAY	Inspected
Instance on AW1-AW9	Inspected
Instance Condition	3 - Fair
Instance Quantity	9
Instance Quantity Uom	EACH
Deficiency	AREAWAY STAIRS: DETERIORATED MATERIAL SLIDE

25
S.F.
REPLACE
PRIORITY 3
LEVEL 2

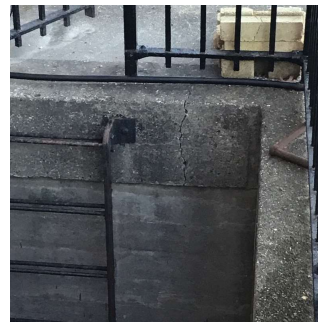
Facade A - AW2
 No violations recorded.

AREAWAY WALLS: CRACKS AND SPALLING

10
 S.F.
 REPAIR
 PRIORITY 3
 LEVEL 2

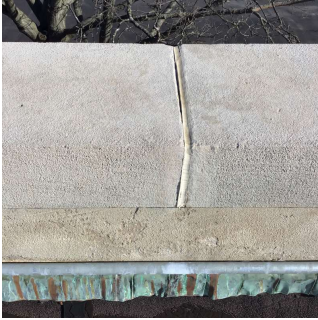
CAST STONE: DETERIORATED TRANSVERSE JOINTS

20
 L.F.
 MAINTENANCE
 PRIORITY 3
 LEVEL 2

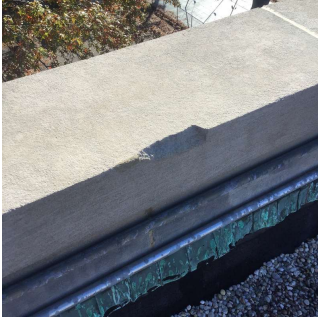
Violations	Roof 1 Facade G No violations recorded.
Deficiency	CAST STONE: CRACKED/BROKEN PIECES
Roof Plan reference

Deficiency Quantity	20
Quantity Uom	L.F.
Potential Action	REPLACE-IN-KIND
Urgency of Action	PRIORITY 4
Purpose of Action	LEVEL 2
Deficiency Photo1

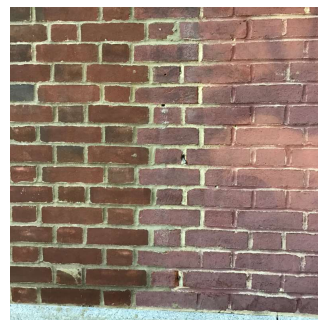
BRICK: DETERIORATED JOINTS

20
S.F.
REPOINT
PRIORITY 3
LEVEL 2

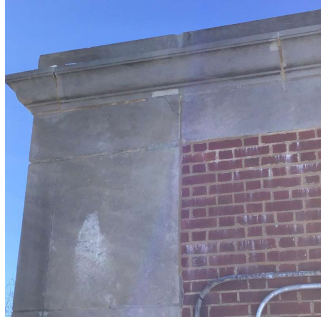
STONE: MAJOR DETERIORATION/CRACKS

Question	Response
EXTERIOR	
PARAPETS	
Potential Action	REMOVE AND REBUILD
Urgency of Action	PRIORITY 4
Purpose of Action	LEVEL 2
Deficiency Photo1

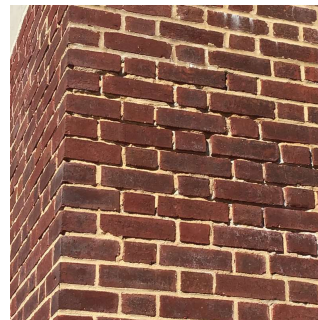
Roof 1 - Bulkhead 1

BULKHEAD/PENTHOUSE WALLS/EXTERIOR: DETERIORATED JOINTS

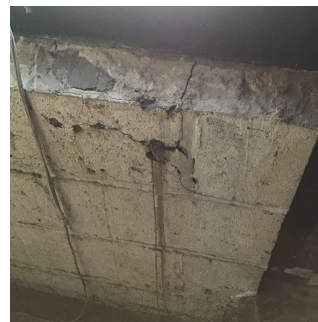
Roof 1 - Bulkhead 2

BULKHEAD/PENTHOUSE WALLS/INTERIOR: CMU CRACKS/SPALLING

10
 S.F.
 REPLACE
 PRIORITY 3
 LEVEL 2

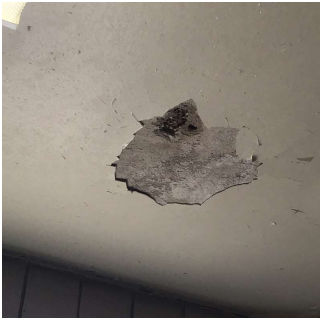
Deficiency **BULKHEAD/PENTHOUSE CEILING: PLASTER DAMAGED/DETERIORATED**

10
 S.F.
 REPLACE
 PRIORITY 3
 LEVEL 2

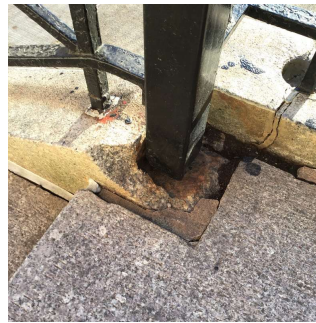
Facade G

Deficiency Quantity	200
Quantity Uom	S.F.
Potential Action	MAINTENANCE
Urgency of Action	PRIORITY 1
Purpose of Action	LEVEL 1
Deficiency Photo1	No photo recorded
Violations	No violations recorded.
CUPOLA/ SPIRES/ TOWERS	Does not Exist
DORMER	Does not Exist
DUNNAGE STEEL	Inspected
Condition	2 - Between Good and Fair
Deficiency	No deficiencies recorded
SKYLIGHT/ROOF VENT	Inspected
Material Type(s)	Glass
Condition	2 - Between Good and Fair
Deficiency	No deficiencies recorded
ROOF/GRAVITY TANK	Does not Exist
STAIRS/RAMPS: EXTERIOR	Inspected
BUILDING CHEEK/FLANK WALLS	Inspected
Condition	3 - Fair
Deficiency	STONE: CRACKS/SPALLING - MAJOR

10
 S.F.
 REPLACE
 PRIORITY 4
 LEVEL 2

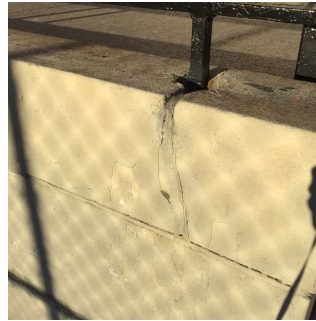
Facade G

STONE: CRACKS/SPALLING - MINOR

20
 S.F.
 REPAIR
 PRIORITY 3
 LEVEL 2

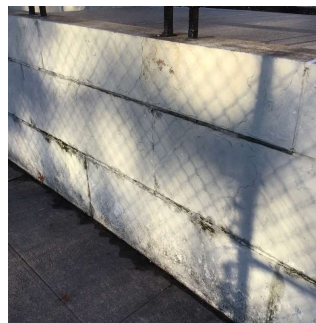
Facade G

STONE: DETERIORATED JOINTS

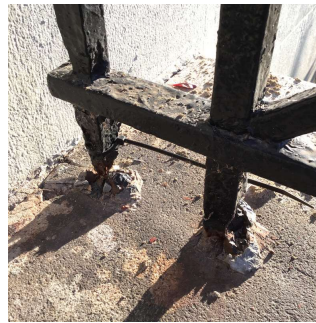
Facade H
No violations recorded.

RUST - MAJOR

30
L.F.
REPLACE
PRIORITY 4
LEVEL 2

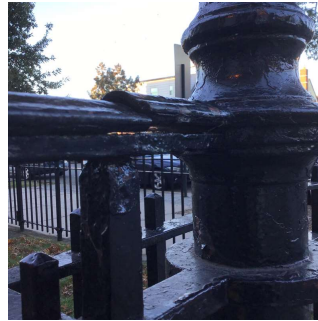
Facade A

DAMAGED

10
L.F.
REPLACE
PRIORITY 4
LEVEL 2

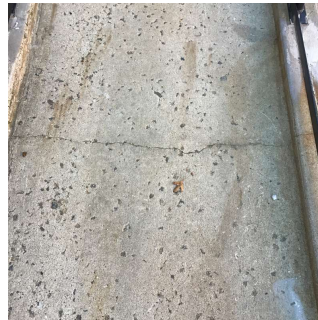
Facade E

CONCRETE: CRACKS/SPALLING - MINOR

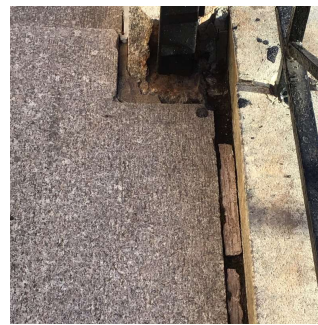
Facade G

STONE: DETERIORATED JOINTS

20
 L.F.
 REPOINT
 PRIORITY 4
 LEVEL 2

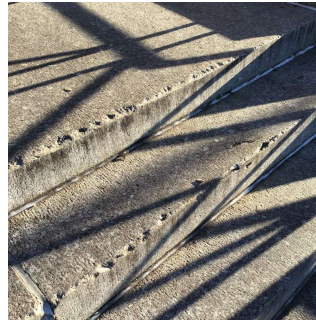
Facade H

STONE: WORN-OUT TREAD/RISER/NOSING

20
 S.F.
 REPLACE
 PRIORITY 4
 LEVEL 2

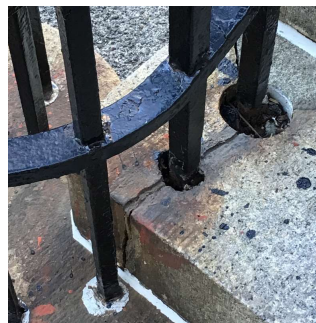
Facade K

STONE: CRACKS/SPALLING - MAJOR

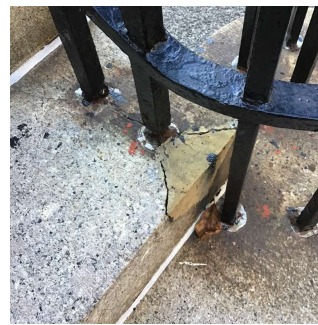
Facade K

STONE: CRACKS/SPALLING - MINOR

10
S.F.
REPAIR
PRIORITY 3
LEVEL 2

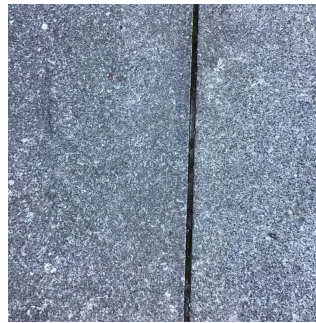
Facade A

STONE: DETERIORATED JOINTS

40
L.F.
REPOINT
PRIORITY 3
LEVEL 2

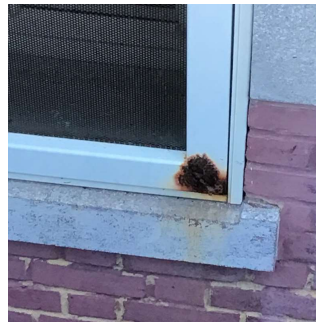
Facade J

RUST - MAJOR

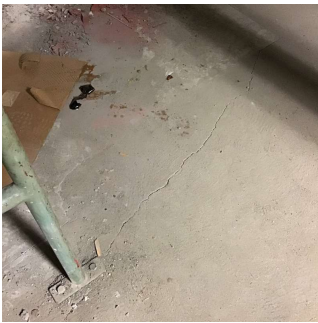
Question	Response
INTERIOR	
STRUCTURAL	
FLOOR STRUCTURE	
Deficiency Photo1

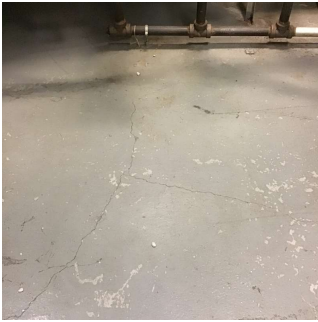
Violations	Room B17 No violations recorded.
Deficiency	CONCRETE: CRACKS/SPALLED/REINFORCEMENT EXPOSED
Deficiency Location/Instance	2nd Floor
Deficiency Quantity	30
Quantity Uom	S.F.
Potential Action	REPAIR
Urgency of Action	PRIORITY 3
Purpose of Action	LEVEL 5
Deficiency Photo1

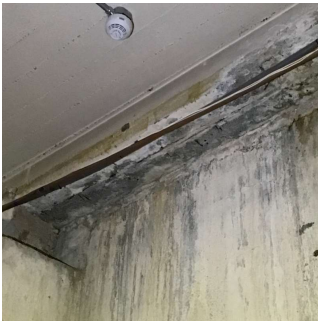
Violations	Room 226 No violations recorded.
FOUNDATION WALLS	
Material Type(s)	Inspected Concrete
Condition	3 - Fair
Deficiency	CONCRETE: WATER INFILTRATION IN NON- INSTRUCTIONAL SPACE
Deficiency Location/Instance	Basement
Deficiency Quantity	50
Quantity Uom	S.F.
Potential Action	INSTALL WATERPROOFING
Urgency of Action	PRIORITY 5
Purpose of Action	LEVEL 5

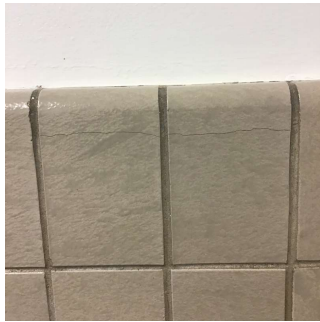
Violations	Near Room 105 No violations recorded.
Deficiency	GLAZED BLOCK: CRACKS/SPALLING
Deficiency Location/Instance	Near Room 233, 228, 203, Near Stair F/1 and others
Deficiency Quantity	75
Quantity Uom	S.F.
Potential Action	REPLACE
Urgency of Action	PRIORITY 3
Purpose of Action	LEVEL 2
Deficiency Photo1

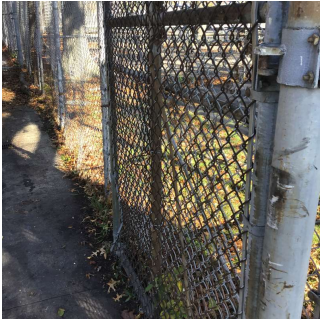
Room 211
Violations	No violations recorded.
LIFE SAFETY	
	Inspected
F.D. HOLDING AREA	
	Does not Exist
STEEL STAIRS	
	Does not Exist
SITE	
	Inspected
CONTAINERIZATION	
	Inspected
Condition	5 - Poor
Deficiency	FENCING DAMAGED
Deficiency Location/Instance	121st Avenue
Deficiency Quantity	600
Quantity Uom	S.F.
Potential Action	REPAIR
Urgency of Action	PRIORITY 3
Purpose of Action	LEVEL 2

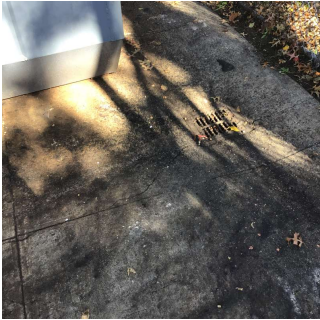
Violations	121st Avenue No violations recorded.
Deficiency	CONCRETE PAD DAMAGED
Deficiency Location/Instance	121st Avenue
Deficiency Quantity	300
Quantity Uom	S.F.
Potential Action	REPAIR
Urgency of Action	PRIORITY 3
Purpose of Action	LEVEL 2
Deficiency Photo1
