**NYC Department of Education**  
**Building Condition Assessment Survey 2023 - 2024**

Architectural Inspection

**Asset:** P.S. 179 - QUEENS, 196-25 PECK AVENUE, New York, 11365

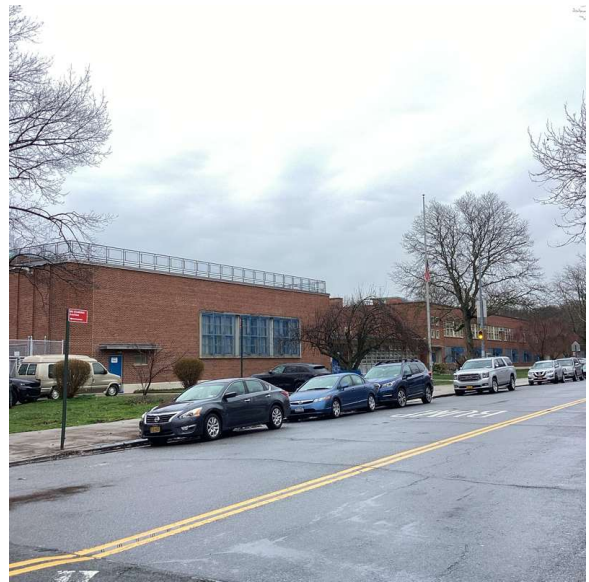
Corner of Peck Avenue and Horace Harding Expressway - Northeast View

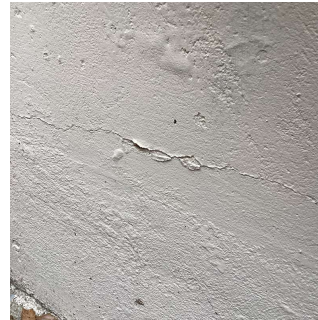
AW2

Deficiency	AREAWAY WALLS: CRACKS AND SPALLING
Roof Plan reference	Q179

Deficiency Quantity	10
Quantity Uom	S.F.
Potential Action	REPAIR
Urgency of Action	PRIORITY 3
Purpose of Action	LEVEL 2

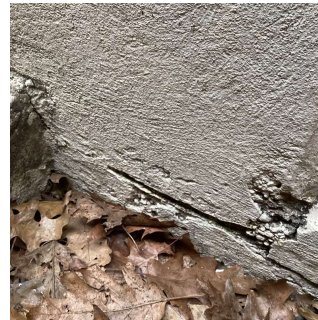
AW2

AREAWAY WALLS: CRACKS AND SPALLING

REPLACE

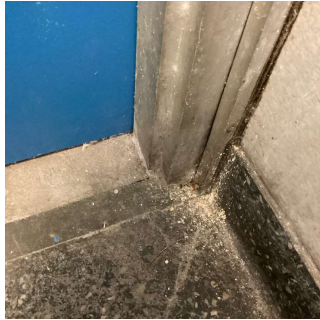
Question	Response
<b>EXTERIOR</b>	
<b>DOORS</b>	
<b>DOORS AND FRAMES</b>	
Potential Action	MAINTENANCE
Urgency of Action	PRIORITY 3
Purpose of Action	LEVEL 2
Deficiency Photo1

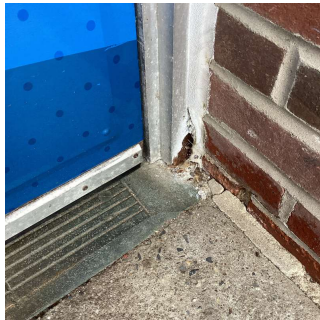
Violations	Facade A - Exit 7/8 No violations recorded.
Deficiency	METAL: DETERIORATED DOOR AND FRAME - MAJOR DETERIORATION
Roof Plan reference	Q179

Deficiency Quantity	4
Quantity Uom	EACH
Potential Action	REPLACE
Urgency of Action	PRIORITY 4
Purpose of Action	LEVEL 2
Deficiency Photo1

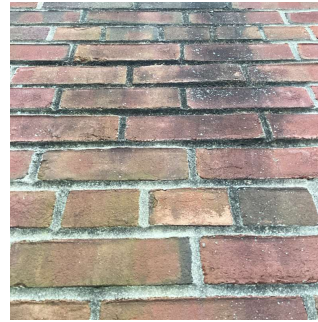
Facade A

BRICK: DETERIORATED JOINTS

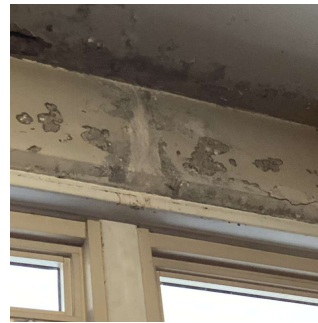
Facade A

BRICK: WATER INFILTRATION IN NON-INSTRUCTIONAL SPACE

REPAIR

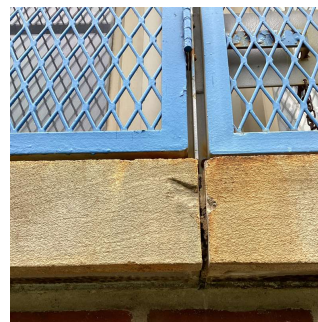
Facade A

BRICK: DETERIORATED MASONRY SILLS - MINOR

REPAIR

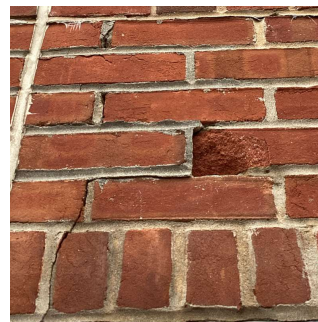
Roof 1  
 No violations recorded.

BRICK: MAJOR DETERIORATION/CRACKS

10  
 S.F.  
 REMOVE AND REBUILD  
 PRIORITY 4  
 LEVEL 2

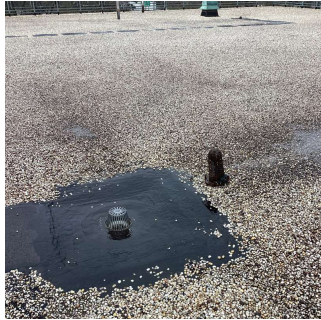
Roof 1
Instance Quantity	37,000
Instance Quantity Uom	S.F.
Does the roof have major mechanical equipment sitting on Dunnage Steel less than 18" above the Roofing?	No
Does this roof instance have a Sustainable Roof System?	No
Do solar panels exist on these roofs?	No
Is/Are the roof(s) suitable for Solar Panel installation?	Yes
Installation Year	1999
Source of Installation	Custodial Staff
Deficiency	BUILT-UP: ROOFING: LOSS OF GRAVEL
Roof Plan reference	Q179

Deficiency Quantity	10
Quantity Uom	S.F.
Potential Action	INSTALL NEW GRAVEL

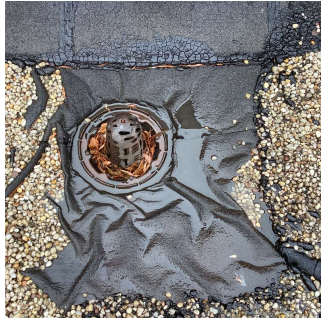
Roof 3
Violations	No violations recorded.
Deficiency	BUILT-UP: ROOFING: DELAMINATION
Roof Plan reference	Q179

Deficiency Quantity	10
Quantity Uom	S.F.
Potential Action	REPLACE ROOFING WITHOUT MAJOR EQUIPMENT REMOVAL
Urgency of Action	PRIORITY 4
Purpose of Action	LEVEL 2
Deficiency Photo1

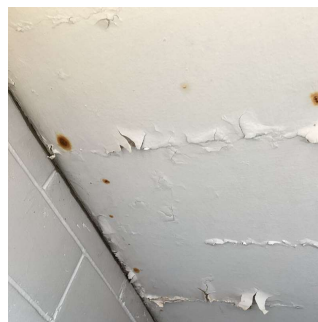
BH1

**BULKHEAD/PENTHOUSE CEILING: PLASTER DAMAGED/DETERIORATED**

REPLACE

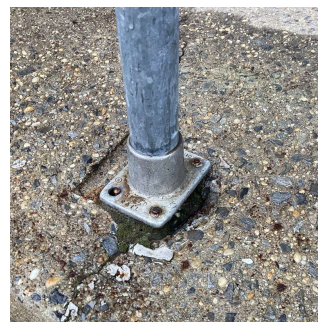
Facade A

**DAMAGED**

REPLACE

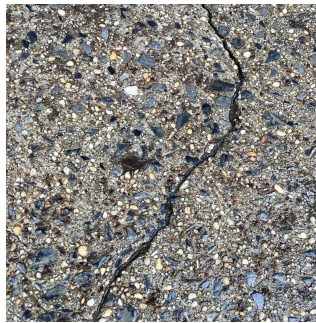
Facade A

CONCRETE: CRACKS/SPALLING - MAJOR

60  
 S.F.  
 REPLACE  
 PRIORITY 4  
 LEVEL 2

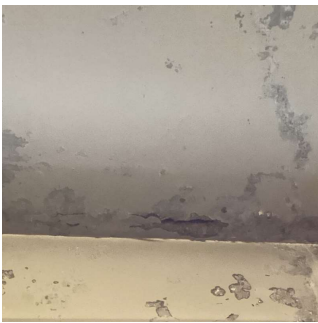
Structural Condition Type	Condition Description	Component Affected	Location Description	Person(s) Notified	Person(s) Title	PhotoImage
Deteriorated Concrete	Deteriorated concrete beam is a potential structural hazard.	INTERIOR   STRUCTURAL   ROOF STRUCTURE	1st Floor - Storage Room near Exit 11	Victor Rivera	Fireman

1st Floor - Storage Room near Exit 11
Violations	No violations recorded.
Deficiency	CONCRETE: CRACKED/SPALLED/REINFORCEMENT EXPOSED
Deficiency Location/Instance	1st Floor - Storage Room near Exit 11, BH1, BH2, BH3
Deficiency Quantity	180
Quantity Uom	S.F.
Potential Action	REPAIR
Urgency of Action	PRIORITY 4
Purpose of Action	LEVEL 5
Deficiency Photo1

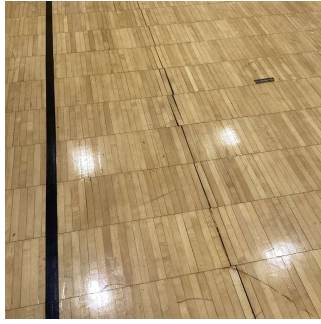
Violations	Office No violations recorded.
Deficiency	WOOD: DAMAGED/DETERIORATED
Deficiency Location/Instance	Left Side, Center, Near Entrance,
Deficiency Quantity	100
Quantity Uom	S.F.
Potential Action	REPLACE
Urgency of Action	PRIORITY 3
Purpose of Action	LEVEL 2
Deficiency Photo1
