NYC Department of Education
Building Condition Assessment Survey 2023 - 2024

Architectural Inspection

Asset: I.S. 323 (OLD IS 180) - QUEENS, 320 BEACH 104 STREET, New York, 11694

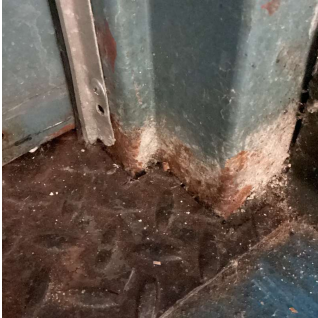
Deficiency	METAL: DETERIORATED DOOR AND FRAME - MAJOR DETERIORATION
------------	--

Deficiency Quantity	9
---------------------	---

Question	Response
EXTERIOR	
DOORS	
DOORS AND FRAMES	
Quantity Uom	EACH
Potential Action	REPLACE
Urgency of Action	PRIORITY 4
Purpose of Action	LEVEL 2
Deficiency Photo1

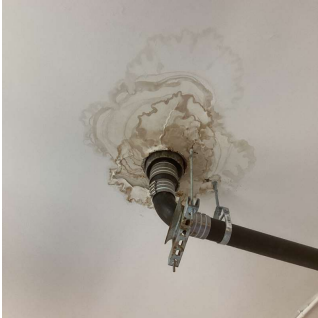
Installation Year	2011
Source of Installation	Custodial Staff
Deficiency	MODIFIED BITUMEN: ROOFING: MAJOR ACTIVE ROOF LEAKS IN INSTRUCTIONAL SPACE
Roof Plan reference

Deficiency Quantity	200
Quantity Uom	S.F.
Potential Action	REPLACE ROOFING WITHOUT MAJOR EQUIPMENT REMOVAL
Urgency of Action	PRIORITY 5

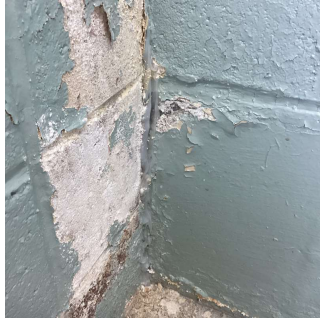
Violations	Roof 1 - Bulkhead 1 No violations recorded.
Deficiency	BULKHEAD/PENTHOUSE WALLS/EXTERIOR: WATER INFILTRATION
Roof Plan reference

Violations	Room 1 - Room 304, also Corridor near Room 308 No violations recorded.
Instance on Built-Up: Roofs 2-4	Under Construction
Instance Quantity	38,000
Instance Quantity Uom	S.F.
Instance on Modified Bitumen: Roof 5	Inspected
Instance Condition	2 - Between Good and Fair
Instance Quantity	1,500
Instance Quantity Uom	S.F.
Does the roof have major mechanical equipment sitting on Dunnage Steel less than 18" above the Roofing?	No
Does this roof instance have a Sustainable Roof System?	No
Do solar panels exist on these roofs?	No
Is/Are the roof(s) suitable for Solar Panel installation?	No
Installation Year	2015
Source of Installation	Custodial Staff
Deficiency	No deficiencies recorded
ROOFING DRAINS	Under Construction
Specialties	Inspected
BULKHEAD/PENTHOUSE	Inspected
Condition	3 - Fair
Deficiency	BULKHEAD/PENTHOUSE WALLS/INTERIOR: CMU CRACKS/SPALLING

Deficiency Quantity	10
Quantity Uom	S.F.
Potential Action	REPLACE
Urgency of Action	PRIORITY 3

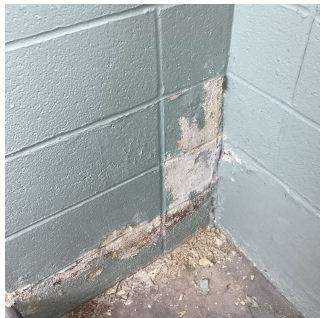
Violations	Roof 1 - Bulkhead 1 No violations recorded.
CUPOLA/ SPIRES/ TOWERS	Does not Exist
DORMER	Does not Exist
DUNNAGE STEEL	Inspected
Condition	2 - Between Good and Fair
Deficiency	No deficiencies recorded
SKYLIGHT/ROOF VENT	Inspected

Deficiency Quantity	100
Quantity Uom	S.F.
Potential Action	REPAIR
Urgency of Action	PRIORITY 5
Purpose of Action	LEVEL 2
Deficiency Photo1

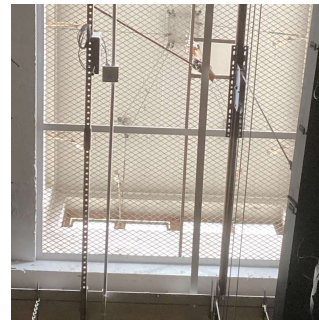
Roof 4 - Auditorium Stage

Deficiency **WATER INFILTRATION**

100
S.F.
MAINTENANCE
PRIORITY 3
LEVEL 2

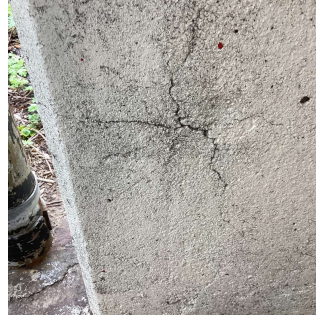
Facade D

Deficiency **CAST IN PLACE CONCRETE: CRACKS/SPALLING - MINOR**

20
S.F.
REPAIR

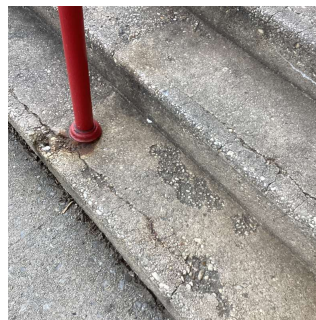
Facade D

CONCRETE: WORN-OUT TREAD/RISER/NOSING

30
 S.F.
 REPLACE
 PRIORITY 4
 LEVEL 2

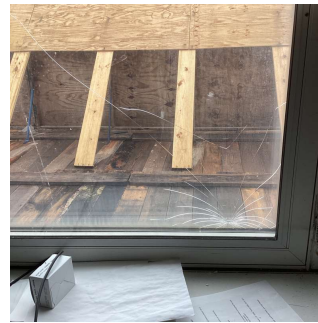
Facade E - Room 232

Deficiency	ALUMINUM - OTHER: BROKEN PANE
------------	-------------------------------

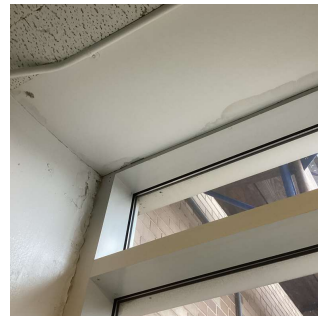
Facade D - Cafeteria, also Facade F - Stair D/3, Facade B - Corridor near Room 300, Corridor near Room 200, Facade E - Room 232

ALUMINUM - OTHER: AIR/WATER INFILTRATION

100

REPLACE TRIM, SILLS OR WEATHERSTRIPPING

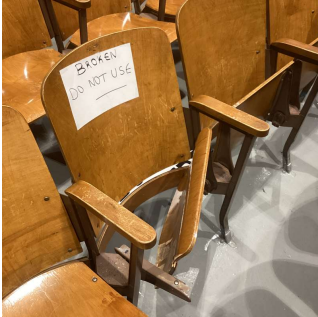
Question	Response
INTERIOR	Inspected
AUDITORIUM	
Fixed H/C Lift	
Fixed Seating	
Instance on 1st Floor (510 Seats)	Inspected
Condition	5 - Poor
Deficiency	DAMAGED/BROKEN/INOPERABLE
Deficiency Location/Instance	Seat K/102
Deficiency Quantity	1
Quantity Uom	EACH
Potential Action	REPLACE
Urgency of Action	PRIORITY 5
Purpose of Action	LEVEL 6
Deficiency Photo1

Seat K/102
Violations	No violations recorded.
Deficiency	DAMAGED/BROKEN/INOPERABLE
Deficiency Location/Instance	Seats F/6, G/3, H/1, 6, J/7, and others
Deficiency Quantity	120
Quantity Uom	EACH
Potential Action	REPLACE
Urgency of Action	PRIORITY 3
Purpose of Action	LEVEL 2
Deficiency Photo1	 
	Seat I/7
Violations	No violations recorded.
Floor Finish	
Instance on 1st Floor (510 Seats)	Inspected
Condition	2 - Between Good and Fair
Deficiency	No deficiencies recorded
Sliding-folding Partition	
Instance on 1st Floor (510 Seats)	Does not Exist
Stage	
Instance on 1st Floor (510 Seats)	Inspected

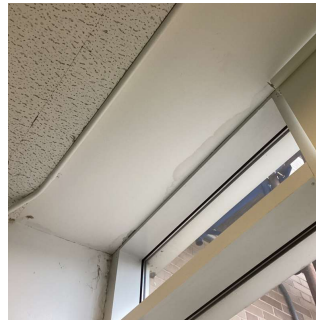
Near Windows

GYPSUM BOARD: DAMAGED/DETERIORATED - ACTIVE LEAK

REPLACE

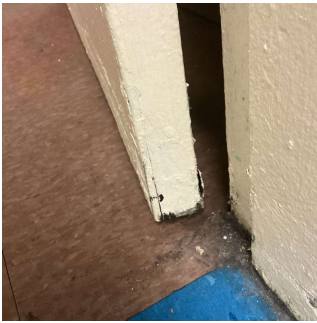
METAL: DETERIORATED DOOR

Violations	Entrance No violations recorded.
Fixed Equipment	
Instance on 1st Floor	Does not Exist
Floor Finish	
Instance on 1st Floor	Inspected
Condition	2 - Between Good and Fair
Deficiency	No deficiencies recorded
Sliding-folding Partition	
Instance on 1st Floor	Does not Exist
Stage	
Instance on 1st Floor	Does not Exist
Walls	
Instance on 1st Floor	Inspected
Condition	2 - Between Good and Fair
Deficiency	GLAZED BLOCK: CRACKS/SPALLING
Deficiency Location/Instance	Near Windows
Deficiency Quantity	10
Quantity Uom	S.F.
Potential Action	REPLACE
Urgency of Action	PRIORITY 3
Purpose of Action	LEVEL 2
Deficiency Photo1

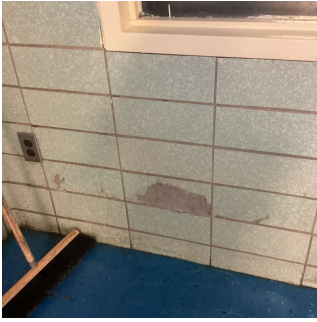
Violations	Near Windows No violations recorded.
Deficiency	PLASTER: CRACKS/SPALLING
Deficiency Location/Instance	Near Entrance, Windows
Deficiency Quantity	30
Quantity Uom	S.F.
Potential Action	REPLACE

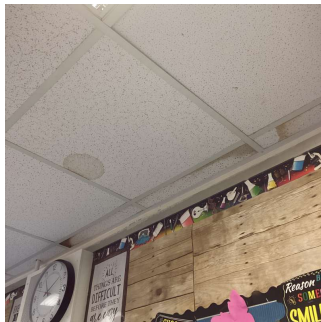
Room 110
Violations	No violations recorded.
Deficiency	PLASTER: CRACKS/SPALLING - ACTIVE LEAK

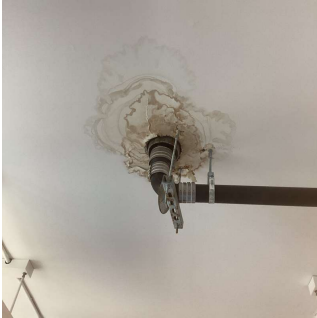
Question	Response
INTERIOR	
CLASSROOMS/CORRIDORS/ADMIN SPACES	
Ceiling	
Deficiency Location/Instance	Room 304, Corridor near Room 200
Deficiency Quantity	40
Quantity Uom	S.F.
Potential Action	REPLACE
Urgency of Action	PRIORITY 5
Purpose of Action	LEVEL 2
Deficiency Photo1

Violations	Room 304 No violations recorded.
Deficiency	PLASTER: CRACKS/SPALLING
Deficiency Location/Instance	Rooms 207, 209, 301
Deficiency Quantity	50
Quantity Uom	S.F.
Potential Action	REPLACE
Urgency of Action	PRIORITY 3
Purpose of Action	LEVEL 2
Deficiency Photo1

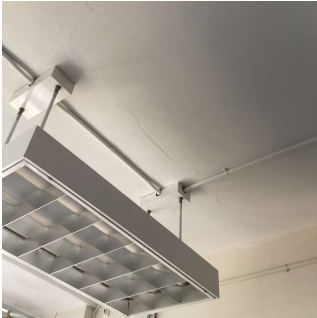
Violations	Room 301 No violations recorded.
Deficiency	ACOUSTIC TILES ON PLASTER: DAMAGED/MISSING
Deficiency Location/Instance	Corridor near Room 300
Deficiency Quantity	10
Quantity Uom	S.F.
Potential Action	REPLACE
Urgency of Action	PRIORITY 3
Purpose of Action	LEVEL 2

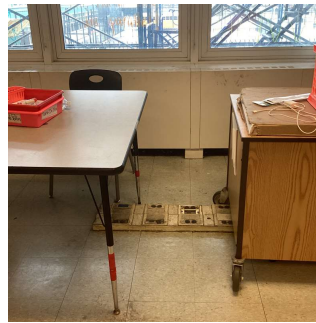
Room 237

SHEET VINYL: BROKEN/DETERIORATED

REPLACE

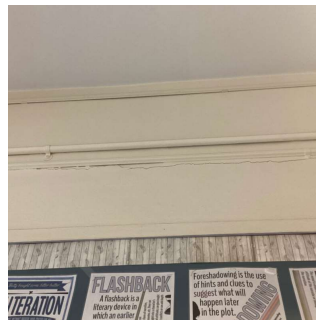
Question	Response
INTERIOR	
CLASSROOMS/CORRIDORS/ADMIN SPACES	
Walls	
Violations	Room 232B No violations recorded.
Deficiency	PLASTER: CRACKS/SPALLING - ACTIVE LEAK
Deficiency Location/Instance	Room 232, Corridor near Room 200
Deficiency Quantity	30
Quantity Uom	S.F.
Potential Action	REPLACE
Urgency of Action	PRIORITY 5
Purpose of Action	LEVEL 2
Deficiency Photo1	 
Violations	Corridor near Room 200 No violations recorded.
Deficiency	GLAZED BLOCK: CRACKS/SPALLING
Deficiency Location/Instance	Room 328, Corridor near Room 232, Near Exit 9
Deficiency Quantity	20
Quantity Uom	S.F.
Potential Action	REPLACE
Urgency of Action	PRIORITY 3
Purpose of Action	LEVEL 2
Deficiency Photo1	 
Violations	Near Exit 9 No violations recorded.
Specialties	Inspected
Classroom Locker(s)	Inspected
Condition	2 - Between Good and Fair
Deficiency	No deficiencies recorded
Fixed Seating	Does not Exist
GYMNASIUM	Inspected
Instance on 1st Floor	Inspected

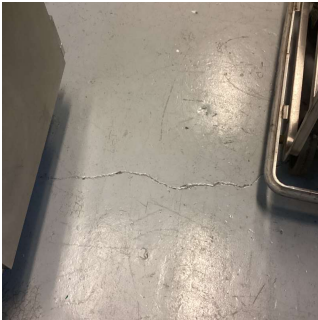
Question	Response
INTERIOR	
KITCHEN	
Floor Finish	
Instance on 1st Floor	Inspected
Condition	4 - Between Fair and Poor
Deficiency	CONCRETE: CRACKS
Deficiency Location/Instance	Storage Room
Deficiency Quantity	10
Quantity Uom	S.F.
Potential Action	REPLACE
Urgency of Action	PRIORITY 3
Purpose of Action	LEVEL 2
Deficiency Photo1

Violations	Storage Room No violations recorded.
Deficiency	CERAMIC TILE: BROKEN/MISSING TILES
Deficiency Location/Instance	Near Sink room , Oven Area, Serving Area, Windows, Mopped Room
Deficiency Quantity	80
Quantity Uom	S.F.
Potential Action	REPLACE
Urgency of Action	PRIORITY 3
Purpose of Action	LEVEL 2
Deficiency Photo1

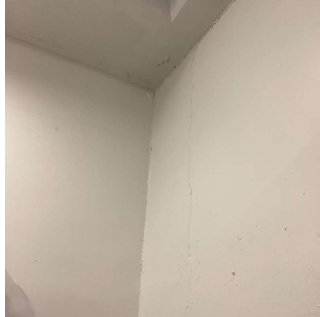
Storage Room
Violations	No violations recorded.
Deficiency	CERAMIC TILE: BROKEN/ MISSING
Deficiency Location/Instance	Serving Area
Deficiency Quantity	20
Quantity Uom	S.F.
Potential Action	REPLACE
Urgency of Action	PRIORITY 3
Purpose of Action	LEVEL 2
Deficiency Photo1	 
	Serving Area
Violations	No violations recorded.
LIBRARY	Inspected
Instance on Room 219	Inspected
Built-in Furnishing	
Instance on Room 219	Does not Exist
Ceiling	
Instance on Room 219	Inspected
Condition	2 - Between Good and Fair
Deficiency	No deficiencies recorded
Door(s)	
Instance on Room 219	Inspected
Condition	4 - Between Fair and Poor
Deficiency	WOOD: DETERIORATED DOOR
Deficiency Location/Instance	Entrance, Office
Deficiency Quantity	2
Quantity Uom	EACH
Potential Action	MAINTENANCE
Urgency of Action	PRIORITY 3

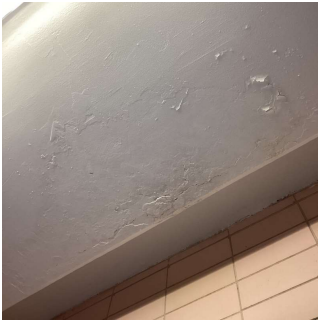
Question	Response
INTERIOR	
STAIRS/RAMPS: INTERIOR	Inspected
Do Letter Stair Signs Exist?	Yes
Ceiling	Inspected
Condition	2 - Between Good and Fair
Deficiency	PLASTER: CRACKS/SPALLING - ACTIVE LEAK
Deficiency Location/Instance	Stair D/3
Deficiency Quantity	10
Quantity Uom	S.F.
Potential Action	REPLACE
Urgency of Action	PRIORITY 5
Purpose of Action	LEVEL 2
Deficiency Photo1	No photo recorded
Violations	No violations recorded.
Deficiency	PLASTER: CRACKS/SPALLING
Deficiency Location/Instance	Stair C/2
Deficiency Quantity	20
Quantity Uom	S.F.
Potential Action	REPLACE
Urgency of Action	PRIORITY 3
Purpose of Action	LEVEL 2
Deficiency Photo1

Violations	No violations recorded.
Door(s)	Inspected
Condition	2 - Between Good and Fair
Deficiency	No deficiencies recorded
Partition	Does not Exist
Railings	Inspected
Condition	2 - Between Good and Fair
Deficiency	No deficiencies recorded
Stairs and Landings	Inspected
Condition	3 - Fair

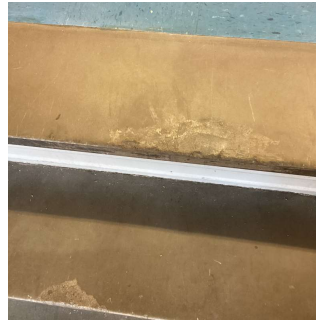
Stair B/2

Deficiency	STONE: BROKEN/MISSING
Deficiency Location/Instance	Stairs B/1, 2, 3, C/1, 2, and others
Deficiency Quantity	150
Quantity Uom	S.F.
Potential Action	REPLACE
Urgency of Action	PRIORITY 3
Purpose of Action	LEVEL 2

TERRAZZO: CRACKS

REPLACE

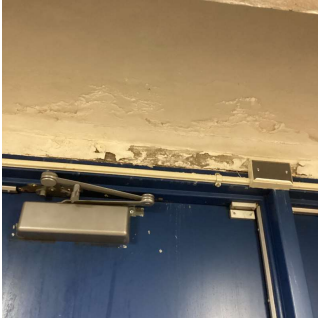
Question	Response
INTERIOR	
STAIRS/RAMPS: INTERIOR	
Walls	Inspected
Condition	2 - Between Good and Fair
Deficiency	PLASTER: CRACKS/SPALLING
Deficiency Location/Instance	Stair A/1
Deficiency Quantity	20
Quantity Uom	S.F.
Potential Action	REPLACE
Urgency of Action	PRIORITY 3
Purpose of Action	LEVEL 2
Deficiency Photo1

Violations	Stair A/1 No violations recorded.
Deficiency	GLAZED BLOCK: CRACKS/SPALLING
Deficiency Location/Instance	Stairs A/1, B/1 - Vestibule, 2, 3, C/1, and others
Deficiency Quantity	50
Quantity Uom	S.F.
Potential Action	REPLACE
Urgency of Action	PRIORITY 3
Purpose of Action	LEVEL 2
Deficiency Photo1

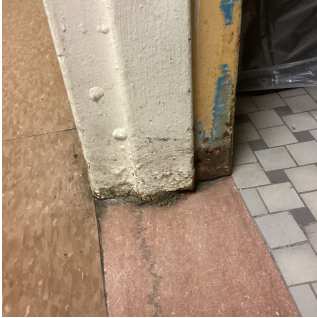
Question	Response
INTERIOR	
TOILET ROOMS - STAFF	
Door(s)	
Potential Action	MAINTENANCE
Urgency of Action	PRIORITY 3
Purpose of Action	LEVEL 2
Deficiency Photo1

Principal Office
Violations	No violations recorded.
Deficiency	WOOD: DETERIORATED DOOR
Deficiency Location/Instance	Room 322, Gymnasium Offices 1, 2, Inside Kitchen Locker Room, Office 111
Deficiency Quantity	5
Quantity Uom	EACH
Potential Action	MAINTENANCE
Urgency of Action	PRIORITY 3
Purpose of Action	LEVEL 2
Deficiency Photo1

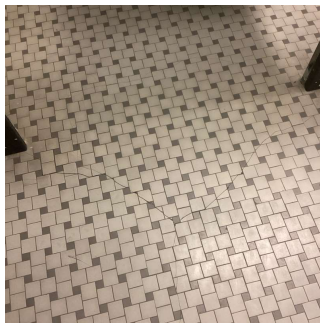
Room 322
Violations	No violations recorded.
Stalls	Inspected
Condition	2 - Between Good and Fair
Deficiency	No deficiencies recorded
Walls	Inspected
Condition	2 - Between Good and Fair
Deficiency	PLASTER: CRACKS/SPALLING
Deficiency Location/Instance	Room 322
Deficiency Quantity	10
Quantity Uom	S.F.
Potential Action	REPLACE
Urgency of Action	PRIORITY 3
Purpose of Action	LEVEL 2
Deficiency Photo1

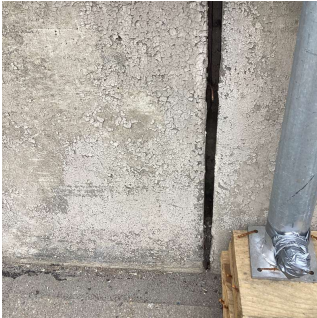
Violations	Rockaway Freeway No violations recorded.
Deficiency	CAST IN PLACE CONCRETE: CRACKS/SPALLING - MAJOR
Deficiency Location/Instance	Rockaway Freeway
Deficiency Quantity	150
Quantity Uom	S.F.
Potential Action	REPLACE
Urgency of Action	PRIORITY 3
Purpose of Action	LEVEL 2
Deficiency Photo1

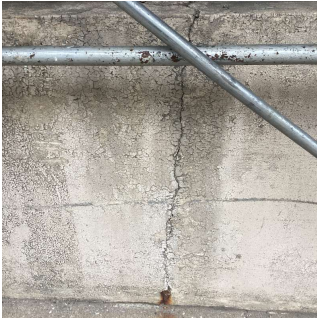
Violations	Rockaway Freeway No violations recorded.
SEATING	Inspected
Benches	Inspected
Concrete	Inspected
Condition	2 - Between Good and Fair
Deficiency	No deficiencies recorded
Metal/Wood/Plastic	Does not Exist
Bleachers	Does not Exist
SITE WALLS (NOT RETAINING WALLS)	Does not Exist
STAIRS/RAMPS: EXTERIOR	Inspected
Railings	Inspected
Condition	2 - Between Good and Fair
Deficiency	No deficiencies recorded
Site Cheek/flank Walls	Inspected
Condition	2 - Between Good and Fair
Deficiency	No deficiencies recorded
Stairs/ramps	Inspected
Condition	2 - Between Good and Fair
