**NYC Department of Education**  
**Building Condition Assessment Survey 2023 - 2024**

Architectural Inspection

**Asset:** P.S. 181 - QUEENS, 148-15 230 STREET, New York, 11413

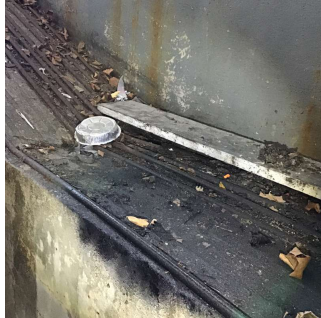
Question	Response
<b>Architectural</b>	
<b>EXTERIOR</b>	Inspected
<b>AREAWAY</b>	Inspected
Instance on AW1, AW2	Inspected
Instance Condition	3 - Fair
Instance Quantity	2
Instance Quantity Uom	EACH
Deficiency	AREAWAY STAIRS: DETERIORATED MATERIAL SLIDE
Roof Plan reference

Facade A - AW2
Violations	No violations recorded.
<b>AWNINGS AND CANOPIES</b>	
Condition	Inspected
Deficiency	2 - Between Good and Fair
	No deficiencies recorded
<b>CHIMNEY</b>	
	Under Construction
<b>COPING</b>	
Condition	Inspected
Deficiency	3 - Fair
Roof Plan reference	CAST STONE: DETERIORATED TRANSVERSE JOINTS

Question	Response
<b>EXTERIOR</b>	
<b>AREAWAY</b>	
Potential Action	REPLACE
Urgency of Action	PRIORITY 3
Purpose of Action	LEVEL 2
Deficiency Photo1

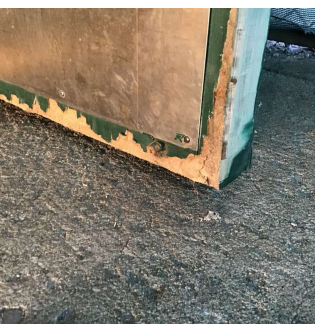
Question	Response
<b>EXTERIOR</b>	
<b>DOORS</b>	Inspected
<b>DOORS AND FRAMES</b>	Inspected
Condition	4 - Between Fair and Poor
Deficiency	METAL CLAD: DETERIORATED DOOR - MAJOR DETERIORATION
Roof Plan reference

Deficiency Quantity	3
Quantity Uom	EACH
Potential Action	REPLACE
Urgency of Action	PRIORITY 4
Purpose of Action	LEVEL 2
Deficiency Photo1

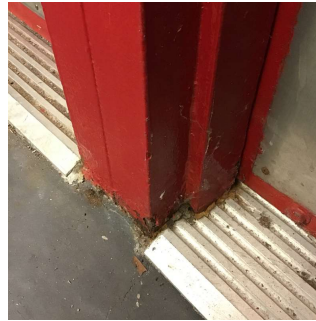
Facade A

Violations	Facade B No violations recorded.
Deficiency	METAL: DETERIORATED DOOR AND FRAME - MINOR DETERIORATION
Roof Plan reference

Deficiency Quantity	3
Quantity Uom	EACH
Potential Action	MAINTENANCE
Urgency of Action	PRIORITY 3
Purpose of Action	LEVEL 2

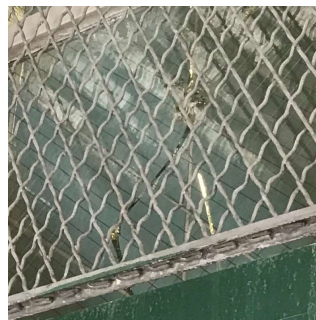
Facade D

METAL: BROKEN GLASS

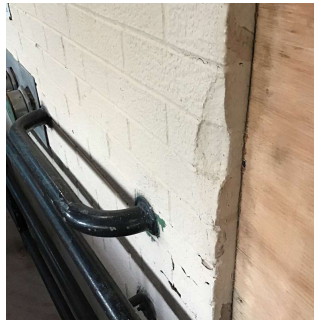
Question	Response
<b>EXTERIOR</b>	
<b>EXTERIOR WALLS</b>	
Material Type(s)	Masonry
Replacement Quantity	29,000
Replacement Uom	S.F.
Instance on Original Building -All Facades	Inspected
Instance Condition	3 - Fair
Instance Quantity	20,000
Instance Quantity Uom	S.F.
Deficiency	BRICK: DETERIORATED MASONRY SILLS - MAJOR
Roof Plan reference	 
Elevation	 
Deficiency Quantity	10
Quantity Uom	L.F.
Potential Action	REMOVE AND REPLACE
Urgency of Action	PRIORITY 4
Purpose of Action	LEVEL 2
Deficiency Photo1	 
Violations	Facade A No violations recorded.
Deficiency	BRICK: MINOR CRACKS AND SPALLING

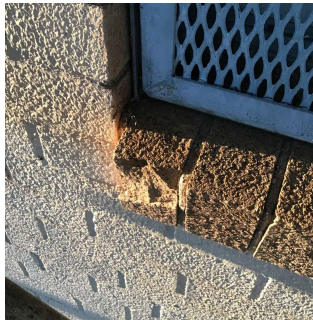
Facade B

BRICK: DETERIORATED MASONRY SILLS - MINOR

REPAIR

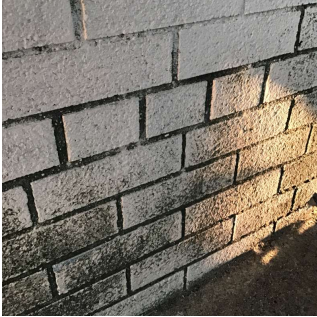
BRICK: DETERIORATED JOINTS

Violations	Facade B No violations recorded.
Instance on 2001 Addition	Under Construction
Instance Quantity	9,000
Instance Quantity Uom	S.F.
<b>EXTERIOR SOFFITS</b>	Inaccessible
<b>LOADING DOCK</b>	Does not Exist
<b>LOUVER</b>	Inspected
Condition	2 - Between Good and Fair
Deficiency	No deficiencies recorded
<b>PARAPETS</b>	Inspected
Material Type(s)	Masonry
Replacement Quantity	1,200
Replacement Uom	C.F.
Instance on 2001 Addition - All Facades	Inspected
Instance Condition	1 - Good
Instance Quantity	1,200
Instance Quantity Uom	C.F.
Deficiency	No deficiencies recorded
<b>PLAZA DECK</b>	Does not Exist
<b>ROOF</b>	Inspected
<b>Roofing</b>	Inspected
Replacement Quantity	44,000
Replacement Uom	S.F.
<b>ROOF HATCH/SMOKE HATCH</b>	Inspected
Condition	2 - Between Good and Fair
Deficiency	No deficiencies recorded

Question	Response
<b>EXTERIOR</b>	
<b>EXTERIOR WALLS</b>	
Urgency of Action	PRIORITY 3
Purpose of Action	LEVEL 2
Deficiency Photo1

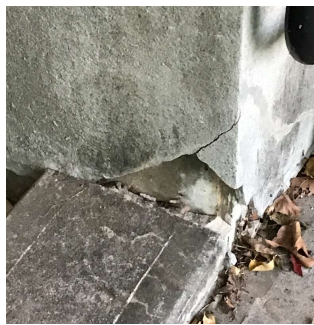
Question	Response
<b>EXTERIOR</b>	
<b>ROOF</b>	
<b>Specialties</b>	
<b>DUNNAGE STEEL</b>	
Deficiency Photo1	 
Violations	Roof 4 No violations recorded.
<b>SKYLIGHT/ROOF VENT</b>	Under Construction
<b>ROOF/GRAVITY TANK</b>	Does not Exist
<b>STAIRS/RAMPS: EXTERIOR</b>	Inspected
<b>BUILDING CHEEK/FLANK WALLS</b>	Inspected
Condition	3 - Fair
Deficiency	CAST IN PLACE CONCRETE: CRACKS/SPALLING - MINOR
Roof Plan reference	<p>Q181</p>  
Deficiency Quantity	30
Quantity Uom	S.F.
Potential Action	REPAIR
Urgency of Action	PRIORITY 3
Purpose of Action	LEVEL 2
Deficiency Photo1	 
Violations	Facade B No violations recorded.
Deficiency	CAST IN PLACE CONCRETE: CRACKS/SPALLING - MAJOR

10  
S.F.  
REPLACE  
PRIORITY 4  
LEVEL 2

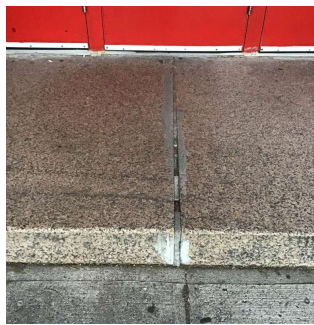
Facade A  
No violations recorded.

STONE: DETERIORATED JOINTS

10  
L.F.  
REPOINT  
PRIORITY 3  
LEVEL 2

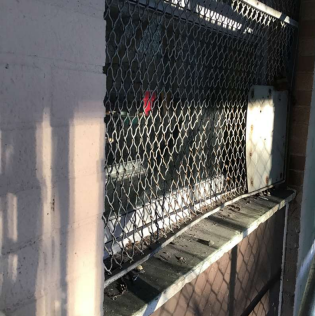
DETERIORATED/TORN-OUT/MISSING

Violations	Facade E No violations recorded.
<b>LINTELS</b>	Inspected
Condition	2 - Between Good and Fair
Deficiency	No deficiencies recorded
<b>WINDOWS</b>	Inspected
Material Type(s)	Aluminum
Instance on Aluminum - Double Hung: Original Building	Inspected
Instance Condition	3 - Fair
Instance Quantity	5,400
Instance Quantity Uom	S.F.
Are these windows insulated	No
Installation Year	2001
Source of Installation	Custodial Staff
Deficiency	ALUMINUM - DOUBLE HUNG: BROKEN PANE

Question	Response
<b>EXTERIOR</b>	
<b>WINDOWS</b>	
<b>EXTERIOR GUARDS</b>	
Elevation	 
Deficiency Quantity	100
Quantity Uom	S.F.
Potential Action	REPLACE
Urgency of Action	PRIORITY 4
Purpose of Action	LEVEL 2
Deficiency Photo1

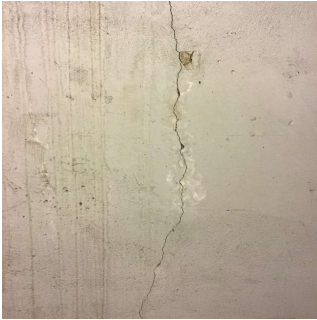
Question	Response
<b>INTERIOR</b>	
<b>STRUCTURAL</b>	
<b>FLOOR STRUCTURE</b>	Inspected
Violations	No violations recorded.
<b>FOUNDATION WALLS</b>	Inspected
Material Type(s)	Concrete, Masonry
Condition	4 - Between Fair and Poor
Deficiency	CONCRETE: CRACKED/SPALLED/REINFORCEMENT EXPOSED
Deficiency Location/Instance	Basement - Fan Area, Storage
Deficiency Quantity	20
Quantity Uom	S.F.
Potential Action	REPAIR
Urgency of Action	PRIORITY 3
Purpose of Action	LEVEL 5
Deficiency Photo1

Basement - Fan Area
Violations	No violations recorded.
Deficiency	BRICK: WATER INFILTRATION IN NON- INSTRUCTIONAL SPACE
Deficiency Location/Instance	Basement - Boiler Room Pit
Deficiency Quantity	100
Quantity Uom	S.F.
Potential Action	INSTALL WATERPROOFING
Urgency of Action	PRIORITY 5
Purpose of Action	LEVEL 5
Deficiency Photo1

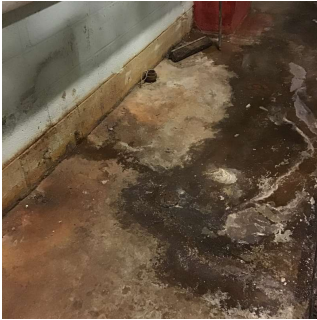
Basement - Boiler Room Pit
Violations	35643133K
Deficiency	CONCRETE: WATER INFILTRATION IN ELECTRICAL PANEL ROOM

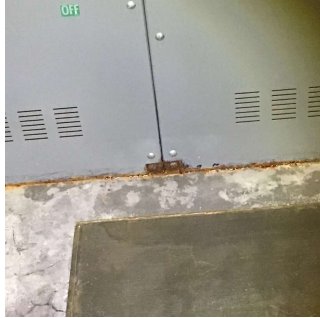
Deficiency Location/Instance	Basement - Electrical Panel Room
Deficiency Quantity	100
Quantity Uom	S.F.
Potential Action	INSTALL WATERPROOFING

Violations	Basement - Electrical Panel Room No violations recorded.
<b>ROOF STRUCTURE</b>	Inspected
Condition	2 - Between Good and Fair
Deficiency	No deficiencies recorded
<b>VAULTS-BUNKERS</b>	Inspected
<b>Foundation Walls</b>	Inspected
Condition	2 - Between Good and Fair
Deficiency	No deficiencies recorded
<b>Slab Structure</b>	Inspected
Condition	2 - Between Good and Fair
Deficiency	No deficiencies recorded
<b>Vault/Ash Hoist Doors and Framing</b>	Inspected
Condition	1 - Good
Deficiency	No deficiencies recorded
<b>AUDITORIUM</b>	Does not Exist
<b>CAFETERIA</b>	Inspected
Instance on 1st Floor	Inspected
<b>Ceiling</b>	
Instance on 1st Floor	Inspected
Condition	2 - Between Good and Fair
Deficiency	TECTUM: DAMAGED/MISSING
Deficiency Location/Instance	Near Exit

Question	Response
<b>INTERIOR</b>	
<b>STRUCTURAL</b>	
<b>FOUNDATION WALLS</b>	Inspected
Urgency of Action	PRIORITY 5
Purpose of Action	LEVEL 6
Deficiency Photo1

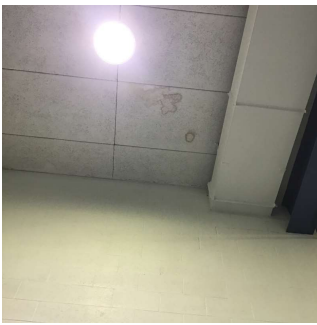
Near Exit
Violations	No violations recorded.
<b>Door(s)</b>	
Instance on 1st Floor	Inspected
Condition	2 - Between Good and Fair
Deficiency	No deficiencies recorded
<b>Fixed Equipment</b>	
Instance on 1st Floor	Does not Exist
<b>Floor Finish</b>	
Instance on 1st Floor	Inspected
Condition	2 - Between Good and Fair
Deficiency	VINYL TILES: BROKEN/DETERIORATED/MISSING TILES
Deficiency Location/Instance	Near Windows
Deficiency Quantity	10
Quantity Uom	S.F.
Potential Action	REPLACE
Urgency of Action	PRIORITY 3
Purpose of Action	LEVEL 2
Deficiency Photo1	 
	Near Windows
Violations	No violations recorded.
<b>Sliding-folding Partition</b>	
Instance on 1st Floor	Inspected
Condition	2 - Between Good and Fair
Deficiency	No deficiencies recorded
<b>Stage</b>	
Instance on 1st Floor	Does not Exist
<b>Walls</b>	
Instance on 1st Floor	Inspected
Condition	2 - Between Good and Fair

Deficiency Quantity	10
Quantity Uom	S.F.
Potential Action	REPLACE
Urgency of Action	PRIORITY 3
Purpose of Action	LEVEL 2

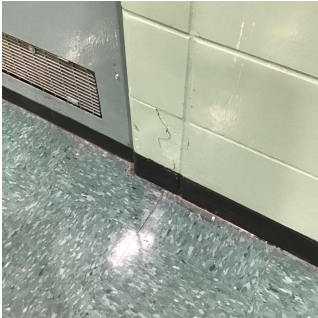
Question	Response
<b>INTERIOR</b>	
<b>CAFETERIA</b>	
<b>Walls</b>	
Deficiency	GLAZED BLOCK: CRACKS/SPALLING
Deficiency Location/Instance	Near Windows, near Kitchen
Deficiency Quantity	20
Quantity Uom	S.F.
Potential Action	REPLACE
Urgency of Action	PRIORITY 3
Purpose of Action	LEVEL 2
Deficiency Photo1

Violations	Near Windows No violations recorded.
<b>Window Curtains/Shades/Blinds</b>	
Instance on 1st Floor	Does not Exist
<b>CLASSROOMS/CORRIDORS/ADMIN SPACES</b>	
<b>Ceiling</b>	Inspected
Condition	2 - Between Good and Fair
Deficiency	ACOUSTIC TILES ON PLASTER: DAMAGED/MISSING
Deficiency Location/Instance	Near Classroom 205,207, 225A
Deficiency Quantity	80
Quantity Uom	S.F.
Potential Action	REPLACE
Urgency of Action	PRIORITY 3
Purpose of Action	LEVEL 2
Deficiency Photo1	 
Violations	Near Classroom 205 No violations recorded.
Deficiency	GYPSUM BOARD: DAMAGED/DETERIORATED
Deficiency Location/Instance	Near Stair E/2, 239

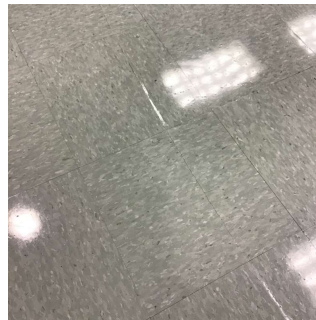
Room 238

VINYL TILES: DETERIORATED SUBSTRATE

REPLACE

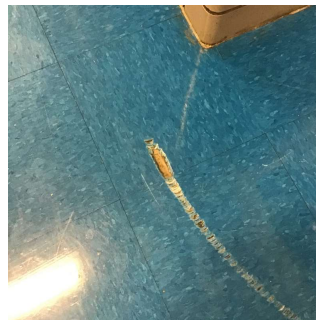
VINYL TILES: BROKEN/DETERIORATED/MISSING TILES

REPLACE

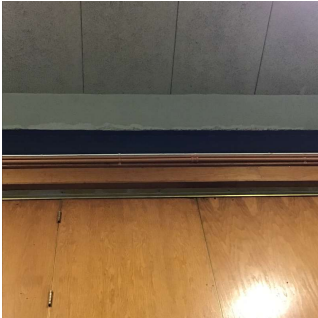
Question	Response
<b>INTERIOR</b>	
<b>CLASSROOMS/CORRIDORS/ADMIN SPACES</b>	
<b>Floor Finish</b>	Inspected
Violations	Near Gymnasium No violations recorded.
<b>Walls</b>	Inspected
Condition	2 - Between Good and Fair
Deficiency	No deficiencies recorded
<b>Specialties</b>	Does not Exist
<b>GYMNASIUM</b>	Inspected
Instance on 1st Floor	Inspected
<b>Ceiling</b>	
Instance on 1st Floor	Inspected
Condition	2 - Between Good and Fair
Deficiency	PLASTER: CRACKS/SPALLING
Deficiency Location/Instance	Near Partition Wall
Deficiency Quantity	40
Quantity Uom	S.F.
Potential Action	REPLACE
Urgency of Action	PRIORITY 3
Purpose of Action	LEVEL 2
Deficiency Photo1

Violations	Near Partition Wall No violations recorded.
<b>Door(s)</b>	
Instance on 1st Floor	Inspected
Condition	2 - Between Good and Fair
Deficiency	No deficiencies recorded
<b>Fixed Equipment</b>	
Instance on 1st Floor	Inspected
Condition	2 - Between Good and Fair
Deficiency	No deficiencies recorded

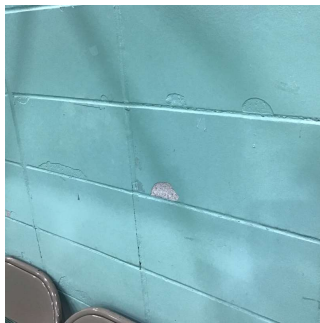
Question	Response
<b>INTERIOR</b>	
<b>GYMNASIUM</b>	
<b>Walls</b>	
Deficiency Photo1

Violations	Along Window Side No violations recorded.
<b>Window Curtains/Shades/Blinds</b>	
Instance on 1st Floor	Inspected
Condition	5 - Poor
Deficiency	INOPERABLE CURTAINS
Deficiency Location/Instance	Window Wall in Gymnasium and Cafeteria
Deficiency Quantity	8
Quantity Uom	EACH
Potential Action	MAINTENANCE
Urgency of Action	PRIORITY 3
Purpose of Action	LEVEL 2
Deficiency Photo1	No photo recorded
Violations	No violations recorded.
Deficiency	WORN/DAMAGED CURTAINS
Deficiency Location/Instance	Window Wall in Gymnasium and Cafeteria
Deficiency Quantity	800
Quantity Uom	S.F.
Potential Action	MAINTENANCE
Urgency of Action	PRIORITY 3
Purpose of Action	LEVEL 2
Deficiency Photo1	No photo recorded
Violations	No violations recorded.
<b>INTERIOR DOOR HARDWARE</b>	
Instance on 1st Floor	Inspected
Condition	2 - Between Good and Fair
Deficiency	No deficiencies recorded

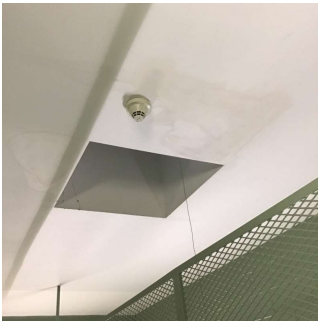
Question	Response
<b>INTERIOR</b>	
<b>LIBRARY</b>	
<b>Floor Finish</b>	
Instance on Room 222	Inspected
Condition	1 - Good
Deficiency	No deficiencies recorded
<b>Walls</b>	
Instance on Room 222	Inspected
Condition	1 - Good
Deficiency	No deficiencies recorded
<b>LOCKER ROOM</b>	Does not Exist
<b>MULTI-PURPOSE ROOM</b>	Does not Exist
<b>SCIENCE DEMO ROOM</b>	Does not Exist
<b>SCIENCE LAB</b>	Does not Exist
<b>SCIENCE PREP ROOM</b>	Does not Exist
<b>SHOWER ROOM</b>	Does not Exist
<b>STAIRS/RAMPS: INTERIOR</b>	Inspected
Do Letter Stair Signs Exist?	Yes
<b>Ceiling</b>	Inspected
Condition	2 - Between Good and Fair
Deficiency	GYPSUM BOARD: DAMAGED/DETERIORATED
Deficiency Location/Instance	Stair F/2
Deficiency Quantity	10
Quantity Uom	S.F.
Potential Action	REPLACE
Urgency of Action	PRIORITY 3
Purpose of Action	LEVEL 2
Deficiency Photo1

Violations	No violations recorded.
Deficiency	PLASTER: CRACKS/SPALLING
Deficiency Location/Instance	Stair D/2, A/2

Deficiency Quantity	80
Quantity Uom	S.F.
Potential Action	REPLACE
Urgency of Action	PRIORITY 3
Purpose of Action	LEVEL 4

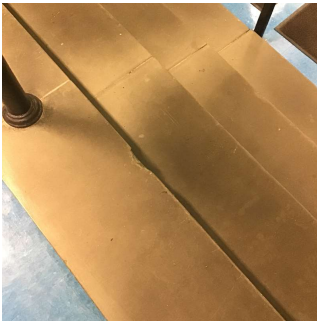
Question	Response
<b>INTERIOR</b>	
<b>STAIRS/RAMPS: INTERIOR</b>	
<b>Stairs and Landings</b>	
Deficiency Photo1

Violations	Stair A/1 No violations recorded.
<b>Walls</b>	Inspected
Condition	2 - Between Good and Fair
Deficiency	No deficiencies recorded
<b>TOILET ROOMS - STAFF</b>	Inspected
<b>Ceiling</b>	Inspected
Condition	2 - Between Good and Fair
Deficiency	No deficiencies recorded
<b>Door(s)</b>	Inspected
Condition	5 - Poor
Deficiency	WOOD: DETERIORATED DOOR
Deficiency Location/Instance	Inside Room 145
Deficiency Quantity	1
Quantity Uom	EACH
Potential Action	MAINTENANCE
Urgency of Action	PRIORITY 3
Purpose of Action	LEVEL 2
Deficiency Photo1	 
Violations	Inside Room 145 No violations recorded.
<b>Floor Finish</b>	Inspected
Condition	2 - Between Good and Fair
Deficiency	No deficiencies recorded
<b>Stalls</b>	Inspected
Condition	2 - Between Good and Fair
Deficiency	No deficiencies recorded
<b>Walls</b>	Inspected

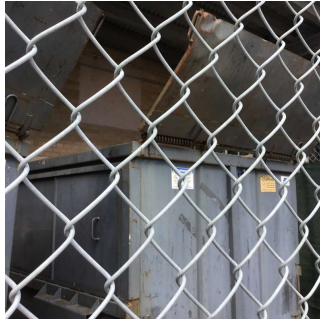
Condition	5 - Poor
Deficiency	CONTAINER DAMAGED
Deficiency Location/Instance	230th Place
Deficiency Quantity	1
Quantity Uom	EACH
Potential Action	REPLACE
Urgency of Action	PRIORITY 3
Purpose of Action	LEVEL 2

Violations	Along 230th Place No violations recorded.
Deficiency	<b>CONCRETE PAD MISSING</b>
Deficiency Location/Instance	Along 230th Place
Deficiency Quantity	100
Quantity Uom	S.F.
Potential Action	INSTALL NEW
Urgency of Action	PRIORITY 3
Purpose of Action	LEVEL 2
Deficiency Photo1

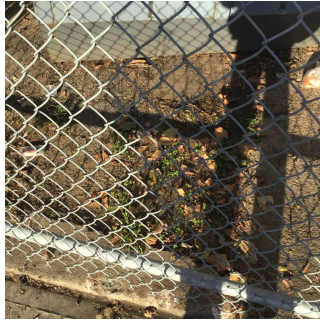
Violations	Along 230th Place No violations recorded.
<b>Drainage System for Asphalt</b>	Inspected
<b>Catch Basins/Manhole - Surrounded by asphalt</b>	Inaccessible
<b>Culverts - Asphalt Covering</b>	Does not Exist
<b>Drainage System for Concrete</b>	Inspected
<b>Catch Basins/Manhole - Surrounded by concrete</b>	Inspected
Condition	2 - Between Good and Fair
Deficiency	No deficiencies recorded
<b>Culverts - Concrete Covering</b>	Does not Exist
<b>Drainage System for Soil</b>	Inspected
<b>Catch Basins/Manhole - Surrounded by Soil</b>	Inaccessible
<b>Culverts - Soil Covering</b>	Does not Exist
