**NYC Department of Education**  
**Building Condition Assessment Survey 2023 - 2024**

Architectural Inspection

Q185

**Asset:** J.H.S. 185 - QUEENS, 147-26 25 DRIVE, New York, 11354

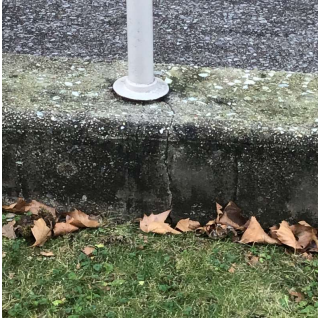
**AREAWAY WALLS: CRACKS AND SPALLING**

40  
S.F.  
REPAIR  
PRIORITY 3  
LEVEL 2

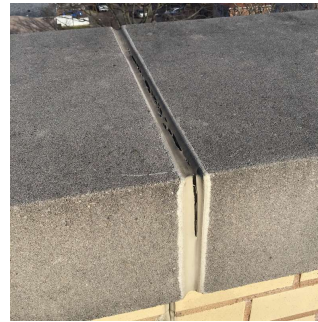
Roof 1  
No violations recorded.

Violations	CH1 No violations recorded.
<b>COPING</b>	
Condition	Inspected 3 - Fair
Deficiency	CAST STONE: DETERIORATED TRANSVERSE JOINTS

50  
L.F.  
MAINTENANCE  
PRIORITY 3  
LEVEL 2

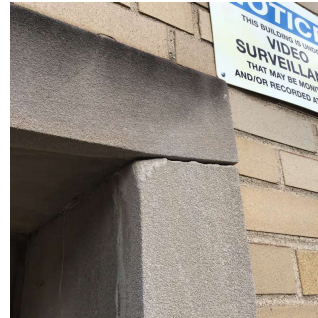
Facade G

STONE: DETERIORATED JOINTS

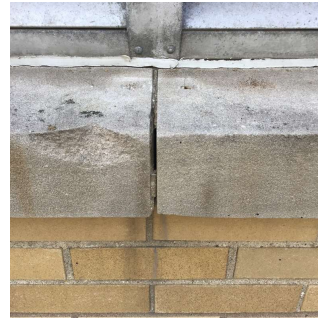
Facade E - Gymnasium Fan Room

BRICK: MASONRY SILLS - DETERIORATED JOINTS

PRIORITY 3  
LEVEL 2

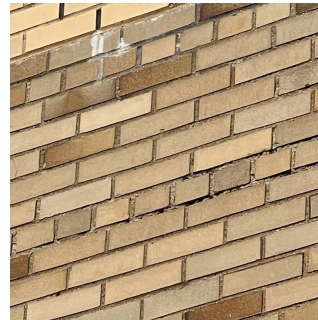
Roof 3

BRICK: DETERIORATED JOINTS

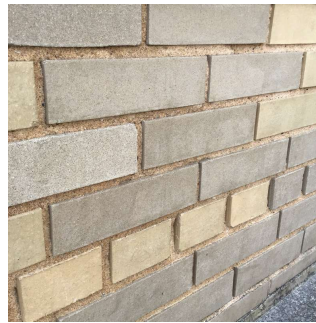
Facade B

BRICK: DETERIORATED JOINTS

40  
 S.F.  
 REPOINT  
 PRIORITY 3  
 LEVEL 2

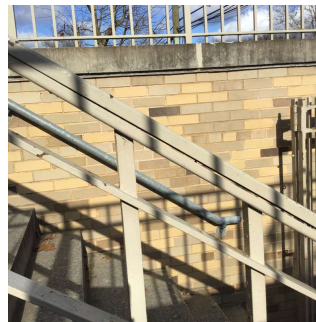
Facade B

DAMAGED

REPLACE

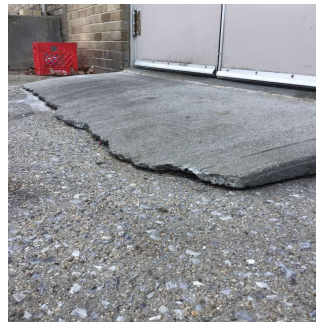
Facade A

CONCRETE: CRACKS/SPALLING - MAJOR

20  
 S.F.  
 REPLACE  
 PRIORITY 4  
 LEVEL 2

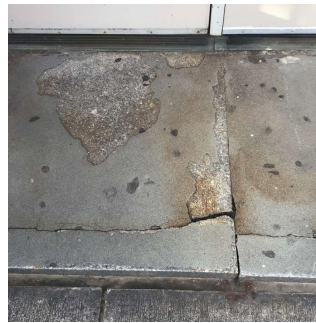
Facade B

STONE: CRACKS/SPALLING - MAJOR

10  
 S.F.  
 REPLACE  
 PRIORITY 4  
 LEVEL 2

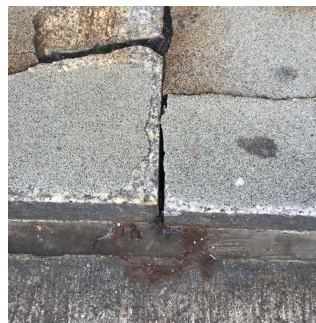
Facade B

**STONE: DETERIORATED JOINTS**

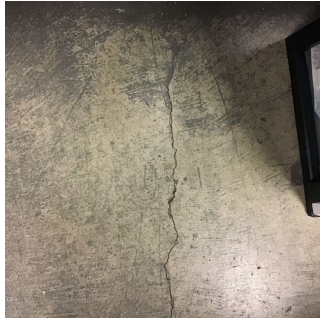
Violations	Room B9 No violations recorded.
Deficiency	CONCRETE: CRACKS/SPALLED/REINFORCEMENT EXPOSED
Deficiency Location/Instance	Gymnasium Fan Room, Room 114
Deficiency Quantity	20
Quantity Uom	S.F.
Potential Action	REPAIR
Urgency of Action	PRIORITY 3

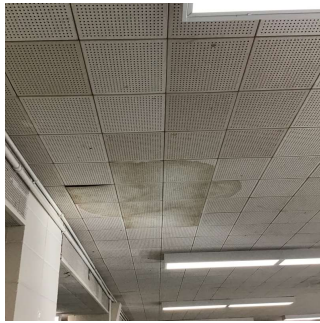
Violations	Near Windows No violations recorded.
Instance on Ground Floor - Students	Inspected
Condition	4 - Between Fair and Poor
Deficiency	ACOUSTIC TILES: DAMAGED/MISSING

Deficiency Location/Instance	Center, Near Windows, Near Serving area, Near Stair EF, Near Entrance
Deficiency Quantity	400
Quantity Uom	S.F.
Potential Action	REPLACE
Urgency of Action	PRIORITY 3
Purpose of Action	LEVEL 2

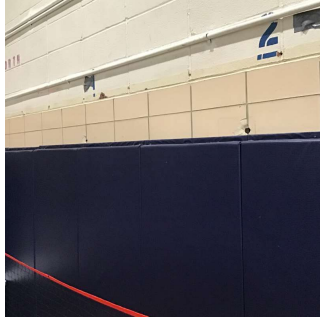
Violations	Center No violations recorded.
<b>Stage</b>	
Instance on Ground Floor	Does not Exist
<b>Walls</b>	
Instance on Ground Floor	Inspected
Condition	2 - Between Good and Fair
Deficiency	GLAZED BLOCK: CRACKS/SPALLING
Deficiency Location/Instance	Right Side Near Entrance
Deficiency Quantity	10
Quantity Uom	S.F.
Potential Action	REPLACE
Urgency of Action	PRIORITY 3
Purpose of Action	LEVEL 2
Deficiency Photo1

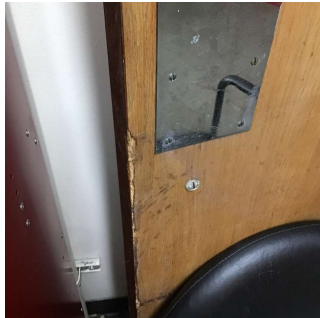
Violations	Inside Gymnasium Office No violations recorded.
<b>Door(s)</b>	Inspected
Condition	5 - Poor
Deficiency	WOOD: DETERIORATED DOOR
Deficiency Location/Instance	Rooms B13A, G13, G11
Deficiency Quantity	3
Quantity Uom	EACH
Potential Action	MAINTENANCE
Urgency of Action	PRIORITY 3
Purpose of Action	LEVEL 2
Deficiency Photo1

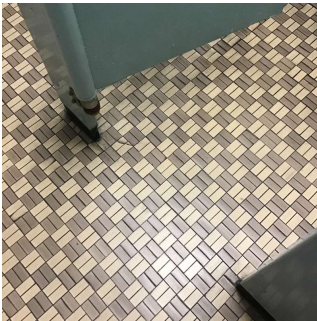
Violations	Room G13 No violations recorded.
<b>Floor Finish</b>	Inspected
Condition	4 - Between Fair and Poor
Deficiency	CERAMIC TILE: BROKEN/MISSING TILES
Deficiency Location/Instance	Rooms 218A, 124A, G13, B13A
Deficiency Quantity	40
Quantity Uom	S.F.
Potential Action	REPLACE
Urgency of Action	PRIORITY 3
Purpose of Action	LEVEL 2

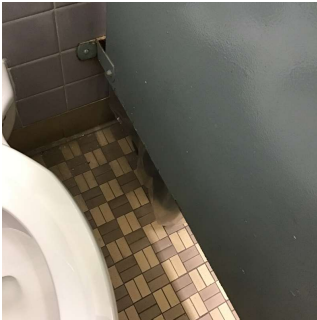
Room 218A
Violations	No violations recorded.
<b>Stalls</b>	
Condition	Inspected
	5 - Poor
Deficiency	RUST - MAJOR
Deficiency Location/Instance	Inside Gymnasium Office, 218A, 124A, G13, B15, B13A
Deficiency Quantity	6
Quantity Uom	EACH
Potential Action	REPLACE
Urgency of Action	PRIORITY 3
Purpose of Action	LEVEL 2
Deficiency Photo1

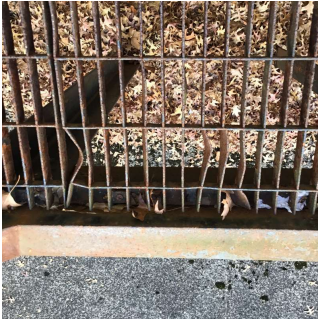
Room 324
Violations	No violations recorded.
<b>LIFE SAFETY</b>	Inspected
<b>F.D. HOLDING AREA</b>	Does not Exist
<b>STEEL STAIRS</b>	Inspected
Condition	5 - Poor
Deficiency	DAMAGED
Deficiency Location/Instance	Facade E
Deficiency Quantity	25
Quantity Uom	S.F.
Potential Action	REPLACE
Urgency of Action	PRIORITY 4
Purpose of Action	LEVEL 2
Deficiency Photo1

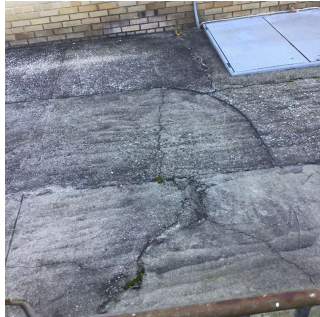
Violations	25th Drive No violations recorded.
Deficiency	CRACKS - MAJOR
Deficiency Location/Instance	25th Drive, Courtyard
Deficiency Quantity	800
Quantity Uom	S.F.
Potential Action	REPLACE
Urgency of Action	PRIORITY 3
Purpose of Action	LEVEL 2
Deficiency Photo1

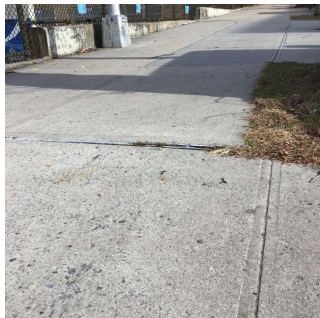
Main Entrance
Violations	No violations recorded.
<b>Pavers</b>	Does not Exist
<b>DOT Sidewalk</b>	Inspected
<b>Asphalt</b>	Does not Exist
<b>Concrete</b>	Inspected
Condition	4 - Between Fair and Poor
Deficiency	HEAVING
Deficiency Location/Instance	26th Avenue, 25th Drive
Deficiency Quantity	100
Quantity Uom	S.F.
Potential Action	REPLACE
Urgency of Action	PRIORITY 3
Purpose of Action	LEVEL 2
Deficiency Photo1
