NYC Department of Education
Building Condition Assessment Survey 2023 - 2024

Architectural Inspection

Asset: P.S. 186 - QUEENS, 252-12 72 AVENUE, New York, 11426

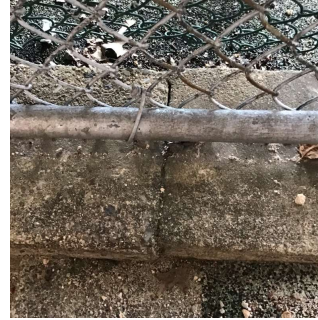
AW2

AREAWAY STAIRS: DETERIORATED
TREADS/RISERS/NOSINGS

REPAIR

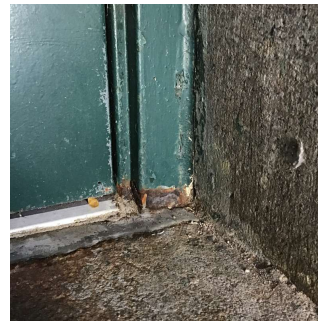
Facade C - Exit 2

METAL: DETERIORATED DOOR AND FRAME - MAJOR DETERIORATION

REPLACE

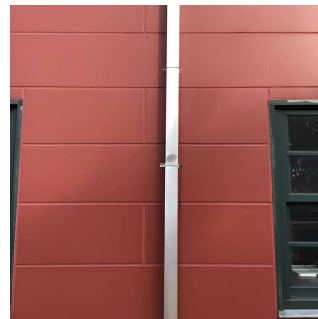
Roof 6

DAMAGED/MISSING

10
L.F.
REPLACE
PRIORITY 4
LEVEL 2

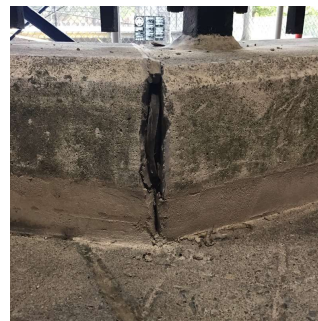
Facade D - Exit 3

RUST - MAJOR

40
L.F.
REPLACE
PRIORITY 4
LEVEL 2

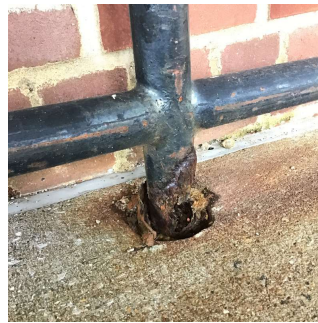
Facade D - Exit 3 HC Ramp
No violations recorded.

STONE: DETERIORATED SUBSTRATE

10
S.F.
REPLACE SUBSTRATE AND RESET
PRIORITY 4
LEVEL 2

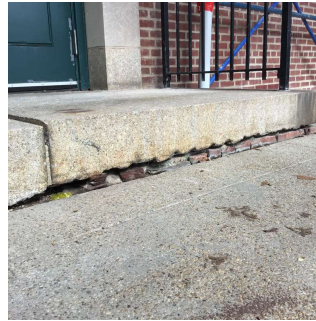
Facade C - Exit 4

CONCRETE: CRACKS/SPALLING - MAJOR

REPLACE

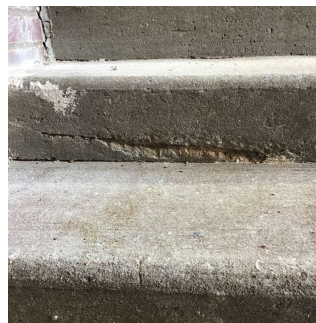
Facade D - Exit 3

STONE: DETERIORATED JOINTS

40
 L.F.
 REPOINT
 PRIORITY 4
 LEVEL 2

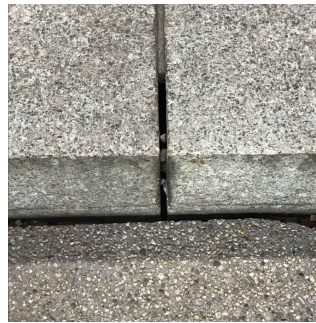
Facade J - Exit 7

CONCRETE: CRACKS/SPALLING - MINOR

20
 S.F.
 REPAIR
 PRIORITY 3
 LEVEL 2

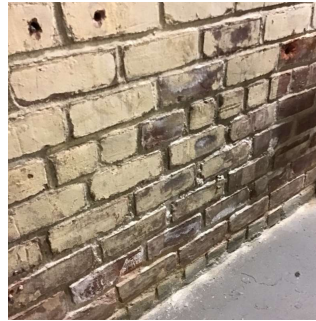
Boiler Room

BRICK: DETERIORATED JOINTS

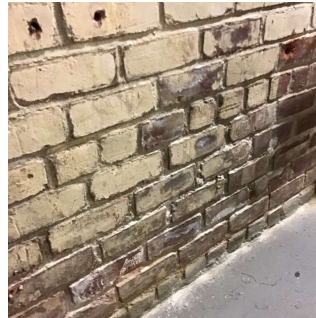
Boiler Room

CONCRETE: CRACKED/SPALLED/REINFORCEMENT EXPOSED

REPAIR

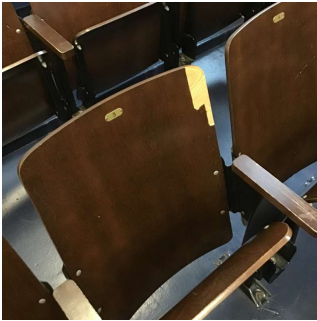
Deficiency Location/Instance	Seats D/106, J/109,M/101,P/3,Q/11,
Deficiency Quantity	5
Quantity Uom	EACH
Potential Action	REPLACE
Urgency of Action	PRIORITY 3
Purpose of Action	LEVEL 2

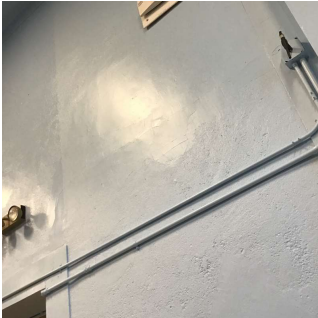
Question	Response
INTERIOR	
AUDITORIUM	
Walls	
Deficiency	PLASTER: CRACKS/SPALLING
Deficiency Location/Instance	Near Entrance Door
Deficiency Quantity	20
Quantity Uom	S.F.
Potential Action	REPLACE
Urgency of Action	PRIORITY 3
Purpose of Action	LEVEL 2
Deficiency Photo1

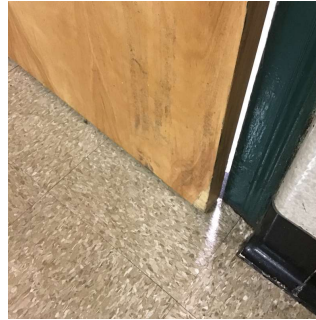
Entrance Door

Condition	5 - Poor
Deficiency	WOOD: DETERIORATED DOOR
Deficiency Location/Instance	Entrance Doors, Near Exit 9
Deficiency Quantity	3
Quantity Uom	EACH
Potential Action	MAINTENANCE
Urgency of Action	PRIORITY 3
Purpose of Action	LEVEL 2
Deficiency Photo1

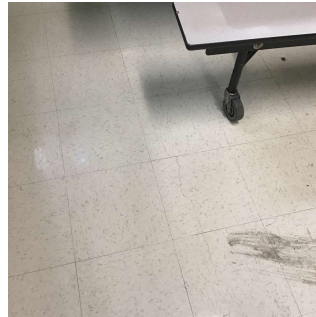
Instance on 1st Floor	Inspected
Condition	2 - Between Good and Fair
Deficiency	VINYL TILES: BROKEN/DETERIORATED/MISSING TILES
Deficiency Location/Instance	Near Window
Deficiency Quantity	20
Quantity Uom	S.F.
Potential Action	REPLACE
Urgency of Action	PRIORITY 3
Purpose of Action	LEVEL 2
Deficiency Photo1

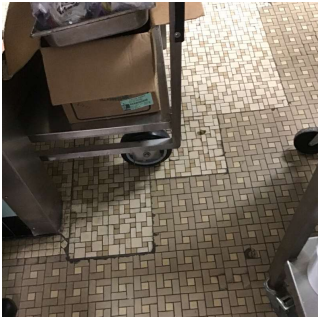
Condition	2 - Between Good and Fair
Deficiency	CERAMIC TILE: BROKEN/MISSING TILES
Deficiency Location/Instance	Near Entrance
Deficiency Quantity	20
Quantity Uom	S.F.
Potential Action	REPLACE
Urgency of Action	PRIORITY 3
