NYC Department of Education
Building Condition Assessment Survey 2023 - 2024

Architectural Inspection

Asset: I.S. 192 - QUEENS, 109-89 204 STREET, New York, 11412

Inspection Id	Inspection Type	Time In	Last Edited
SA : Q192	Architectural - Senior	2023-12-19 7:30 AM	2024-01-04 3:46 PM
AA : Q192	Architectural - Associate	2023-12-19 7:28 AM	2024-01-02 6:17 PM

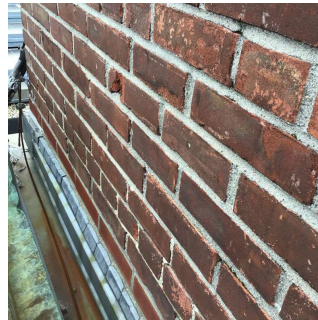
Roof 1
 No violations recorded.

CHIMNEY	Inspected
Material Type(s)	Masonry
Condition	3 - Fair
Deficiency	BRICK: DETERIORATED JOINTS

30
 S.F.
 REPOINT
 PRIORITY 3
 LEVEL 2

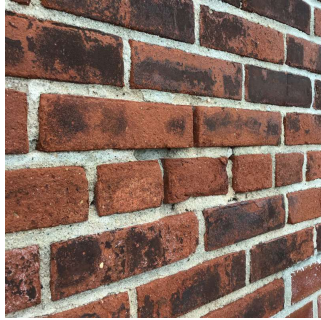
BRICK: DETERIORATED JOINTS

10
 S.F.
 REPOINT
 PRIORITY 4
 LEVEL 2

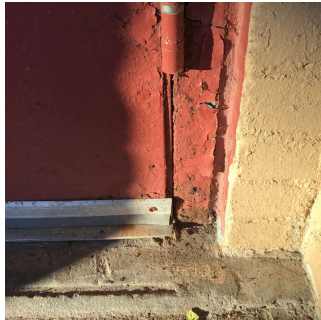
Violations	Roof 1 No violations recorded.
COPING	Does not Exist
CORNICE	Does not Exist
DOORS	Inspected
DOORS AND FRAMES	Inspected
Condition	5 - Poor
Deficiency	METAL CLAD: DETERIORATED DOOR AND FRAME - MAJOR DETERIORATION
Roof Plan reference	Q192
Deficiency Quantity	4
Quantity Uom	EACH
Potential Action	REPLACE
Urgency of Action	PRIORITY 4
Purpose of Action	LEVEL 2
Deficiency Photo1

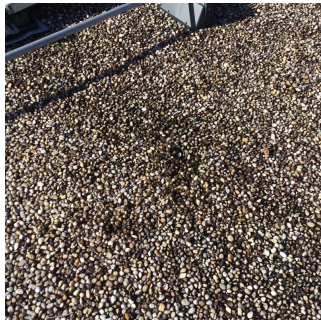
Roof 1
Instance Quantity	63,000
Instance Quantity Uom	S.F.
Does the roof have major mechanical equipment sitting on Dunnage Steel less than 18" above the Roofing?	No
Does this roof instance have a Sustainable Roof System?	No
Do solar panels exist on these roofs?	Yes
Solar Panel Location (Roof Number)	Roofs 1, 2
Installation Year	2009
Source of Installation	Custodial Staff
Deficiency	BUILT-UP: ROOFING: DELAMINATION
Roof Plan reference	Q192

Deficiency Quantity	30
Quantity Uom	S.F.
Potential Action	REPLACE ROOFING WITHOUT MAJOR EQUIPMENT REMOVAL
Urgency of Action	PRIORITY 4
Purpose of Action	LEVEL 2
Deficiency Photo1

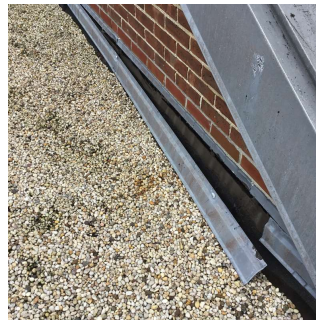
Roof 1
 No violations recorded.

Roof 2
Violations	No violations recorded.
Deficiency	BUILT-UP: FLASHING: CAP FLASHING DAMAGED

30
 L.F.
 REPLACE
 PRIORITY 4
 LEVEL 2

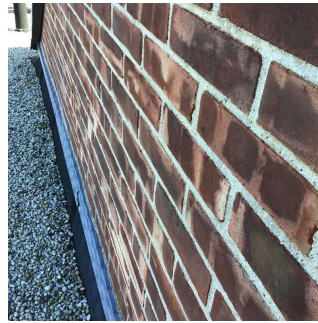
Roof 2 - Bulkhead 5

Inspected
 4 - Between Fair and Poor
 BULKHEAD/PENTHOUSE WALLS/EXTERIOR: DETERIORATED JOINTS

100
 S.F.
 REPOINT

PRIORITY 3
 LEVEL 2

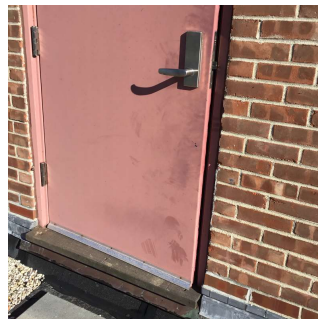
BULKHEAD/PENTHOUSE DOORS: DETERIORATED DOOR AND FRAME

Roof 2 - Bulkhead 5 - door does not close

1
 EACH
 REPLACE DOOR AND FRAME
 PRIORITY 4
 LEVEL 2

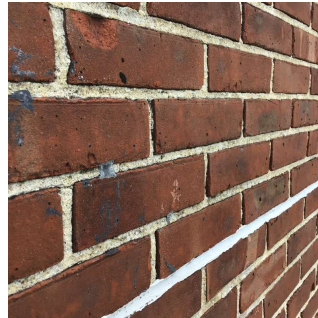
Roof 1 - Bulkhead 3

BULKHEAD/PENTHOUSE WALLS/EXTERIOR: DETERIORATED JOINTS

300
S.F.
REPOINT
PRIORITY 4
LEVEL 2

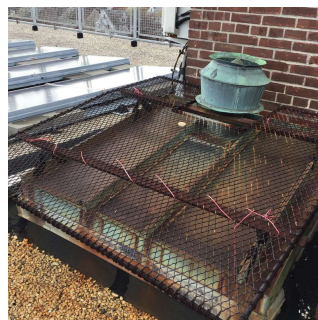
Roof 1 - Skylight 1

DAMAGED GUARDS

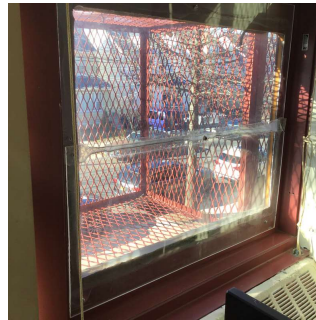
Facade A - Room 207

ALUMINUM - DOUBLE HUNG: BROKEN PANE

30
S.F.
MAINTENANCE
PRIORITY 3
LEVEL 2

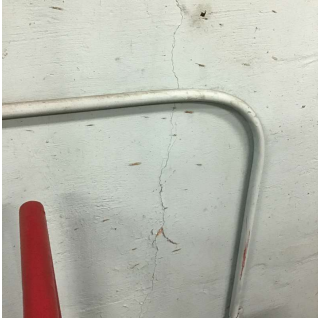
Question	Response
EXTERIOR	
WINDOWS	
WINDOWS	
Potential Action	REPLACE BALANCES
Urgency of Action	PRIORITY 3
Purpose of Action	LEVEL 2
Deficiency Photo1	No photo recorded
Violations	No violations recorded.
Instance on Aluminum - Other: Facade A - 1st Floor , Facade C, C1 - 3rd Floor	Inspected
Instance Condition	2 - Between Good and Fair
Instance Quantity	1,600
Instance Quantity Uom	S.F.
Are these windows insulated	Yes
Installation Year	2009
Source of Installation	Custodial Staff
Deficiency	No deficiencies recorded
INTERIOR	Inspected
POOLS	Does not Exist
STRUCTURAL	Inspected
COLUMNS/BEAMS/BEARING WALLS	Inspected
Condition	2 - Between Good and Fair
Deficiency	No deficiencies recorded
FLOOR STRUCTURE	Inspected
Condition	2 - Between Good and Fair
Deficiency	No deficiencies recorded
FOUNDATION WALLS	Inspected
Material Type(s)	Concrete
Condition	3 - Fair
Deficiency	CONCRETE: CRACKED/SPALLED/REINFORCEMENT EXPOSED
Deficiency Location/Instance	Basement - Boiler Room

Basement - Boiler Room
Violations	No violations recorded.
Deficiency	CONCRETE: CRACKED/SPALLED/REINFORCEMENT EXPOSED

Deficiency Quantity	10
Quantity Uom	S.F.
Potential Action	REPAIR
Urgency of Action	PRIORITY 3
Purpose of Action	LEVEL 5
Deficiency Photo1

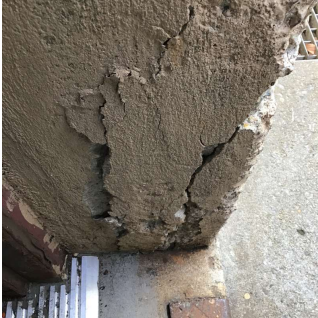
Question	Response
INTERIOR	
STRUCTURAL	
FOUNDATION WALLS	
Deficiency Location/Instance	Basement - Boiler Room entrance
Deficiency Quantity	10
Quantity Uom	S.F.
Potential Action	REPAIR
Urgency of Action	PRIORITY 4
Purpose of Action	LEVEL 5
Deficiency Photo1

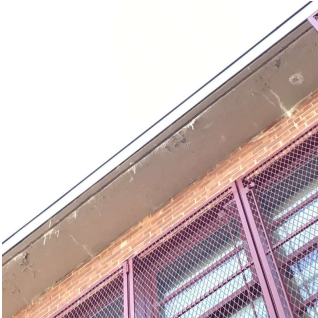
Violations	Basement - Boiler Room entrance No violations recorded.
ROOF STRUCTURE	
Condition	Inspected
Deficiency	3 - Fair CONCRETE: CRACKED/SPALLED/REINFORCEMENT EXPOSED
Deficiency Location/Instance	Roof 2 - overhang
Deficiency Quantity	40
Quantity Uom	S.F.
Potential Action	REPAIR
Urgency of Action	PRIORITY 3
Purpose of Action	LEVEL 5
Deficiency Photo1

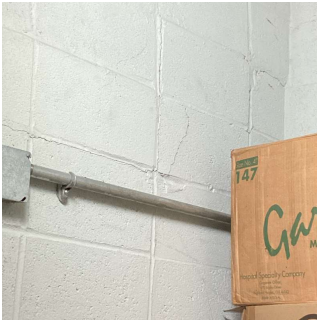
Near Left Stage
Violations	No violations recorded.
Deficiency	MASONRY: CRACKS/SPALLING
Deficiency Location/Instance	Storage Room
Deficiency Quantity	10
Quantity Uom	S.F.
Potential Action	REPLACE
Urgency of Action	PRIORITY 3
Purpose of Action	LEVEL 2
Deficiency Photo1

Storage Room
Violations	No violations recorded.
Window Curtains/Shades/Blinds	
Instance on 1st Floor (600 Seats)	Does not Exist
CAFETERIA	
Instance on 1st Floor	Inspected
Instance on 1st Floor	Inspected
Ceiling	
Instance on 1st Floor	Inspected
Condition	2 - Between Good and Fair
Deficiency	ACOUSTIC TILES ON PLASTER: DAMAGED/MISSING
Deficiency Location/Instance	Near the center
Deficiency Quantity	10
Quantity Uom	S.F.
Potential Action	REPLACE
Urgency of Action	PRIORITY 3
Purpose of Action	LEVEL 2

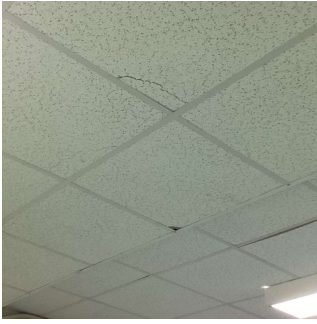
Near the center
Violations	No violations recorded.
Deficiency	ACOUSTIC TILES: DAMAGED/MISSING
Deficiency Location/Instance	Near the Drinking Fountain
Deficiency Quantity	20
Quantity Uom	S.F.
Potential Action	REPLACE
Urgency of Action	PRIORITY 3
Purpose of Action	LEVEL 2
Deficiency Photo1

Near the Drinking Fountain
Violations	No violations recorded.
Door(s)	
Instance on 1st Floor	Inspected
Condition	2 - Between Good and Fair
Deficiency	No deficiencies recorded
Fixed Equipment	
Instance on 1st Floor	Does not Exist
Floor Finish	
Instance on 1st Floor	Inspected
Condition	2 - Between Good and Fair
Deficiency	No deficiencies recorded
Sliding-folding Partition	
Instance on 1st Floor	Does not Exist
Stage	
Instance on 1st Floor	Does not Exist
Walls	
Instance on 1st Floor	Inspected
Condition	2 - Between Good and Fair
Deficiency	GLAZED BLOCK: CRACKS/SPALLING

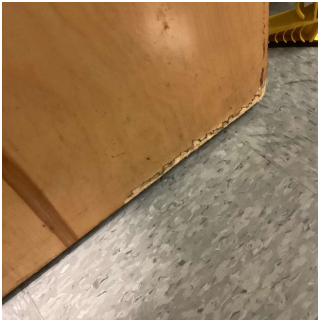
Violations	Near the Drinking Fountain No violations recorded.
Door(s)	
Instance on 1st Floor	Inspected
Condition	4 - Between Fair and Poor
Deficiency	WOOD: DETERIORATED DOOR
Deficiency Location/Instance	Offices
Deficiency Quantity	2
Quantity Uom	EACH
Potential Action	MAINTENANCE
Urgency of Action	PRIORITY 3
Purpose of Action	LEVEL 2
Deficiency Photo1

Violations	Office No violations recorded.
Fixed Equipment	
Instance on 1st Floor	Inspected
Condition	2 - Between Good and Fair
Deficiency	No deficiencies recorded
Floor Finish	
Instance on 1st Floor	Inspected
Condition	2 - Between Good and Fair
Deficiency	No deficiencies recorded
Seating	
Instance on 1st Floor	Inspected
Condition	2 - Between Good and Fair
Deficiency	DAMAGED BLEACHERS
Deficiency Location/Instance	Left side
Deficiency Quantity	20
Quantity Uom	S.F.

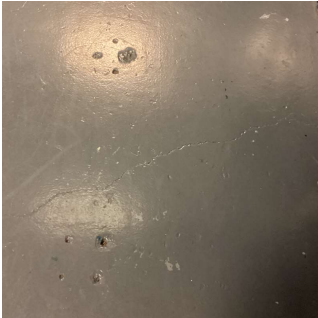
Main Entrance
Violations	No violations recorded.
Floor Finish	
Instance on 1st Floor - Boys (1418 Lockers)	Inspected
Condition	3 - Fair
Deficiency	CONCRETE: CRACKS
Deficiency Location/Instance	Near the windows, by Locker #1170, 1173, 1290
Deficiency Quantity	60
Quantity Uom	S.F.
Potential Action	REPLACE
Urgency of Action	PRIORITY 3
Purpose of Action	LEVEL 2
Deficiency Photo1

Near Locker 1170
Violations	No violations recorded.
Locker Room Lockers	
Instance on 1st Floor - Boys (1418 Lockers)	Inspected
Condition	2 - Between Good and Fair
Deficiency	DAMAGED UNITS
Deficiency Location/Instance	Near Lockers #653, 1244, 1284, 1304, at Locker 1178, and others
Deficiency Quantity	20
Quantity Uom	EACH
Potential Action	REPLACE
Urgency of Action	PRIORITY 3
Purpose of Action	LEVEL 2

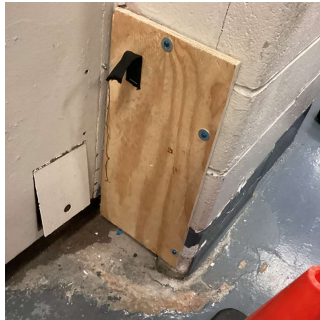
Violations	Locker 1178 No violations recorded.
Walls	
Instance on 1st Floor - Boys (1418 Lockers)	Inspected
Condition	2 - Between Good and Fair
Deficiency	MASONRY: CRACKS/SPALLING
Deficiency Location/Instance	Near the Drinking Fountain, by windows, entrance
Deficiency Quantity	30
Quantity Uom	S.F.
Potential Action	REPLACE
Urgency of Action	PRIORITY 3
Purpose of Action	LEVEL 2
Deficiency Photo1

Violations	Near the window side No violations recorded.
MULTI-PURPOSE ROOM	Does not Exist
SCIENCE DEMO ROOM	Inspected
Instance on Room 301	Inspected
Alternative use	Yes
Fixed Equipment	
Instance on Room 301	Inspected
Condition	3 - Fair
Deficiency	DEMO TABLE: DAMAGED/DETERIORATED
Deficiency Location/Instance	Room 301
Deficiency Quantity	1
Quantity Uom	EACH
Potential Action	REPLACE
Urgency of Action	PRIORITY 3
Purpose of Action	LEVEL 2
Deficiency Photo1	No photo recorded

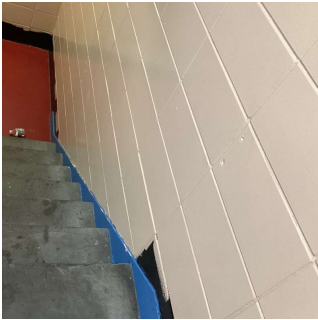
Violations	Stair F/1 - Leading to Auditorium Stage No violations recorded.
Partition	Does not Exist
Railings	Inspected
Condition	3 - Fair
Deficiency	METAL: MISSING
Deficiency Location/Instance	Stair D/2
Deficiency Quantity	10
Quantity Uom	L.F.
Potential Action	REPLACE
Urgency of Action	PRIORITY 5
Purpose of Action	LEVEL 6
Deficiency Photo1

Violations	Stair D/2 No violations recorded.
Stairs and Landings	Inspected
Condition	3 - Fair
Deficiency	TERRAZZO: CRACKS
Deficiency Location/Instance	Stairs C/1 Vestibule, D/1 Vestibule, Exit 5 Vestibule
Deficiency Quantity	50
Quantity Uom	S.F.
Potential Action	REPLACE
Urgency of Action	PRIORITY 3
Purpose of Action	LEVEL 2

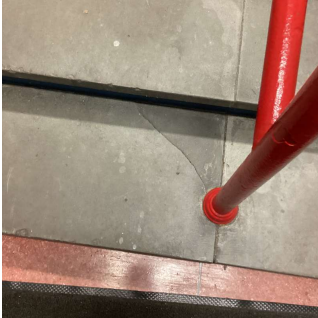
Question	Response
INTERIOR	
STAIRS/RAMPS: INTERIOR	
Stairs and Landings	
Deficiency	STONE: BROKEN/MISSING
Deficiency Location/Instance	Stairs A/1,2, C/1, G/2, in Exit 4, and others
Deficiency Quantity	200
Quantity Uom	S.F.
Potential Action	REPLACE
Urgency of Action	PRIORITY 3
Purpose of Action	LEVEL 2
Deficiency Photo1

Violations	Stair C/1 No violations recorded.
Deficiency	METAL: RUST - MAJOR
Deficiency Location/Instance	Stairs B/1, C/2, D/1
Deficiency Quantity	30
Quantity Uom	S.F.
Potential Action	REPLACE
Urgency of Action	PRIORITY 3
Purpose of Action	LEVEL 2
Deficiency Photo1	 
Violations	Stair C/2 No violations recorded.
Deficiency	VINYL TILES: DETERIORATED SUBSTRATE
Deficiency Location/Instance	StairS A/2, C/1, D/1, G/1
Deficiency Quantity	50
Quantity Uom	S.F.
Potential Action	REPLACE
Urgency of Action	PRIORITY 3
Purpose of Action	LEVEL 2

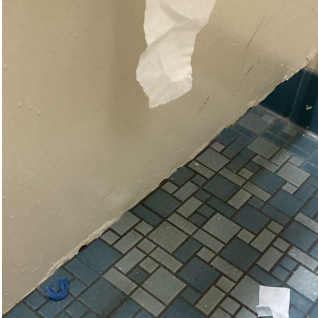
Question	Response
INTERIOR	
TOILET ROOMS - STAFF	
Stalls	Inspected
Condition	4 - Between Fair and Poor
Deficiency	RUST - MAJOR
Deficiency Location/Instance	Room 329
Deficiency Quantity	1
Quantity Uom	EACH
Potential Action	REPLACE
Urgency of Action	PRIORITY 3
Purpose of Action	LEVEL 2
Deficiency Photo1

Room 329
Violations	No violations recorded.
Walls	Inspected
Condition	2 - Between Good and Fair
Deficiency	PLASTER: CRACKS/SPALLING
Deficiency Location/Instance	Inside Gymnasium Office
Deficiency Quantity	10
Quantity Uom	S.F.
Potential Action	REPLACE
Urgency of Action	PRIORITY 3
Purpose of Action	LEVEL 2
Deficiency Photo1

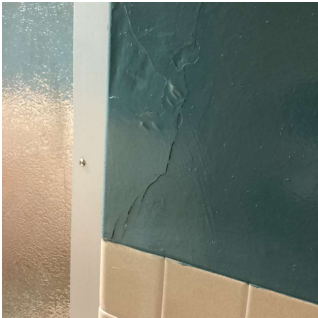
Inside Gymnasium Office
Violations	No violations recorded.
TOILET ROOMS - STUDENTS	
	Inspected
Ceiling	Inspected
Condition	2 - Between Good and Fair
Deficiency	No deficiencies recorded
Door(s)	Inspected
Condition	5 - Poor
Deficiency	WOOD: DETERIORATED DOOR
Deficiency Location/Instance	Rooms 119, 219, 4th Floor Boys

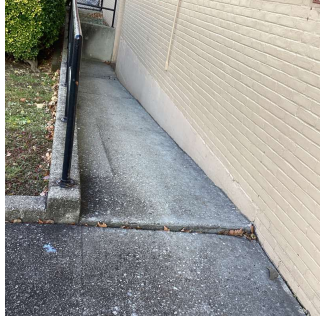
Violations	205th Street No violations recorded.
Pavers	Does not Exist
Student Use	Does not Exist
Site Sidewalks & Walkways	Inspected
Asphalt	Does not Exist
Concrete	Inspected
Condition	4 - Between Fair and Poor
Deficiency	HEAVING
Deficiency Location/Instance	204th Street, 205th Street
Deficiency Quantity	100
Quantity Uom	S.F.
Potential Action	REPLACE
Urgency of Action	PRIORITY 3
Purpose of Action	LEVEL 2
Deficiency Photo1

Violations	204th Street No violations recorded.
Deficiency	DAMAGED/DETERIORATED/MISSING SECTIONS
Deficiency Location/Instance	204th Street, 205th Street, 111th Avenue
Deficiency Quantity	2,000
Quantity Uom	S.F.
Potential Action	REPLACE
Urgency of Action	PRIORITY 3
Purpose of Action	LEVEL 2

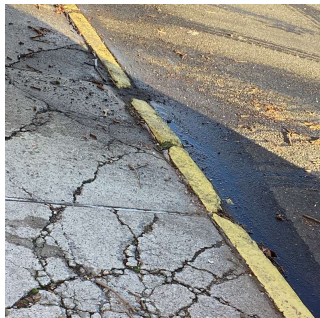
Violations	111th Avenue No violations recorded.
Pavers	Does not Exist
DOT Sidewalk	Inspected
Asphalt	Does not Exist
Concrete	Inspected
Condition	4 - Between Fair and Poor
Deficiency	DAMAGED CURBS
Deficiency Location/Instance	205th Street, 111th Avenue
Deficiency Quantity	170
Quantity Uom	L.F.
Potential Action	REPLACE
Urgency of Action	PRIORITY 3
Purpose of Action	LEVEL 2
Deficiency Photo1

Violations	205th Street No violations recorded.
Deficiency	HEAVING
Deficiency Location/Instance	204th Street, 205th Street, 111th Avenue
Deficiency Quantity	475
Quantity Uom	S.F.
Potential Action	REPLACE
Urgency of Action	PRIORITY 3
Purpose of Action	LEVEL 2
