NYC Department of Education
Building Condition Assessment Survey 2023 - 2024

Architectural Inspection

Asset: J.H.S. 194 - QUEENS, 154-60 17 AVENUE, New York, 11357

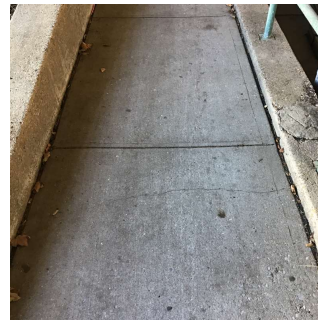
AREAWAY SLAB: CRACKS AND SPALLING

20
 S.F.
 REPLACE
 PRIORITY 4
 LEVEL 2

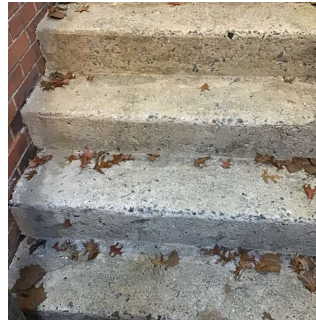
AW4
No violations recorded.

AREAWAY STAIRS: DETERIORATED TREADS/RISERS/NOSINGS

50
 S.F.
 REPAIR
 PRIORITY 3
 LEVEL 2

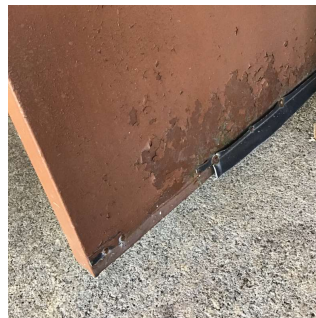
METAL: DETERIORATED DOOR - MINOR DETERIORATION

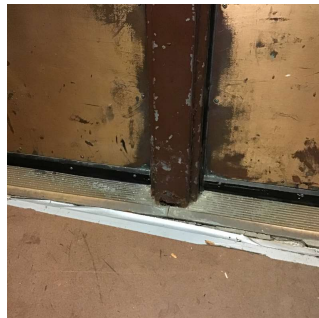
Violations	17th rd No violations recorded.
------------	------------------------------------

Deficiency	METAL: DETERIORATED DOOR AND FRAME - MAJOR DETERIORATION
------------	--

Deficiency Quantity	2
Quantity Uom	EACH
Potential Action	REPLACE
Urgency of Action	PRIORITY 4
Purpose of Action	LEVEL 2

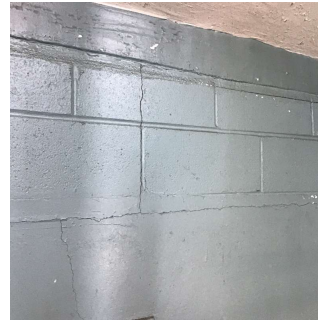
BH1

Do solar panels exist on these roofs?	No
Is/Are the roof(s) suitable for Solar Panel installation?	Yes
Installation Year	2023
Source of Installation	Custodial Staff
Deficiency	No deficiencies recorded
ROOFING DRAINS	Inspected
Condition	1 - Good
Deficiency	No deficiencies recorded
Specialties	Inspected
BULKHEAD/PENTHOUSE	Inspected
Condition	3 - Fair
Deficiency	BULKHEAD/PENTHOUSE WALLS/INTERIOR: CMU CRACKS/SPALLING

10
S.F.
REPLACE
PRIORITY 3
LEVEL 2

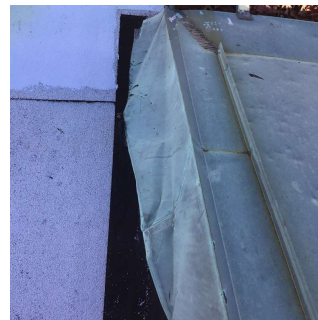
BULKHEAD/PENTHOUSE ROOF: DETERIORATED

30
S.F.
REPLACE
PRIORITY 4
LEVEL 2

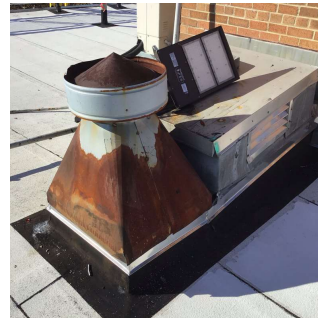
Roof 1

SHAFT VENTS DAMAGED

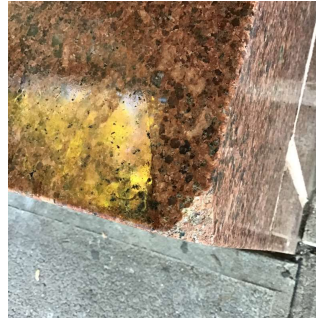
Facade A

STONE: CRACKS/SPALLING - MINOR

Deficiency Quantity	10
Quantity Uom	S.F.
Potential Action	REPAIR
Urgency of Action	PRIORITY 3
Purpose of Action	LEVEL 2
Deficiency Photo1

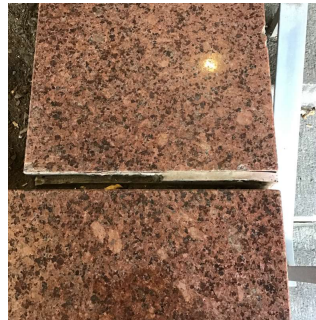
Facade A

Deficiency	STONE: DETERIORATED JOINTS
------------	----------------------------

Deficiency Quantity	10
Quantity Uom	S.F.
Potential Action	REPOINT
Urgency of Action	PRIORITY 4
Purpose of Action	LEVEL 2
Deficiency Photo1

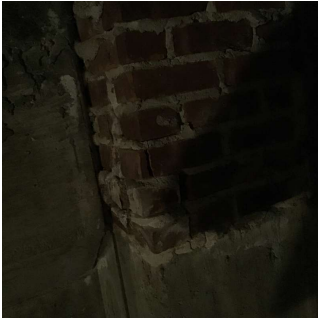
Deficiency	No deficiencies recorded
INTERIOR	Inspected
POOLS	Does not Exist
STRUCTURAL	Inspected
COLUMNS/BEAMS/BEARING WALLS	Inspected
Condition	3 - Fair
Deficiency	STEEL COLUMNS/BEAMS: DETERIORATED MASONRY FIREPROOFING
Deficiency Location/Instance	Basement - House Trap C,

Question	Response
INTERIOR	
STRUCTURAL	
COLUMNS/BEAMS/BEARING WALLS	
Deficiency Quantity	10
Quantity Uom	S.F.
Potential Action	REPLACE
Urgency of Action	PRIORITY 4
Purpose of Action	LEVEL 5
Deficiency Photo1

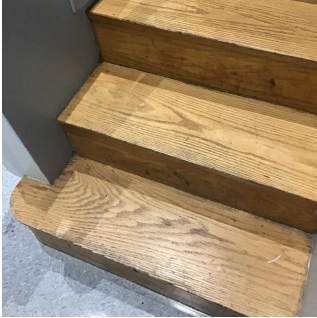
Stage	
Instance on 1st Floor (582 Seats)	Inspected
Condition	2 - Between Good and Fair
Deficiency	DAMAGED STEPS
Deficiency Location/Instance	Right and Left Side
Deficiency Quantity	20
Quantity Uom	S.F.
Potential Action	REPLACE

Question	Response
INTERIOR	
AUDITORIUM	
Stage	
Stage	
Urgency of Action	PRIORITY 3
Purpose of Action	LEVEL 2
Deficiency Photo1

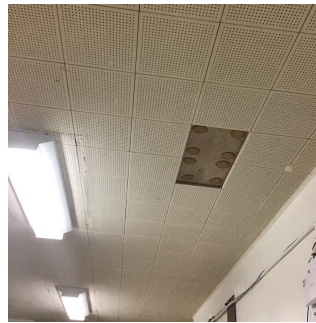
Near Center

Left Side
Violations	No violations recorded.
Stage Curtain Rigging	Inspected
Instance on 1st Floor (582 Seats)	Inspected
Condition	1 - Good
Deficiency	No deficiencies recorded
Stage Curtains	Inspected
Instance on 1st Floor (582 Seats)	Inspected
Condition	1 - Good
Deficiency	No deficiencies recorded
Walls	
Instance on 1st Floor (582 Seats)	Inspected
Condition	2 - Between Good and Fair
Deficiency	No deficiencies recorded
Window Curtains/Shades/Blinds	
Instance on 1st Floor (582 Seats)	Inspected
Condition	1 - Good
Deficiency	No deficiencies recorded
CAFETERIA	
Instance on Basement - staff (1000 SF)	Inspected
Instance on Basement - Students	Inspected
Ceiling	
Instance on Basement - staff (1000 SF)	Inspected
Condition	2 - Between Good and Fair
Deficiency	ACOUSTIC TILES ON PLASTER: DAMAGED/MISSING

Deficiency Location/Instance	Near Center, Entrance, Serving Area
Deficiency Quantity	30
Quantity Uom	S.F.
Potential Action	REPLACE
Urgency of Action	PRIORITY 3
Purpose of Action	LEVEL 2

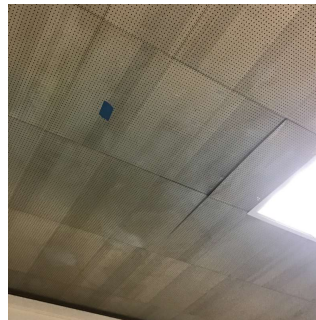
Near Serving Area

METAL PAN: DAMAGED/MISSING

REPLACE

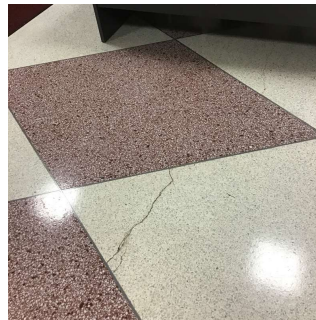
Main Entrance Hall

TERRAZZO: CRACKS

REPLACE

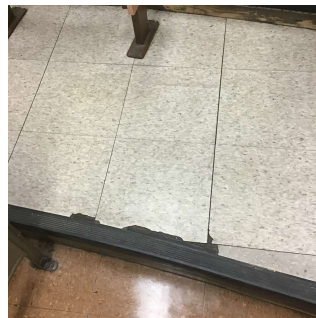
VINYL TILES: BROKEN/DETERIORATED/MISSING TILES

REPLACE

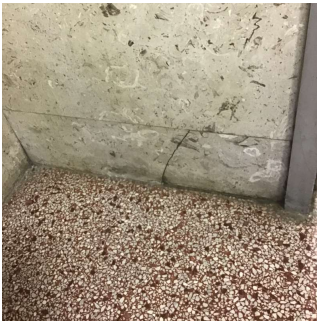
Main Entrance hall
Violations	No violations recorded.
Deficiency	STONE MOLDINGS: CRACKS/SPALLING
Deficiency Location/Instance	Main Entrance
Deficiency Quantity	10
Quantity Uom	L.F.
Potential Action	REPLACE
Urgency of Action	PRIORITY 3
Purpose of Action	LEVEL 2

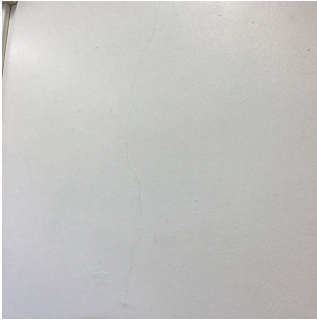
Main Entrance
Violations	No violations recorded.
Deficiency	PLASTER: CRACKS/SPALLING
Deficiency Location/Instance	Rooms 115, 231, 329, 331, Corridor near Room B14, and others.
Deficiency Quantity	100
Quantity Uom	S.F.
Potential Action	REPLACE
Urgency of Action	PRIORITY 3
Purpose of Action	LEVEL 2
Deficiency Photo1

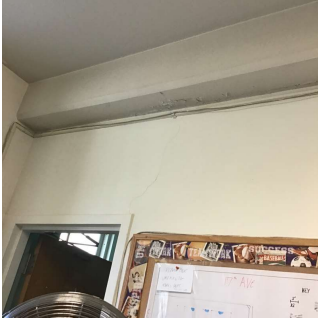
Question	Response
INTERIOR	
GYMNASIUM	
Walls	
Instance on 1st Floor	Inspected
Condition	2 - Between Good and Fair
Deficiency	PLASTER: CRACKS/SPALLING
Deficiency Location/Instance	Inside Office
Deficiency Quantity	10
Quantity Uom	S.F.
Potential Action	REPLACE
Urgency of Action	PRIORITY 3
Purpose of Action	LEVEL 2
Deficiency Photo1

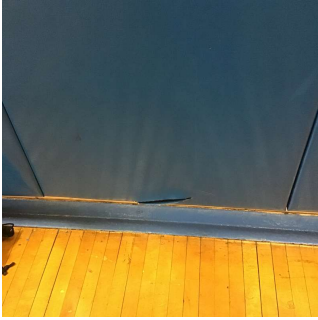
Violations	Inside Office No violations recorded.
Deficiency	WALL PADDING: DETERIORATED
Deficiency Location/Instance	Near Office, Storage Room.
Deficiency Quantity	60
Quantity Uom	S.F.
Potential Action	REPLACE
Urgency of Action	PRIORITY 3
Purpose of Action	LEVEL 2
Deficiency Photo1
