**NYC Department of Education**  
**Building Condition Assessment Survey 2023 - 2024**

Architectural Inspection

**Asset:** P.S. 195 - QUEENS, 253-50 149 AVENUE, New York, 11422

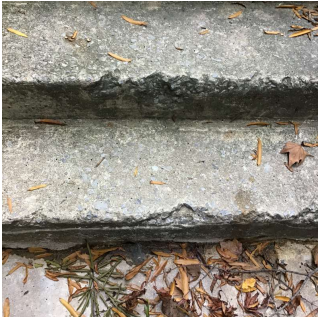
Facade A - AW1
Violations	No violations recorded.
Deficiency	AREAWAY STAIRS: DETERIORATED MATERIAL SLIDE
Roof Plan reference	Q195

Question	Response
<b>Architectural</b>	
<b>EXTERIOR</b>	Inspected
<b>AREAWAY</b>	Inspected
Instance on AW1-2	Inspected
Instance Condition	3 - Fair
Instance Quantity	2
Instance Quantity Uom	EACH
Deficiency	AREAWAY STAIRS: DETERIORATED TREADS/RISERS/NOSINGS
Roof Plan reference	Q195
Deficiency Quantity	30
Quantity Uom	S.F.
Potential Action	REPAIR

Question	Response
<b>EXTERIOR</b>	
<b>AREAWAY</b>	
Urgency of Action	PRIORITY 3
Purpose of Action	LEVEL 2
Deficiency Photo1

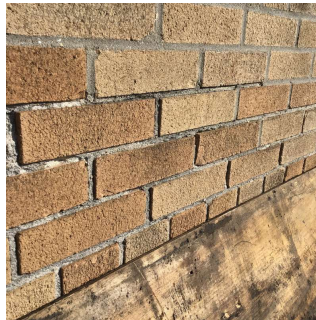
Roof 1  
 No violations recorded.

Facade A - AW1
Violations	No violations recorded.
<b>AWNINGS AND CANOPIES</b>	Inaccessible
<b>CHIMNEY</b>	Inspected
Material Type(s)	Masonry
Condition	3 - Fair
Deficiency	BRICK: DETERIORATED JOINTS

100  
 S.F.  
 REPOINT  
 PRIORITY 4  
 LEVEL 2

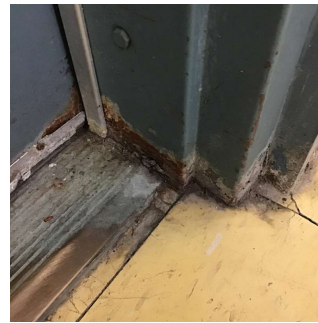
Facade F

METAL: DETERIORATED DOOR AND FRAME - MAJOR DETERIORATION

2  
 EACH  
 REPLACE  
 PRIORITY 4  
 LEVEL 2

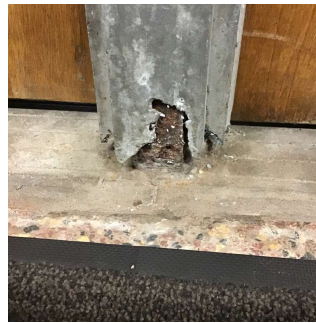
Facade A

**METAL CLAD: DETERIORATED DOOR AND FRAME - MAJOR DETERIORATION**

REPLACE

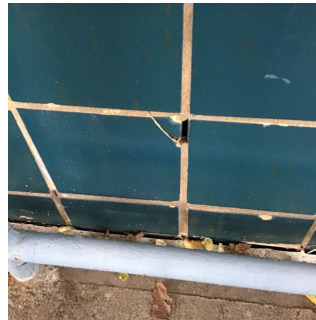
Facade H

CERAMIC TILE: CHIPPED, SPALLED, BROKEN PIECES

REPLACE

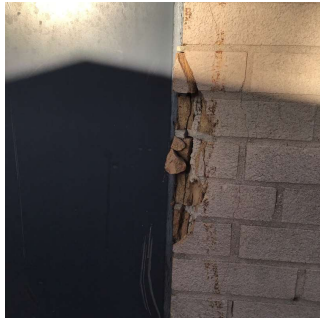
BRICK: MAJOR / THRU CRACKS

Question	Response
<b>EXTERIOR</b>	
<b>EXTERIOR WALLS</b>	
Urgency of Action	PRIORITY 4
Purpose of Action	LEVEL 2
Deficiency Photo1

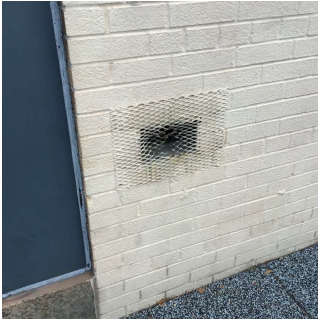
Violations	Facade B No violations recorded.
<b>EXTERIOR SOFFITS</b>	Does not Exist
<b>LOADING DOCK</b>	Does not Exist
<b>LOUVER</b>	Inspected
Condition	3 - Fair
Deficiency	BROKEN/ DENTED BLADES
Roof Plan reference	Q195
Elevation

Deficiency Quantity	20
Quantity Uom	S.F.
Potential Action	REPLACE
Urgency of Action	PRIORITY 4
Purpose of Action	LEVEL 2

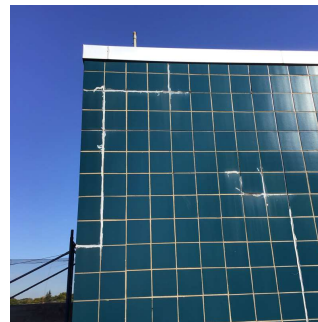
Penthouse

BULKHEAD/PENTHOUSE WALLS/EXTERIOR: DETERIORATED JOINTS

500  
 S.F.  
 REPOINT  
 PRIORITY 3  
 LEVEL 2

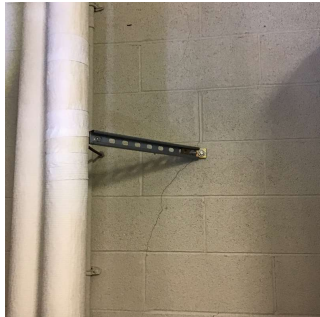
BULKHEAD/PENTHOUSE WALLS/INTERIOR: CMU CRACKS/SPALLING

100  
 S.F.  
 REPLACE  
 PRIORITY 3  
 LEVEL 2

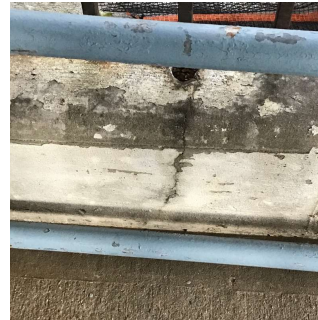
Facade H

CAST IN PLACE CONCRETE: CRACKS/SPALLING - MINOR

REPAIR

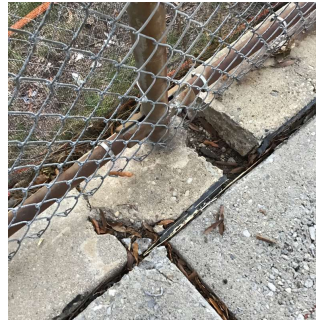
Facade B

CAST IN PLACE CONCRETE: CRACKS/SPALLING - MAJOR

REPLACE

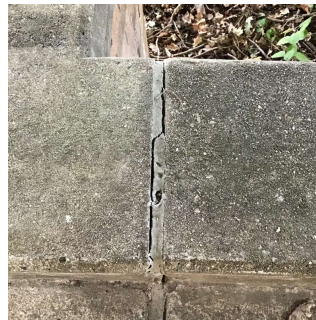
Facade B

CAST IN PLACE CONCRETE: DETERIORATED CONTROL/EXPANSION JOINT

REPLACE

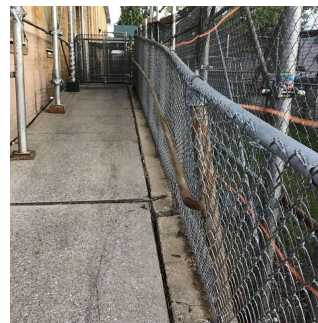
Facade B  
No violations recorded.

DAMAGED

20  
L.F.  
REPLACE  
PRIORITY 4  
LEVEL 2

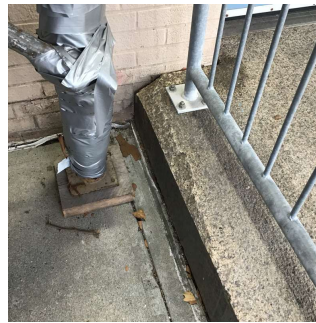
Facade E

STONE: CRACKS/SPALLING - MAJOR

10  
S.F.  
REPLACE  
PRIORITY 4  
LEVEL 2

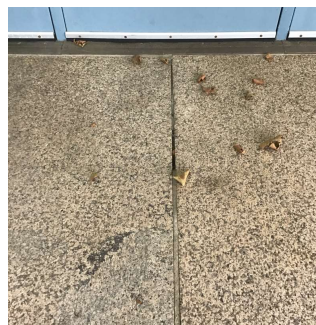
Facade E

**STONE: DETERIORATED JOINTS**

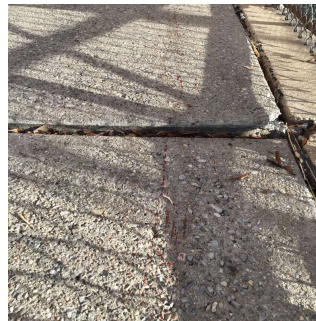
Facade B

**CONCRETE: DETERIORATED SUBSTRATE**

20  
S.F.  
REPLACE SUBSTRATE AND RESET  
PRIORITY 4  
LEVEL 2

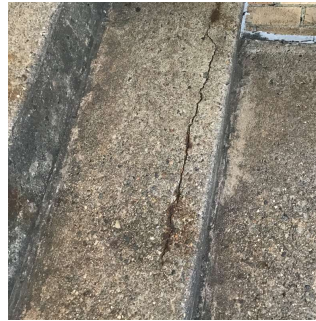
Facade B

CONCRETE: WORN-OUT TREAD/RISER/NOSING

20  
S.F.  
REPLACE  
PRIORITY 4  
LEVEL 2

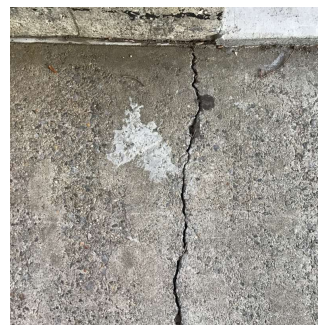
Facade B

**CONCRETE: CRACKS/SPALLING - MAJOR**

REPLACE

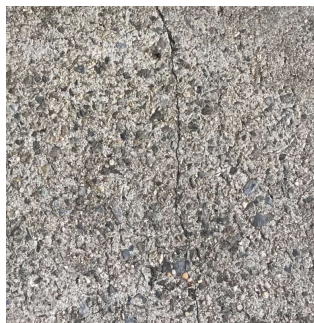
Facade B

**CONCRETE: CRACKS/SPALLING - MINOR**

40  
S.F.  
REPAIR  
PRIORITY 3  
LEVEL 2

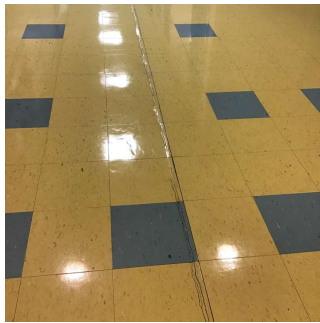
2nd Floor Corridor
Violations	No violations recorded.
<b>FOUNDATION WALLS</b>	Inspected

Basement - Boiler Room
Violations	No violations recorded.
Deficiency	CONCRETE: CRACKS/SPALLED/REINFORCEMENT EXPOSED
Deficiency Location/Instance	1st and 2nd Floor Corridor
Deficiency Quantity	200
Quantity Uom	S.F.
Potential Action	REPAIR
Urgency of Action	PRIORITY 4
Purpose of Action	LEVEL 5
Deficiency Photo1

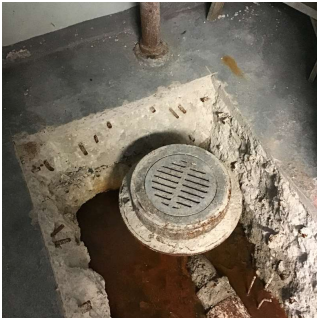
Violations	Basement - Ash Hoist Vault No violations recorded.
<b>Slab Structure</b>	Inspected
Condition	3 - Fair
Deficiency	CONCRETE SLAB ON GRADE: THRU CRACKS
Deficiency Location/Instance	Basement - Ash Hoist Vault
Deficiency Quantity	30
Quantity Uom	S.F.
Potential Action	REPLACE
Urgency of Action	PRIORITY 4
Purpose of Action	LEVEL 5
Deficiency Photo1

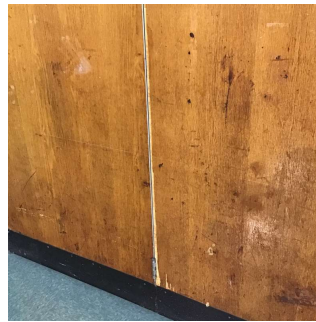
Left Side

Deficiency	MOVABLE PANELS: DAMAGED
------------	-------------------------

Potential Action	REPLACE
------------------	---------

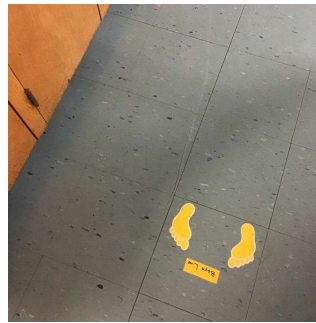
Room 228

Room 236
Violations	No violations recorded.
<b>Floor Finish</b>	Inspected
Condition	3 - Fair
Deficiency	VINYL TILES: BROKEN/DETERIORATED/MISSING TILES
Deficiency Location/Instance	Rooms 110,126,228, 230, 231 and others
Deficiency Quantity	500
Quantity Uom	S.F.
Potential Action	REPLACE
Urgency of Action	PRIORITY 3
Purpose of Action	LEVEL 2

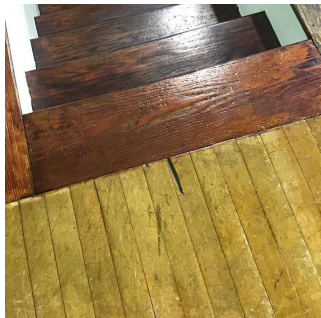
Question	Response
<b>INTERIOR</b>	
<b>GYMNASIUM</b>	
<b>Stage</b>	
<b>Stage</b>	
Instance on 1st Floor	Inspected
Condition	2 - Between Good and Fair
Deficiency	DAMAGED FLOOR
Deficiency Location/Instance	Left Side, Right Side
Deficiency Quantity	20
Quantity Uom	S.F.
Potential Action	REPLACE
Urgency of Action	PRIORITY 3
Purpose of Action	LEVEL 2
Deficiency Photo1

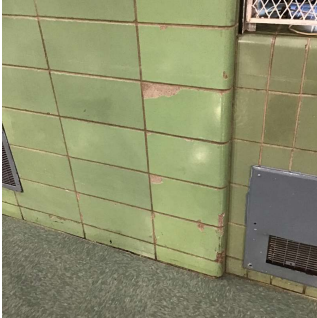
Question	Response
<b>INTERIOR</b>	
<b>GYMNASIUM</b>	
<b>Walls</b>	
Instance on 1st Floor	Inspected
Condition	2 - Between Good and Fair
Deficiency	GLAZED BLOCK: CRACKS/SPALLING
Deficiency Location/Instance	Along Windows, Near Stage, Right Side
Deficiency Quantity	100
Quantity Uom	S.F.
Potential Action	REPLACE
Urgency of Action	PRIORITY 3
Purpose of Action	LEVEL 2
Deficiency Photo1

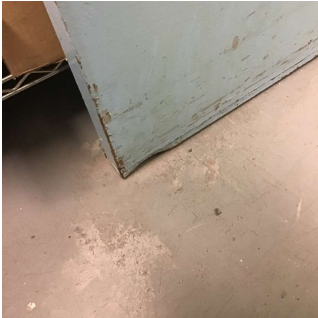
Violations	Front No violations recorded.
<b>Door(s)</b>	
Instance on 1st Floor	Inspected
Condition	3 - Fair
Deficiency	METAL: DETERIORATED DOOR
Deficiency Location/Instance	Storage Room
Deficiency Quantity	1
Quantity Uom	EACH
Potential Action	MAINTENANCE
Urgency of Action	PRIORITY 3
Purpose of Action	LEVEL 2
Deficiency Photo1

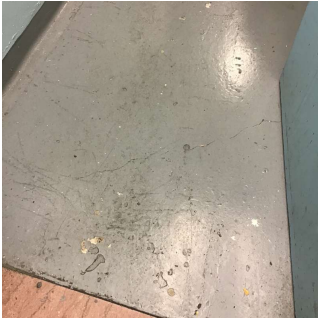
Violations	Storage Room No violations recorded.
<b>Floor Finish</b>	
Instance on 1st Floor	Inspected
Condition	3 - Fair
Deficiency	CONCRETE: CRACKS
Deficiency Location/Instance	Storage Room

Question	Response
<b>INTERIOR</b>	
<b>KITCHEN</b>	
<b>Floor Finish</b>	
Deficiency Quantity	20
Quantity Uom	S.F.
Potential Action	REPLACE
Urgency of Action	PRIORITY 3
Purpose of Action	LEVEL 2
Deficiency Photo1

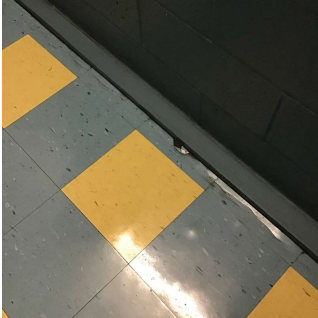
Question	Response
<b>INTERIOR</b>	
<b>STAIRS/RAMPS: INTERIOR</b>	
<b>Stairs and Landings</b>	Inspected
Condition	3 - Fair
Deficiency	VINYL TILES: DETERIORATED SUBSTRATE
Deficiency Location/Instance	Stairs B/1,C/1,D1
Deficiency Quantity	30
Quantity Uom	S.F.
Potential Action	REPLACE
Urgency of Action	PRIORITY 3
Purpose of Action	LEVEL 2
Deficiency Photo1

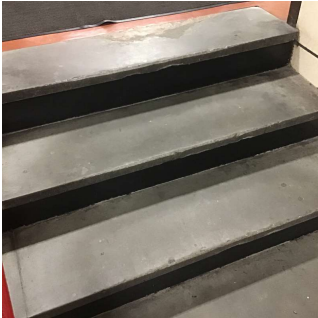
Violations	Stair C/1 No violations recorded.
Deficiency	STONE: BROKEN/MISSING
Deficiency Location/Instance	Stair A/1,2, B/1 C/1
Deficiency Quantity	120
Quantity Uom	S.F.
Potential Action	REPLACE
Urgency of Action	PRIORITY 3
Purpose of Action	LEVEL 2
Deficiency Photo1

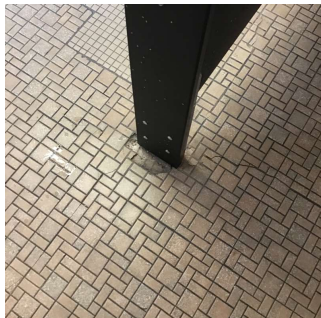
Room 101	
Violations	No violations recorded.
<b>Floor Finish</b>	Inspected
Condition	3 - Fair
Deficiency	CERAMIC TILE: DETERIORATED SUBSTRATE
Deficiency Location/Instance	Room 131
Deficiency Quantity	10
Quantity Uom	S.F.
Potential Action	REPLACE
Urgency of Action	PRIORITY 3
Purpose of Action	LEVEL 2
Deficiency Photo1

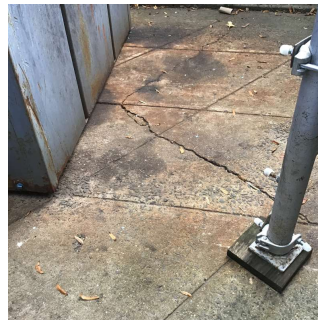
CONCRETE PAD DAMAGED  
Along Weller Lane  
100  
S.F.  
REPAIR  
PRIORITY 3  
LEVEL 2

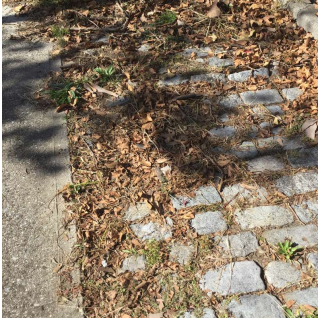
149th Road
Violations	No violations recorded.
<b>Pavers</b>	Inspected
Condition	3 - Fair
Deficiency	DAMAGED/MISSING
Deficiency Location/Instance	149th Road
Deficiency Quantity	90
Quantity Uom	S.F.
Potential Action	REPLACE
Urgency of Action	PRIORITY 3
Purpose of Action	LEVEL 2
Deficiency Photo1
