NYC Department of Education
Building Condition Assessment Survey 2023 - 2024

Architectural Inspection

Q196

Asset: P.S. 196 - QUEENS, 71-25 113TH STREET, New York, 11375

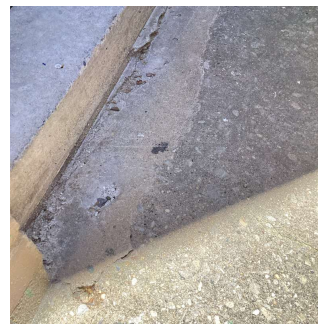
AW4
 No violations recorded.

AREAWAY SLAB: CRACKS AND SPALLING

20
 S.F.
 REPAIR
 PRIORITY 3
 LEVEL 2

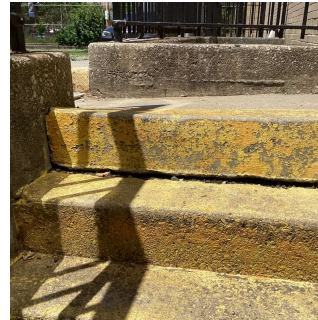
AW4

AREAWAY STAIRS: DETERIORATED TREADS/RISERS/NOSINGS

10
 S.F.
 REPAIR
 PRIORITY 3
 LEVEL 2

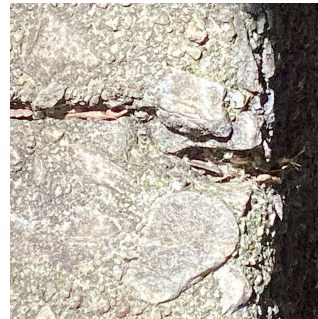
AW2

AREAWAY WALLS: CRACKS AND SPALLING

REPAIR

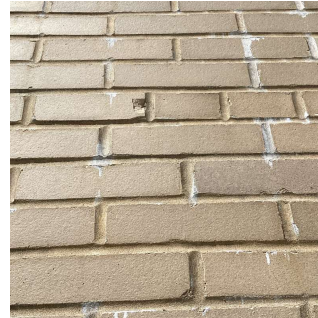
CH
 No violations recorded.

BRICK: MINOR CRACKS AND SPALLING

30
 S.F.
 RESTITCH
 PRIORITY 3
 LEVEL 2

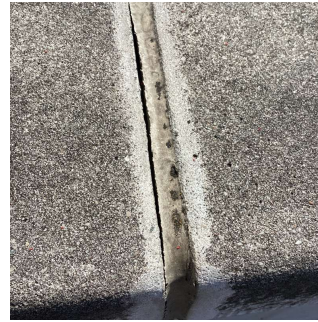
Roof 6

CAST STONE: DETERIORATED TRANSVERSE JOINTS

200
 L.F.
 MAINTENANCE
 PRIORITY 3
 LEVEL 2

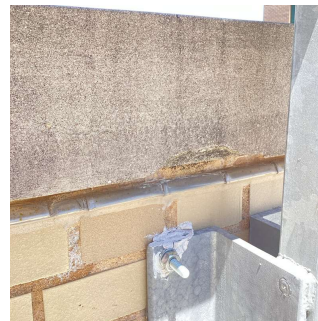
Roof 2

CAST STONE: CRACKED/BROKEN PIECES

REPLACE-IN-KIND

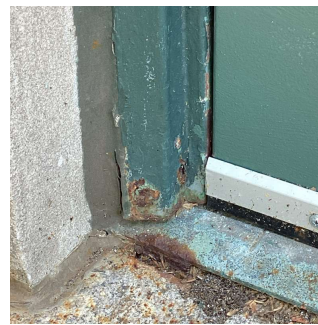
Facade A

METAL: DETERIORATED DOOR AND FRAME - MINOR DETERIORATION

2
EACH
MAINTENANCE
PRIORITY 3
LEVEL 2

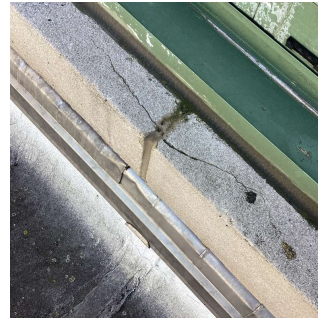
Facade B

BRICK: DETERIORATED MASONRY SILLS - MINOR

REPAIR

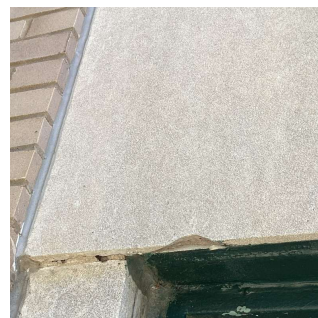
CAST IN PLACE / PRE-CAST CONCRETE: MINOR CRACKS/SPALLING

10
S.F.
REPAIR
PRIORITY 3
LEVEL 2

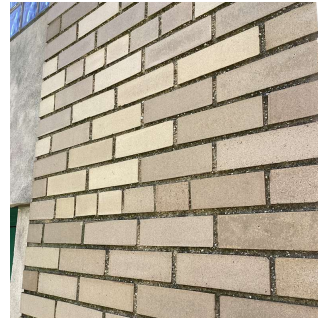
Facade B

BRICK: DETERIORATED JOINTS

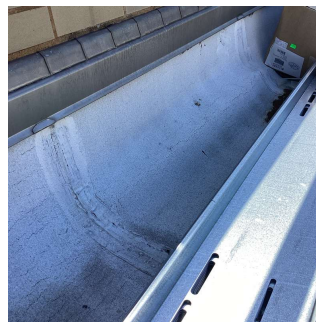
Roof 1
 No violations recorded.

Sustainable Roof Location (Roof Number)	Roofs 1 - 5
Do solar panels exist on these roofs?	No
Is/Are the roof(s) suitable for Solar Panel installation?	Yes
Installation Year	2016
Source of Installation	Custodial Staff
Deficiency	MODIFIED BITUMEN: FLASHING: BASE FLASHING DETERIORATED

70
 S.F.
 REPLACE
 PRIORITY 4
 LEVEL 2

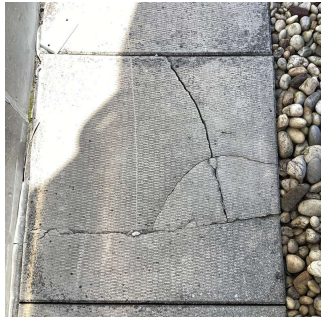
Question	Response
EXTERIOR	
ROOF	
Roofing	
ROOFING	
Deficiency Photo1	 
	Roof 1
Violations	No violations recorded.
Instance on IRMA: Roofs 6 - 10	Inspected
Instance Condition	3 - Fair
Instance Photo	 
	Roof 6
Instance Quantity	10,000
Instance Quantity Uom	S.F.
Does the roof have major mechanical equipment sitting on Dunnage Steel less than 18" above the Roofing?	No
Does this roof instance have a Sustainable Roof System?	No
Do solar panels exist on these roofs?	No
Is/Are the roof(s) suitable for Solar Panel installation?	Yes
Installation Year	2011
Source of Installation	Custodial Staff
Deficiency	IRMA: ROOFING: DETERIORATED PAVERS WITH INTEGRAL INSULATION
Roof Plan reference	<p>Q196</p>  
Deficiency Quantity	10
Quantity Uom	S.F.
Potential Action	REPLACE
Urgency of Action	PRIORITY 4
Purpose of Action	LEVEL 2

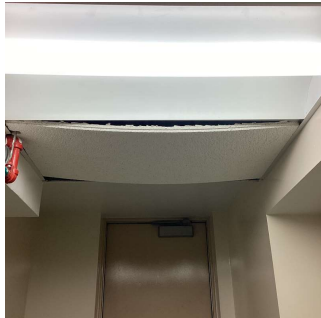
Violations	Roof 6 No violations recorded.
ROOFING DRAINS	Inspected
Condition	2 - Between Good and Fair
Deficiency	No deficiencies recorded
Specialties	Inspected
BULKHEAD/PENTHOUSE	Inspected
Condition	3 - Fair
Deficiency	BULKHEAD/PENTHOUSE CEILING: ACOUSTIC TILES DAMAGED/MISSING
Roof Plan reference	Q196

Deficiency Quantity	10
Quantity Uom	S.F.
Potential Action	REPLACE
Urgency of Action	PRIORITY 3
Purpose of Action	LEVEL 2
Deficiency Photo1

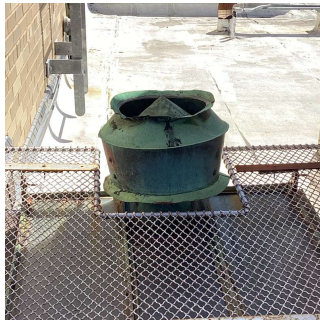
SK
Violations	No violations recorded.
Deficiency	SHAFT VENTS DAMAGED
Roof Plan reference	Q196

Deficiency Quantity	1
Quantity Uom	EACH
Potential Action	MAINTENANCE
Urgency of Action	PRIORITY 3
Purpose of Action	LEVEL 2
Deficiency Photo1

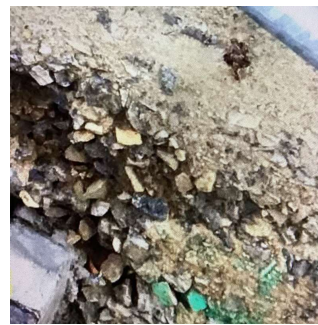
Facade B
 No violations recorded.

SK
Violations	No violations recorded.
ROOF/GRAVITY TANK	Does not Exist
STAIRS/RAMPS: EXTERIOR	Inspected
BUILDING CHEEK/FLANK WALLS	Inspected
Condition	5 - Poor
Deficiency	CAST IN PLACE CONCRETE: CRACKS/SPALLING - MAJOR

25
 S.F.
 REPLACE
 PRIORITY 4
 LEVEL 2

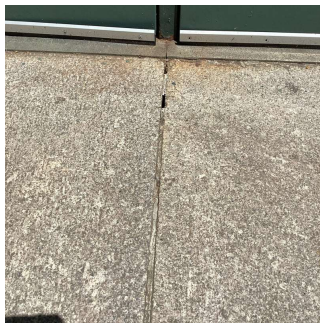
STONE: DETERIORATED JOINTS

20
 L.F.
 REPOINT
 PRIORITY 4
 LEVEL 2

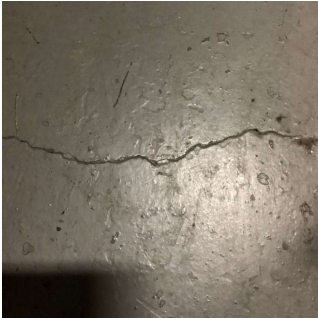
Violations	Basement - Boiler Room No violations recorded.
FLOOR STRUCTURE	Inspected
Condition	4 - Between Fair and Poor
Deficiency	CONCRETE SLAB ON GRADE: THRU CRACKS
Deficiency Location/Instance	Sub-basement Corridor, Basement - 2022 Addition Electrical Room, Sprinkler Room, Rooms 31F, 31G, G12, G13
Deficiency Quantity	520
Quantity Uom	S.F.
Potential Action	REPAIR
Urgency of Action	PRIORITY 3
Purpose of Action	LEVEL 5
Deficiency Photo1

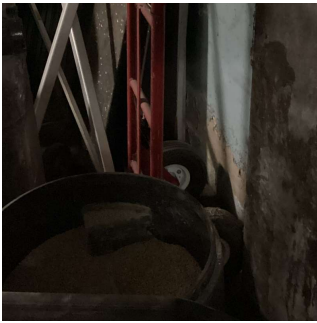
Violations	Basement - Boiler Room No violations recorded.
Deficiency	CONCRETE: WATER INFILTRATION IN NON- INSTRUCTIONAL SPACE
Deficiency Location/Instance	Basement - Storage Room
Deficiency Quantity	100
Quantity Uom	S.F.
Potential Action	INSTALL WATERPROOFING
Urgency of Action	PRIORITY 5
Purpose of Action	LEVEL 5

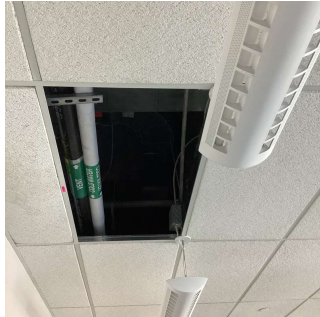
Question	Response
INTERIOR	
CLASSROOMS/CORRIDORS/ADMIN SPACES	
Ceiling	
Purpose of Action	LEVEL 2
Deficiency Photo1

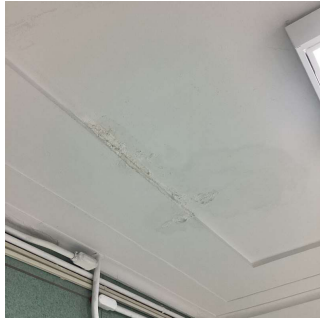
Room 341
Violations	No violations recorded.
Deficiency	PLASTER: CRACKS/SPALLING
Deficiency Location/Instance	Corridor near Auditorium, Room 113
Deficiency Quantity	40
Quantity Uom	S.F.
Potential Action	REPLACE
Urgency of Action	PRIORITY 3
Purpose of Action	LEVEL 2
Deficiency Photo1

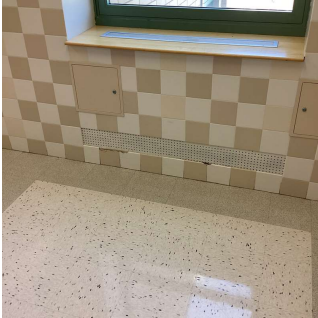
Question	Response
INTERIOR	
CLASSROOMS/CORRIDORS/ADMIN SPACES	
Floor Finish	Inspected
Violations	Corridor near Room 14 No violations recorded.
Walls	Inspected
Condition	2 - Between Good and Fair
Deficiency	CERAMIC TILE: BROKEN/ MISSING
Deficiency Location/Instance	Corridor near Room 327, Main Entrance Lobby, Near Stair G/1, Exit 13 Vestibule
Deficiency Quantity	40
Quantity Uom	S.F.
Potential Action	REPLACE
Urgency of Action	PRIORITY 3
Purpose of Action	LEVEL 2
Deficiency Photo1

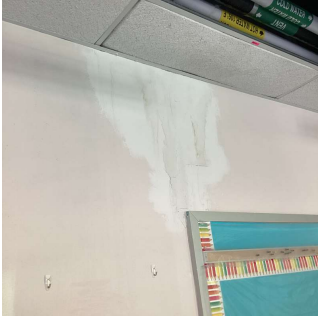
Violations	Corridor near Room 327 No violations recorded.
Deficiency	GYPSUM BOARD: DETERIORATED
Deficiency Location/Instance	Room 341, Corridor near Rooms 327, 223
Deficiency Quantity	60
Quantity Uom	S.F.
Potential Action	REPLACE
Urgency of Action	PRIORITY 3
Purpose of Action	LEVEL 2
Deficiency Photo1

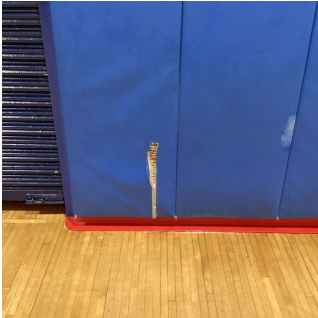
Violations	Right Side No violations recorded.
Deficiency	WALL PADDING: DETERIORATED
Deficiency Location/Instance	Near Entrance
Deficiency Quantity	240
Quantity Uom	S.F.
Potential Action	REPLACE
Urgency of Action	PRIORITY 3
Purpose of Action	LEVEL 2
Deficiency Photo1
