NYC Department of Education
Building Condition Assessment Survey 2023 - 2024

Architectural Inspection

Asset: P.S. 197 - QUEENS, 825 HICKSVILLE ROAD, New York, 11691

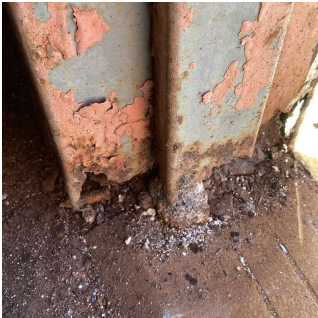
Violations	Facade F No violations recorded.

Violations	Roof 1 - Chimney No violations recorded.
COPING	Does not Exist
CORNICE	Does not Exist
DOORS	Inspected
DOORS AND FRAMES	Inspected
Condition	5 - Poor
Deficiency	METAL: DETERIORATED DOOR AND FRAME - MAJOR DETERIORATION
Roof Plan reference

Deficiency Quantity	4
Quantity Uom	EACH
Potential Action	REPLACE
Urgency of Action	PRIORITY 4
Purpose of Action	LEVEL 2
Deficiency Photo1

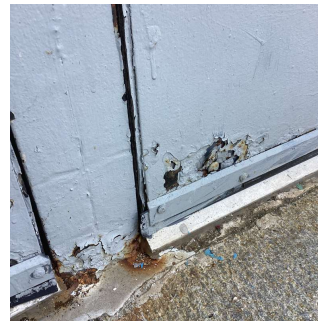
Facade H

METAL CLAD: DETERIORATED DOOR AND FRAME - MAJOR DETERIORATION

9

REPLACE

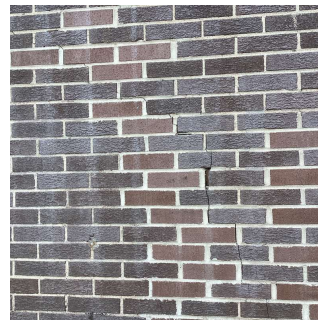
Facade C

BRICK: CRACKS/DISPLACED/SPALLED BRICK AT BUILDING CORNERS

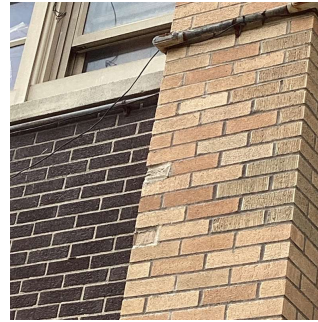
Facade H

BRICK: MINOR CRACKS AND SPALLING

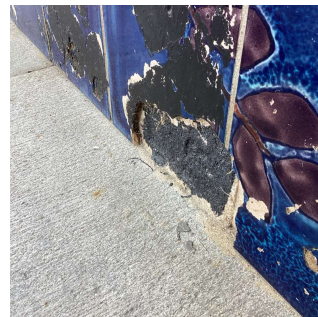
Facade H

CERAMIC TILE: CHIPPED, SPALLED, BROKEN PIECES

REPLACE

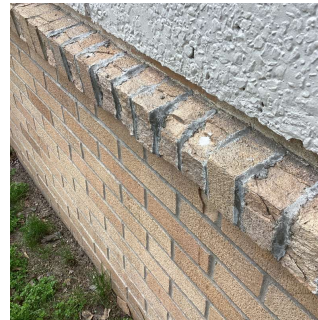
Facade H

BRICK: DETERIORATED MASONRY SILLS - MAJOR

REMOVE AND REPLACE

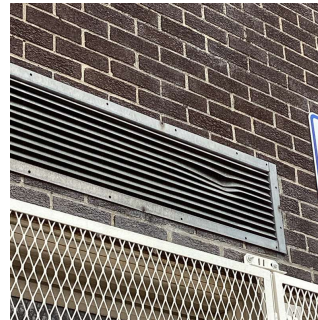
Facade C
No violations recorded.

BROKEN/ DENTED BLADES

10
S.F.
REPLACE
PRIORITY 4
LEVEL 2

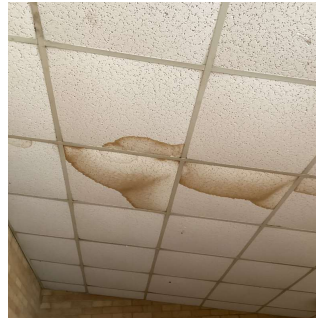
Roof 3 - Corridor near Room 130 (Gymnasium) - two locations

Roof 1
Instance Quantity	35,000
Instance Quantity Uom	S.F.
Does the roof have major mechanical equipment sitting on Dunnage Steel less than 18" above the Roofing?	No
Does this roof instance have a Sustainable Roof System?	Yes
Sustainable Roof Type	White Roof
Sustainable Roof Location (Roof Number)	All Roofs
Do solar panels exist on these roofs?	No
Is/Are the roof(s) suitable for Solar Panel installation?	Yes
Installation Year	2020
Source of Installation	Custodial Staff
Deficiency	MODIFIED BITUMEN: ROOFING: MAJOR ACTIVE ROOF LEAKS IN INSTRUCTIONAL SPACE
Roof Plan reference

Deficiency Quantity	200
Quantity Uom	S.F.
Potential Action	REPLACE ROOFING WITHOUT MAJOR EQUIPMENT REMOVAL
Urgency of Action	PRIORITY 5

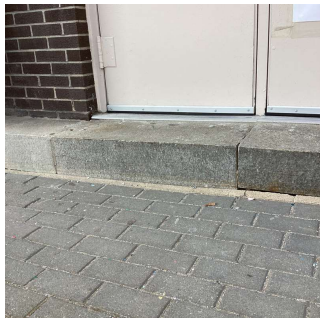
Question	Response
EXTERIOR	
ROOF	
Specialties	
SKYLIGHT/ROOF VENT	Inspected
Deficiency Photo1	 
	Roof 1
Violations	No violations recorded.
ROOF/GRAVITY TANK	Does not Exist
STAIRS/RAMPS: EXTERIOR	Inspected
BUILDING CHEEK/FLANK WALLS	Does not Exist
RAILINGS	Does not Exist
STAIRS/RAMPS	Inspected
Condition	4 - Between Fair and Poor
Deficiency	STONE: DETERIORATED SUBSTRATE
Roof Plan reference

Deficiency Quantity	10
Quantity Uom	S.F.
Potential Action	REPLACE SUBSTRATE AND RESET
Urgency of Action	PRIORITY 4
Purpose of Action	LEVEL 2
Deficiency Photo1

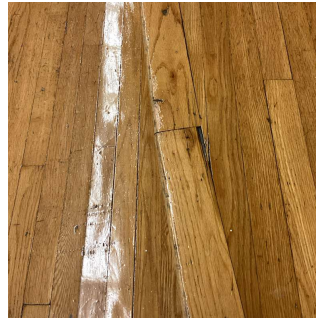
Stage	
Instance on 1st Floor (425 Seats)	Inspected
Condition	2 - Between Good and Fair
Deficiency	DAMAGED STEPS
Deficiency Location/Instance	Front
Deficiency Quantity	20
Quantity Uom	S.F.
Potential Action	REPLACE
Urgency of Action	PRIORITY 3
Purpose of Action	LEVEL 2

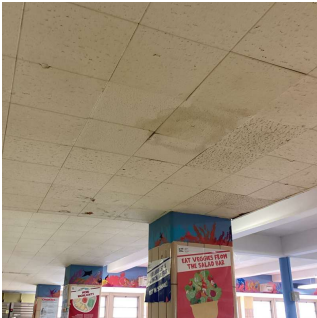
Question	Response
INTERIOR	
CAFETERIA	
Ceiling	
Violations	Near Windows No violations recorded.
Deficiency	ACOUSTIC TILES ON PLASTER: DAMAGED/MISSING
Deficiency Location/Instance	Near Center, Windows, Serving Area
Deficiency Quantity	80
Quantity Uom	S.F.
Potential Action	REPLACE
Urgency of Action	PRIORITY 3
Purpose of Action	LEVEL 2
Deficiency Photo1

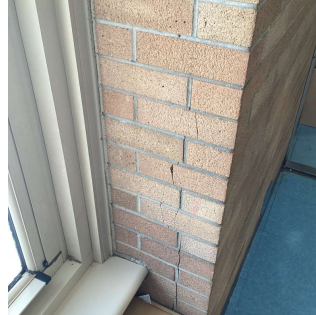
Corridor near Room B19
No violations recorded.

Violations	Room 115 No violations recorded.
Walls	Inspected
Condition	2 - Between Good and Fair
Deficiency	BRICK: CRACKS/SPALLING
Deficiency Location/Instance	Corridor near Rooms B19, 128
Deficiency Quantity	20
Quantity Uom	S.F.

PRIORITY 3
LEVEL 2

Potential Action	REPLACE

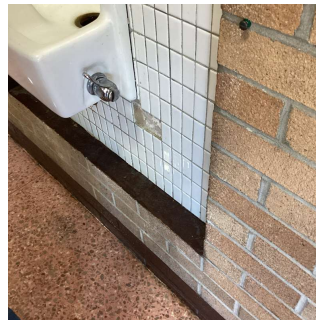
Corridor near Room 128
No violations recorded.

CERAMIC TILE: BROKEN/ MISSING
Corridor near Room 128
10
S.F.
REPLACE
PRIORITY 3
LEVEL 2

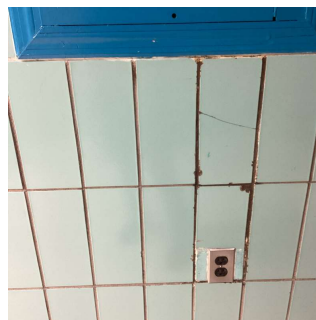
GLAZED BLOCK: CRACKS/SPALLING
Corridor near Rooms 210, 215
10
S.F.
REPLACE
PRIORITY 3
LEVEL 2

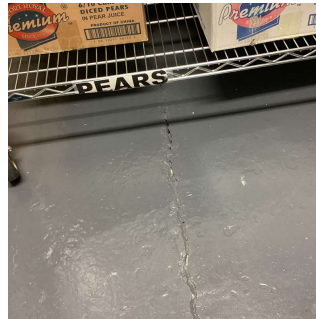
Outside Storage Room

Condition	5 - Poor
-----------	----------

Deficiency	CONCRETE: CRACKS
------------	------------------

Deficiency Location/Instance	Storage Rooms B6, B8
------------------------------	----------------------

Deficiency Quantity	60
---------------------	----

Potential Action	REPLACE
------------------	---------

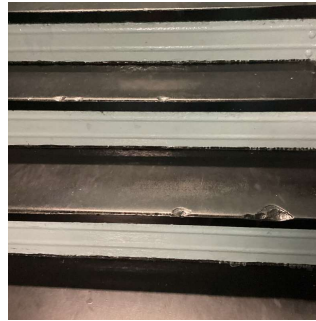
Stair G/Basement

Deficiency	STONE: BROKEN/MISSING
Deficiency Location/Instance	Stairs G/Basement, 1, 2, EF/1, 2, and others
Deficiency Quantity	210
Quantity Uom	S.F.
Potential Action	REPLACE
Urgency of Action	PRIORITY 3
Purpose of Action	LEVEL 2

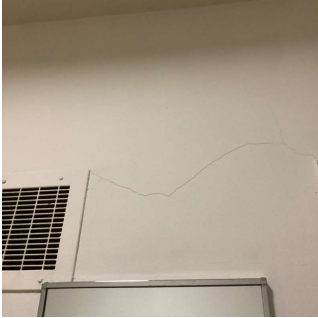
Question	Response
INTERIOR	
TOILET ROOMS - STAFF	
Stalls	
Condition	5 - Poor
Deficiency	RUST - MAJOR
Deficiency Location/Instance	Rooms 126, 128, 223
Deficiency Quantity	3
Quantity Uom	EACH
Potential Action	REPLACE
Urgency of Action	PRIORITY 3
Purpose of Action	LEVEL 2
Deficiency Photo1	 
Violations	Room 126 No violations recorded.
Walls	
Condition	Inspected 2 - Between Good and Fair
Deficiency	PLASTER: CRACKS/SPALLING
Deficiency Location/Instance	Rooms 126, 128, 223, 323
Deficiency Quantity	40
Quantity Uom	S.F.
Potential Action	REPLACE
Urgency of Action	PRIORITY 3
Purpose of Action	LEVEL 2
Deficiency Photo1

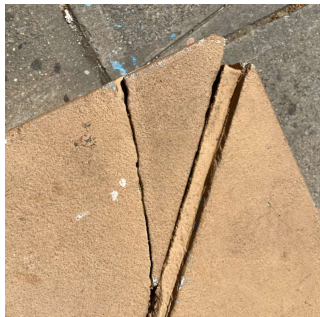
Deficiency Quantity	20
Quantity Uom	S.F.
Potential Action	REPLACE
Urgency of Action	PRIORITY 3
Purpose of Action	LEVEL 2
Deficiency Photo1
