NYC Department of Education
Building Condition Assessment Survey 2023 - 2024

Architectural Inspection

Asset: I.S. 198 - QUEENS, 3-65 BEACH 56 STREET, New York, 11692

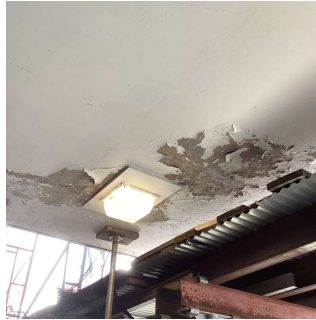
Facade A
No violations recorded.

| Question | Response |
|---|---|
| Condition | 4 - Between Fair and Poor |
| Deficiency | CONCRETE: WATER PENETRATION |

100
S.F.
REPAIR
PRIORITY 5
LEVEL 2

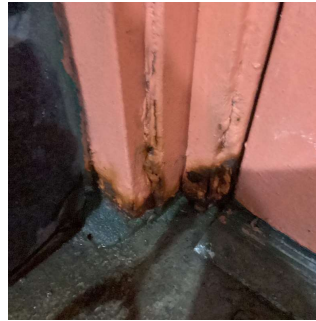
Facade D

Deficiency

METAL: DETERIORATED DOOR AND FRAME - MAJOR DETERIORATION

12
EACH
REPLACE
PRIORITY 4
LEVEL 2

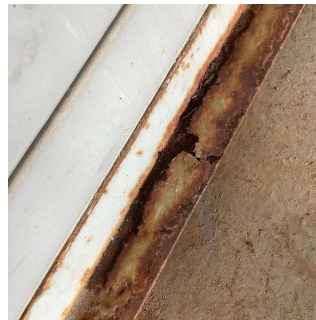
Facade E

Deficiency

ROLL-UP DOOR: DETERIORATED DOOR AND FRAME - MAJOR DETERIORATION

REPLACE

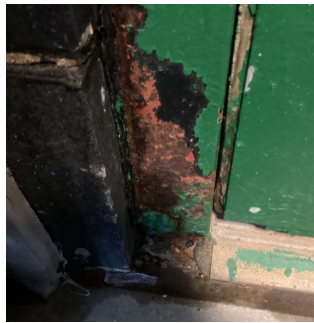
Facade H
 No violations recorded.

Deficiency

METAL CLAD: DETERIORATED DOOR AND FRAME - MAJOR DETERIORATION

1
 EACH
 REPLACE
 PRIORITY 4
 LEVEL 2

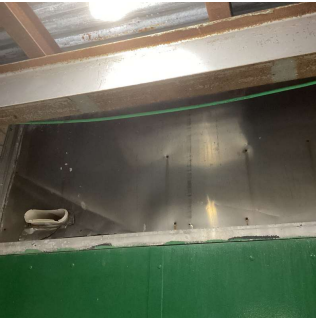
| Question | Response |
|---|--|
| Violations | Facade D No violations recorded. |

| Question | Response |
|---|--|
| Condition | 4 - Between Fair and Poor |
| Deficiency | METAL: DENTED, MAJOR RUSTING |

| Question | Response |
|---|--|
| Potential Action | REPLACE |

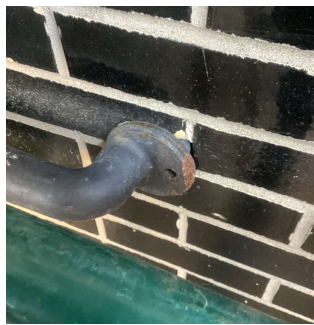
Facade A

| Question | Response |
|---|---|
| Condition | 3 - Fair |
| Deficiency | BROKEN BRACKET |

1
 EACH
 REPLACE
 PRIORITY 4
 LEVEL 2

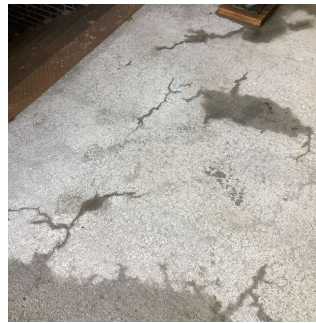
Facade D

Deficiency

CONCRETE: CRACKS/SPALLING - MINOR

30
 S.F.
 REPAIR
 PRIORITY 3
 LEVEL 2

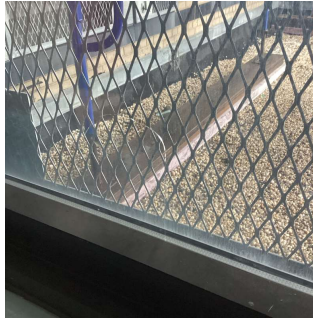
Facade M - Room 209

Deficiency

ALUMINUM - DOUBLE HUNG: BROKEN PANE

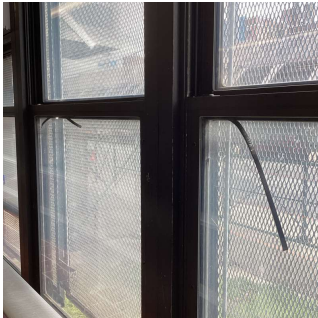
| Question | Response |
|--|--|
| Violations | Facade J No violations recorded. |

Deficiency

ALUMINUM - DOUBLE HUNG: AIR/WATER INFILTRATION, DETERIORATED JOINTS WITH DAMAGED CAULKING

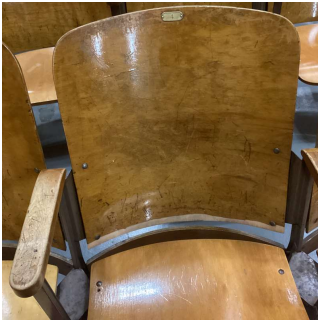
| Question | Response |
|--|--|
| Condition | 5 - Poor |
| Deficiency | DAMAGED/BROKEN/INOPERABLE |
| Deficiency Location/Instance | Seats A/4, 101, C/103, F/111, G/101, and others |

| Question | Response |
|--|--|
| Potential Action | REPLACE |

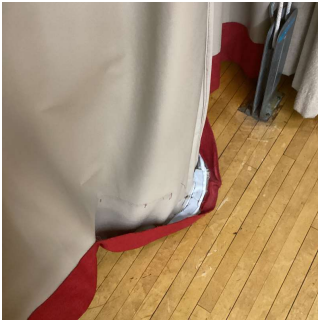
| Question | Response |
|---|--|
| | Man Right Side |

| Question | Response |
|---|--|
| Condition | 4 - Between Fair and Poor |

| Question | Response |
|---|--|
| Deficiency | WORN/DETERIORATED |
| Deficiency Location/Instance | Main Right and left Side, Back right Side |

| Question | Response |
|---|--|
| Potential Action | REPLACE |

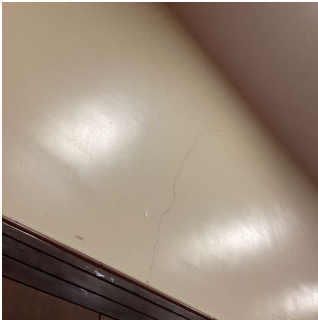
| Question | Response |
|---|--|
| | Near center |

| Question | Response |
|---|--|
| Deficiency | PLASTER: CRACKS/SPALLING |
| Deficiency Location/Instance | Near center |

| Question | Response |
|---|--|
| Potential Action | REPLACE |

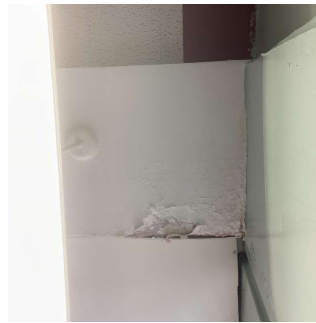
| Question | Response |
|--|--|
| Deficiency | PLASTER: CRACKS/SPALLING - ACTIVE LEAK |
| Deficiency Location/Instance | Near Windows |

| Question | Response |
|--|--|
| Potential Action | REPLACE |

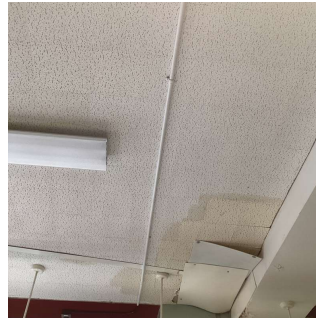
Near Windows

ACOUSTIC TILES ON PLASTER: DAMAGED/MISSING - ACTIVE LEAK

REPLACE

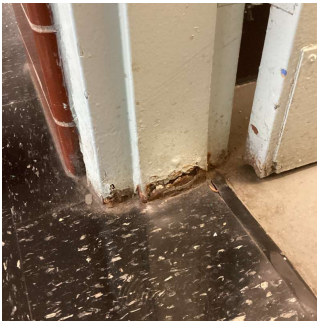
| Question | Response |
|--|--|
| Violations | Vestibule Exit 5 No violations recorded. |

METAL: DETERIORATED DOOR AND FRAME

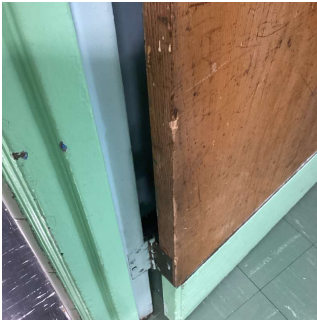
| Question | Response |
|--|--|
| Violations | Entrance No violations recorded. |

| Question | Response |
|--|--|
| Condition | 3 - Fair |
| Deficiency | WOOD: DETERIORATED DOOR |
| Deficiency Location/Instance | Entrance |

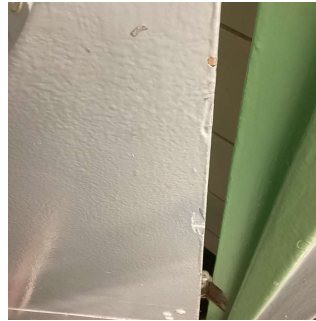
Entrance

| Question | Response |
|--|--|
| Condition | 5 - Poor |
| Deficiency | WOOD: DETERIORATED DOOR |
| Deficiency Location/Instance | Entrances |

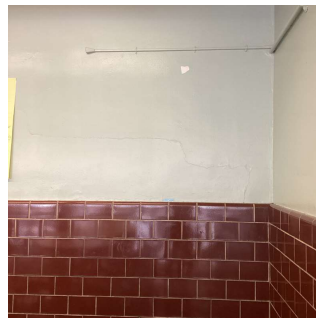
Near Exit 5

PLASTER: CRACKS/SPALLING

REPLACE

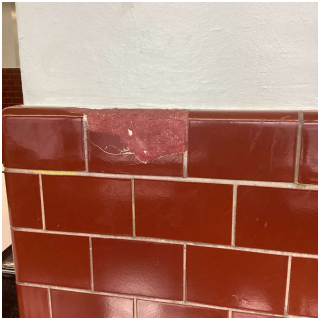
| Question | Response |
|--|--|
| Violations | Column Near Windows No violations recorded. |

| Question | Response |
|--|--|
| Deficiency | GLAZED BLOCK: CRACKS/SPALLING |
| Deficiency Location/Instance | Column Near Windows , Entrance |

| Question | Response |
|--|--|
| Potential Action | REPLACE |

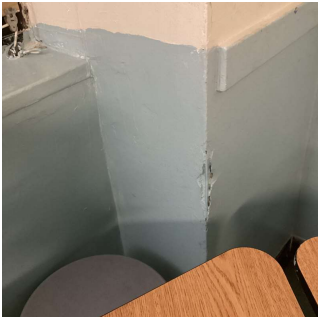
| Question | Response |
|--|--|
| Violations | Near Windows No violations recorded. |

| Question | Response |
|--|--|
| Condition | 2 - Between Good and Fair |
| Deficiency | PLASTER: CRACKS/SPALLING |
| Deficiency Location/Instance | Near Entrance, Back Side, Windows |

| Question | Response |
|--|--|
| Potential Action | REPLACE |

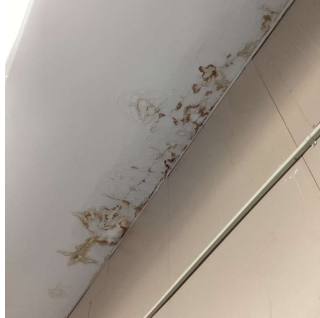
| Question | Response |
|--|--|
| | Room 303B |

| Question | Response |
|--|--|
| Deficiency | PLASTER: CRACKS/SPALLING |

| Question | Response |
|--|--|
| Deficiency Location/Instance | Rooms 418, 422, 323, 303B |

| Question | Response |
|--|--|
| Potential Action | REPLACE |

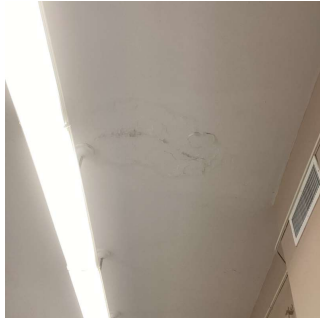
| Question | Response |
|--|--|
| | Room 408 |

| Question | Response |
|--|--|
| Deficiency | PLASTER: CRACKS/SPALLING |
| Deficiency Location/Instance | Rooms 328, 337, 404, 408, 409, 418 |
| Violations | 35423361H, 35671772P |

| Question | Response |
|--|--|
| Potential Action | REPLACE |

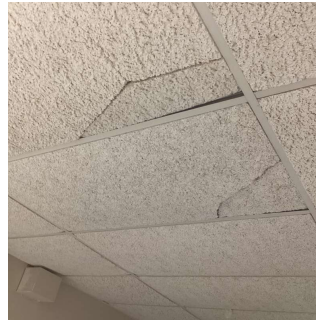
Corridor near Room 427

| Question | Response |
|--|--|
| Deficiency | ACOUSTIC TILES: DAMAGED/MISSING |
| Deficiency Location/Instance | Room 337, Corridor near Rooms 322, 427, 431, 436, and others |

| Question | Response |
|--|--|
| Potential Action | REPLACE |

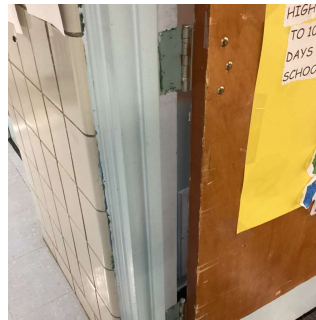
Room 408

WOOD: DETERIORATED DOOR
