NYC Department of Education
Building Condition Assessment Survey 2023 - 2024

Architectural Inspection

Asset: P.S. 199 - QUEENS, 39-20 48 AVENUE, New York, 11104

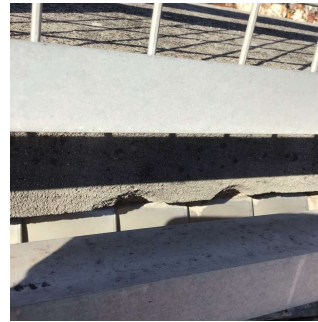
Roof 1
No violations recorded.

Deficiency Quantity
Quantity Uom
Potential Action
Urgency of Action
Purpose of Action
Deficiency Photo1

30
L.F.
REPLACE-IN-KIND
PRIORITY 4
LEVEL 2

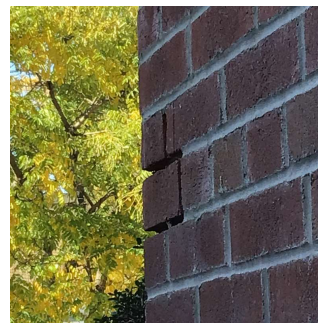
BRICK: CRACKS/DISPLACED/SPALLED BRICK AT BUILDING CORNERS

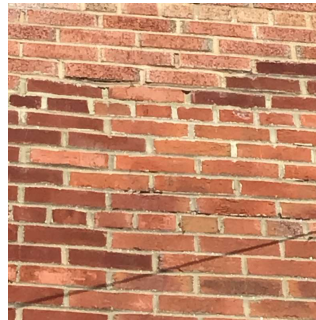
Facade G

BRICK: DETERIORATED JOINTS

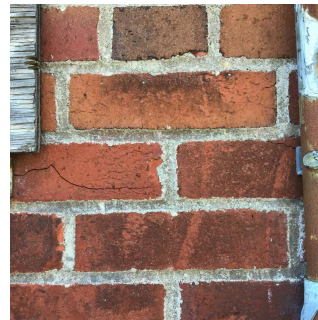
BH2
No violations recorded.

**BULKHEAD/PENTHOUSE WALLS/EXTERIOR:
CRACKS/SPALLING - MINOR**

20
S.F.
REPAIR
PRIORITY 3
LEVEL 2

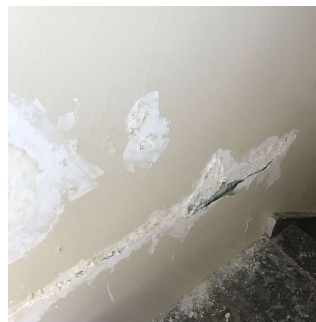
BH2
No violations recorded.

**BULKHEAD/PENTHOUSE WALLS/EXTERIOR: WATER
INFILTRATION**

100
S.F.
REPAIR
PRIORITY 5
LEVEL 2

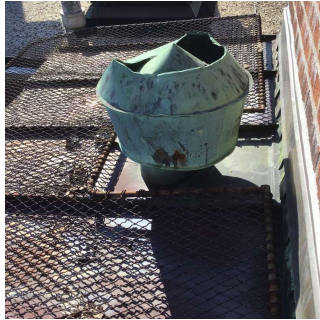
Question	Response
EXTERIOR	
ROOF	
Specialties	
SKYLIGHT/ROOF VENT	
Urgency of Action	PRIORITY 3
Purpose of Action	LEVEL 2
Deficiency Photo1

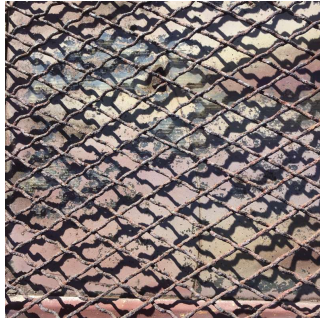
SK
Violations	No violations recorded.
ROOF/GRAVITY TANK	Does not Exist
STAIRS/RAMPS: EXTERIOR	Inspected
BUILDING CHEEK/FLANK WALLS	Inspected
Condition	2 - Between Good and Fair
Deficiency	No deficiencies recorded
RAILINGS	Inspected

Roof 1
Violations	No violations recorded.
Deficiency	BROKEN GLASS
Roof Plan reference	Q199

Deficiency Quantity	30
Quantity Uom	S.F.
Potential Action	MAINTENANCE
Urgency of Action	PRIORITY 3
Purpose of Action	LEVEL 2
Deficiency Photo1

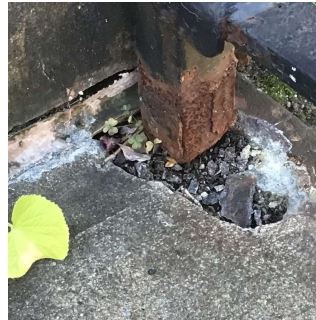
Facade A	No violations recorded.
----------	-------------------------

Deficiency	RUST - MAJOR
------------	--------------

Potential Action	REPLACE
------------------	---------

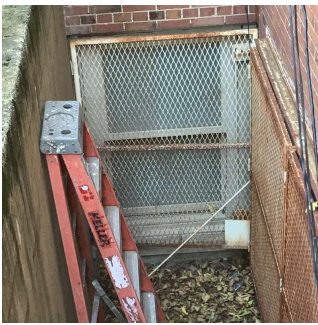
Violations	Facade A No violations recorded.
WINDOWS	Inspected
Replacement Quantity	9,000
Replacement Uom	S.F.
EXTERIOR GUARDS	Inspected
Condition	3 - Fair
Deficiency	RUST - MAJOR
Roof Plan reference

Deficiency Quantity	120
Quantity Uom	S.F.
Potential Action	REPLACE
Urgency of Action	PRIORITY 4
Purpose of Action	LEVEL 2

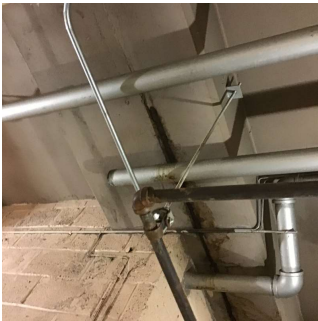
Violations	Facade G No violations recorded.
LINTELS	Inspected
Condition	2 - Between Good and Fair
Deficiency	No deficiencies recorded
WINDOWS	Inspected
Material Type(s)	Aluminum
Instance on Aluminum - Double Hung: All Facades	Inspected
Instance Condition	3 - Fair
Instance Quantity	8,000
Instance Quantity Uom	S.F.
Are these windows insulated	No
Installation Year	2003
Source of Installation	Custodial Staff
Deficiency	No deficiencies recorded
Instance on Aluminum - Other: Auditorium, Cafeteria, Gymnasium, Staircases	Inspected
Instance Condition	3 - Fair
Instance Quantity	1,000
Instance Quantity Uom	S.F.
Are these windows insulated	No
Installation Year	2003
Source of Installation	Custodial Staff
Deficiency	No deficiencies recorded
INTERIOR	Inspected
POOLS	Does not Exist
STRUCTURAL	Inspected
COLUMNS/BEAMS/BEARING WALLS	Inspected
Condition	3 - Fair
Deficiency	STEEL COLUMNS/BEAMS: DETERIORATED CONCRETE FIREPROOFING

Deficiency Location/Instance	Basement - Gas Meter Room
Deficiency Quantity	20
Quantity Uom	S.F.
Potential Action	REPLACE
Urgency of Action	PRIORITY 4
Purpose of Action	LEVEL 5

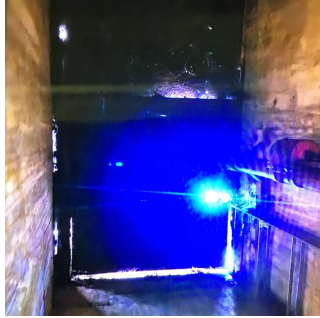
Violations	Basement - Bunker No violations recorded.
ROOF STRUCTURE	Inspected
Condition	2 - Between Good and Fair
Deficiency	No deficiencies recorded
VAULTS-BUNKERS	Inspected
Foundation Walls	Inspected
Condition	2 - Between Good and Fair
Deficiency	No deficiencies recorded
Slab Structure	Inspected
Condition	2 - Between Good and Fair
Deficiency	No deficiencies recorded
Vault/Ash Hoist Doors and Framing	Inspected
Condition	5 - Poor
Deficiency	DETERIORATED/DAMAGED VAULT/ASH HOIST DOORS AND FRAMING

Deficiency Location/Instance	Basement - Vault/Ash Hoist Door and Framing
Deficiency Quantity	2
Quantity Uom	EACH
Potential Action	REPLACE

Question	Response
INTERIOR	
STRUCTURAL	
VAULTS-BUNKERS	
Vault/Ash Hoist Doors and Framing	
Urgency of Action	PRIORITY 4
Purpose of Action	LEVEL 2
Deficiency Photo1

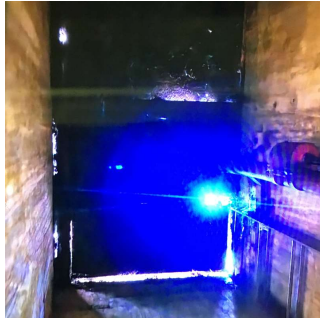
Violations	Basement - Ash Hoist Vault No violations recorded.
Deficiency	WATER INFILTRATION
Deficiency Location/Instance	Basement - Vault/Ash Hoist Door
Deficiency Quantity	10
Quantity Uom	S.F.
Potential Action	REPAIR
Urgency of Action	PRIORITY 5
Purpose of Action	LEVEL 2
Deficiency Photo1

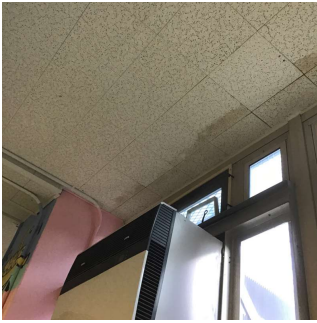
Yes	Potential Falling Debris	Loose ceiling tile is a potential safety hazard.	INTERIOR CAFETERIA Ceiling	Near Windows	Billy Peake	Custodian

Question	Response
INTERIOR	
CAFETERIA	
Ceiling	
Deficiency Photo1

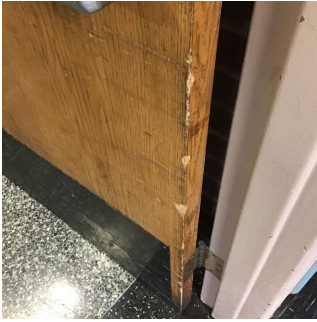
Violations	Near Windows No violations recorded.
Door(s)	
Instance on 1st Floor	Inspected
Condition	4 - Between Fair and Poor
Deficiency	WOOD: DETERIORATED DOOR
Deficiency Location/Instance	Exit
Deficiency Quantity	2
Quantity Uom	EACH
Potential Action	MAINTENANCE
Urgency of Action	PRIORITY 3
Purpose of Action	LEVEL 2
Deficiency Photo1

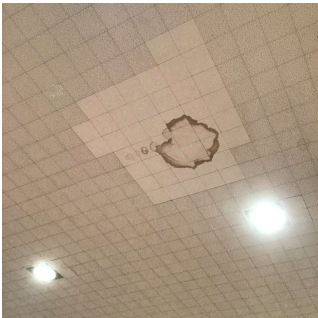
Near Entrance

Deficiency	ACOUSTIC TILES ON PLASTER: DAMAGED/MISSING - ACTIVE LEAK
Deficiency Location/Instance	Near Entrance, Windows
Deficiency Quantity	40
Quantity Uom	S.F.
Potential Action	REPLACE
Urgency of Action	PRIORITY 5
Purpose of Action	LEVEL 2
Deficiency Photo1

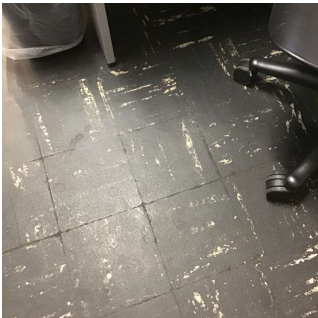
Instance on 1st Floor	Inspected
Condition	2 - Between Good and Fair
Deficiency	VINYL TILES: BROKEN/DETERIORATED/MISSING TILES
Deficiency Location/Instance	Office
Deficiency Quantity	40
Quantity Uom	S.F.
Potential Action	REPLACE
Urgency of Action	PRIORITY 3
Purpose of Action	LEVEL 2
Deficiency Photo1

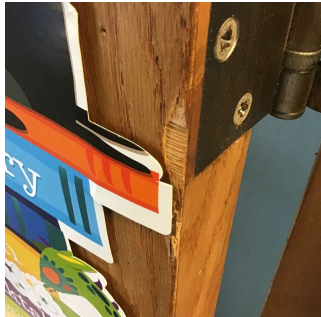
Entrance
Violations	No violations recorded.

Violations	Near Entrance No violations recorded.
Door(s)	
Instance on Room 321	Inspected
Condition	3 - Fair
Deficiency	WOOD: DETERIORATED DOOR
Deficiency Location/Instance	Entrance
Deficiency Quantity	1
Quantity Uom	EACH
Potential Action	MAINTENANCE
Urgency of Action	PRIORITY 3

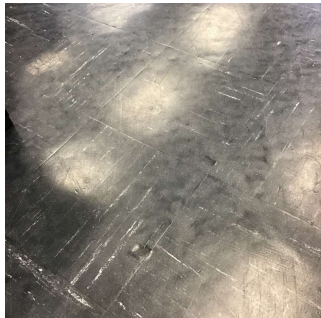
Near Entrance
Violations	No violations recorded.

Floor Finish	
Instance on Room 321	Inspected
Condition	2 - Between Good and Fair
Deficiency	VINYL TILES: BROKEN/DETERIORATED/MISSING TILES
Deficiency Location/Instance	Near Entrance, Center
Deficiency Quantity	20
Quantity Uom	S.F.
Potential Action	REPLACE
Urgency of Action	PRIORITY 3
Purpose of Action	LEVEL 2
Deficiency Photo1

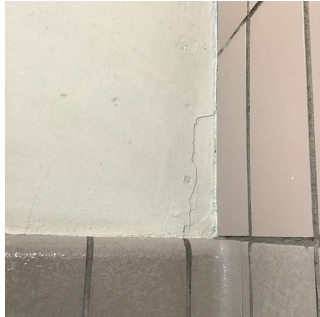
Stair D/3
Violations	No violations recorded.
Walls	Inspected
Condition	2 - Between Good and Fair
Deficiency	PLASTER: CRACKS/SPALLING
Deficiency Location/Instance	Stairs C/1, 2, D/2
Deficiency Quantity	40
Quantity Uom	S.F.
Potential Action	REPLACE
Urgency of Action	PRIORITY 3
Purpose of Action	LEVEL 2
Deficiency Photo1

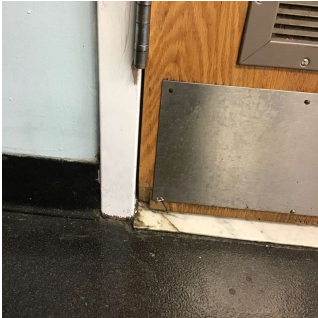
Violations	Room 313 No violations recorded.
Door(s)	Inspected
Condition	5 - Poor
Deficiency	WOOD: DETERIORATED DOOR
Deficiency Location/Instance	Rooms 111A, 216A, 223A
Deficiency Quantity	3
Quantity Uom	EACH
Potential Action	MAINTENANCE
Urgency of Action	PRIORITY 3
Purpose of Action	LEVEL 2
Deficiency Photo1

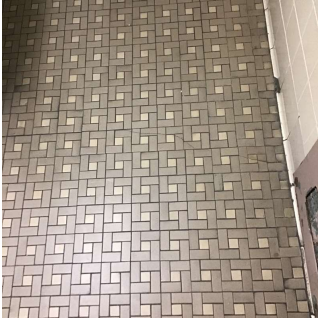
Question	Response
INTERIOR	
TOILET ROOMS - STUDENTS	Inspected
Floor Finish	
Deficiency Location/Instance	Rooms A/1, 111A, 301
Deficiency Quantity	20
Quantity Uom	S.F.
Potential Action	REPLACE
Urgency of Action	PRIORITY 3
Purpose of Action	LEVEL 2
Deficiency Photo1

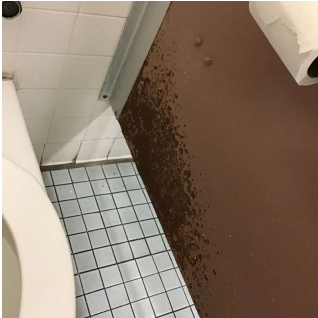
Room 111A
Violations	No violations recorded.
Stalls	Inspected
Condition	4 - Between Fair and Poor
Deficiency	RUST - MAJOR
Deficiency Location/Instance	Room 214A/216A
Deficiency Quantity	3
Quantity Uom	EACH
Potential Action	REPLACE
Urgency of Action	PRIORITY 3
Purpose of Action	LEVEL 2
Deficiency Photo1

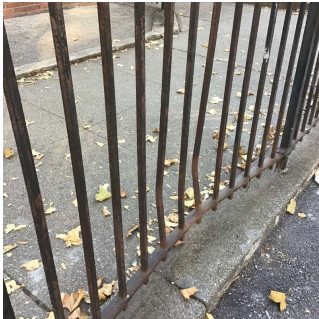
Violations	39th Place No violations recorded.

Violations	Near 39th Street No violations recorded.
Deficiency	WROUGHT IRON: DAMAGED/DETERIORATED
Deficiency Location/Instance	48th Avenue, 39th Place
Deficiency Quantity	320
Quantity Uom	S.F.
Potential Action	REPLACE
Urgency of Action	PRIORITY 3
Purpose of Action	LEVEL 2
Deficiency Photo1

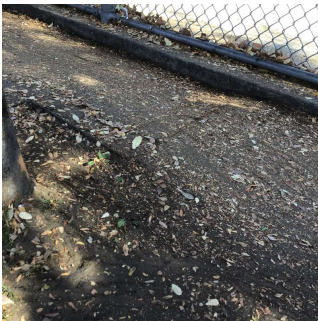
Yes	Tripping Hazard	Severely heaving pavers are a tripping hazard Condition.	SITE PAVING Student Use Pavers	Near 40th Street, Stair Entrance	Billy Peake	Custodian

Violations	Schoolyard- Near center No violations recorded.
Concrete	Inspected
Condition	1 - Good
Deficiency	No deficiencies recorded
Pavers	Inspected
Condition	3 - Fair
Deficiency	HEAVING
Deficiency Location/Instance	Near 40th Street, 48th Avenue, Stair Entrance
Deficiency Quantity	40
Quantity Uom	S.F.
Potential Action	REPLACE
Urgency of Action	PRIORITY 5
Purpose of Action	LEVEL 6
Deficiency Photo1

Violations	Near 40th Street No violations recorded.
Deficiency	DAMAGED/MISSING
Deficiency Location/Instance	Near 40th Street , Stair Entrance.
Deficiency Quantity	40
Quantity Uom	S.F.
Potential Action	REPLACE

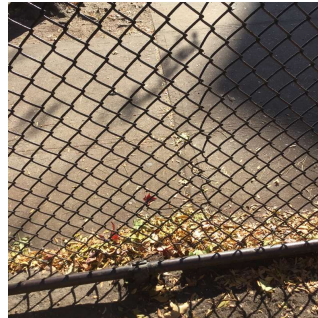
Green point Avenue
No violations recorded.

CHAIN LINK: DAMAGED/DETERIORATED
Green point Avenue
50
S.F.
REPLACE
PRIORITY 3
LEVEL 2

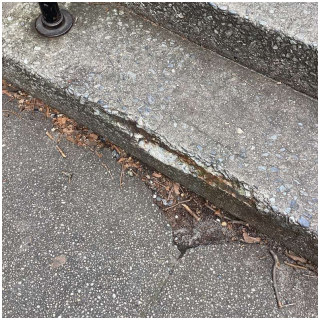
Handball wall
Violations	No violations recorded.
STAIRS/RAMPS: EXTERIOR	
	Inspected
Railings	Inspected
Condition	2 - Between Good and Fair
Deficiency	No deficiencies recorded
Site Cheek/flank Walls	Inspected
Condition	2 - Between Good and Fair
Deficiency	No deficiencies recorded
Stairs/ramps	Inspected
Condition	3 - Fair
Deficiency	CAST IN PLACE CONCRETE: CRACKS/SPALLING - MAJOR
Deficiency Location/Instance	Schoolyard
Deficiency Quantity	50
Quantity Uom	S.F.
Potential Action	REPLACE
Urgency of Action	PRIORITY 3
Purpose of Action	LEVEL 2
Deficiency Photo1
