NYC Department of Education
Building Condition Assessment Survey 2023 - 2024

Architectural Inspection

Asset: P.S. 200 - QUEENS, 70-10 164 STREET, New York, 11365

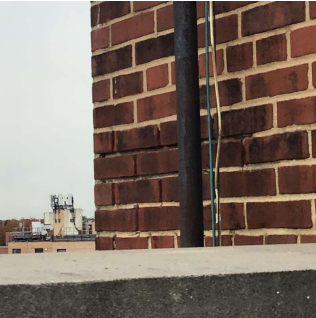
CH No violations recorded.
COPING	
Condition Deficiency Roof Plan reference Deficiency Quantity Quantity Uom Potential Action Urgency of Action Purpose of Action Deficiency Photo1 Violations	Inspected 4 - Between Fair and Poor CAST STONE: DETERIORATED TRANSVERSE JOINTS

Violations	AW4 No violations recorded.
AWNINGS AND CANOPIES	
Does not Exist	
CHIMNEY	
Material Type(s)	Inspected Masonry
Condition	3 - Fair
Deficiency	BRICK: DETERIORATED JOINTS
Roof Plan reference

Deficiency Quantity	10
Quantity Uom	S.F.
Potential Action	REPOINT
Urgency of Action	PRIORITY 4
Purpose of Action	LEVEL 2

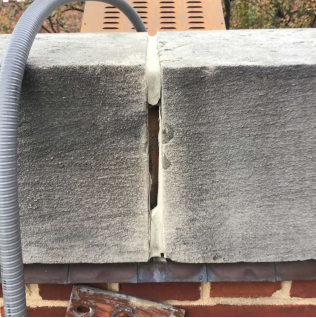
Roof 1 No violations recorded.
Deficiency	CAST STONE: CRACKED/BROKEN PIECES

200 L.F. MAINTENANCE PRIORITY 3 LEVEL 2

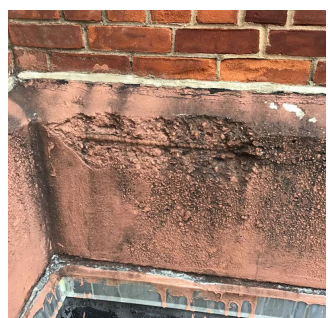
Roof 1	
Violations	No violations recorded.
Deficiency	BRICK: DETERIORATED CONTROL/EXPANSION JOINT

Question	Response
EXTERIOR	
EXTERIOR WALLS	Inspected
Violations	No violations recorded.
EXTERIOR SOFFITS	Does not Exist
LOADING DOCK	Does not Exist
LOUVER	Inspected
Condition	2 - Between Good and Fair
Deficiency	No deficiencies recorded
PARAPETS	Inspected
Material Type(s)	Masonry, Concrete
Replacement Quantity	6,000
Replacement Uom	C.F.
Instance on All Roofs	Inspected
Instance Condition	4 - Between Fair and Poor
Instance Quantity	6,000
Instance Quantity Uom	C.F.
Deficiency	CONCRETE: MAJOR DETERIORATION/CRACKS
Roof Plan reference

Deficiency Quantity	10
Quantity Uom	S.F.
Potential Action	REMOVE AND REBUILD
Urgency of Action	PRIORITY 4
Purpose of Action	LEVEL 2
Deficiency Photo1

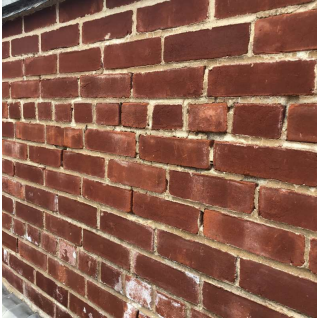
Violations	Roof 4 No violations recorded.
Deficiency	BRICK: DETERIORATED JOINTS
Roof Plan reference

Deficiency Quantity	120
Quantity Uom	S.F.
Potential Action	REPOINT
Urgency of Action	PRIORITY 4
Purpose of Action	LEVEL 2
Deficiency Photo1

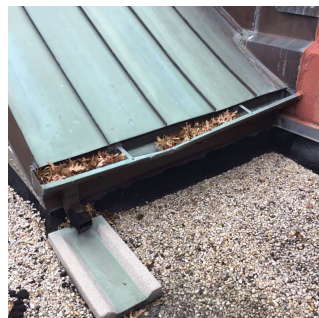
Violations	Roof 4 No violations recorded.
PLAZA DECK	Does not Exist
ROOF	Inspected
Roofing	Inspected
Replacement Quantity	28,000
Replacement Uom	S.F.
ROOF HATCH/SMOKE HATCH	Does not Exist
LEADERS, GUTTERS, DOWNSPOUTS, SCUPPERS	Inspected
Condition	3 - Fair
Deficiency	DAMAGED/MISSING

Deficiency Quantity	20
Quantity Uom	L.F.
Potential Action	REPLACE
Urgency of Action	PRIORITY 4
Purpose of Action	LEVEL 2
Deficiency Photo1

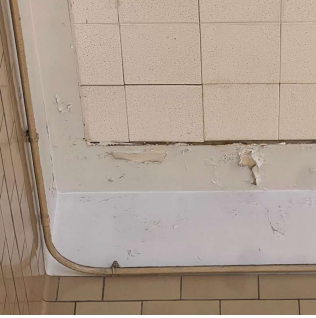
Question	Response
EXTERIOR	
ROOF	
Roofing	
ROOFING	
Installation Year	2000
Source of Installation	Custodial Staff
Deficiency	BUILT-UP: ROOFING: MAJOR ACTIVE ROOF LEAKS IN INSTRUCTIONAL SPACE
Roof Plan reference

Deficiency Quantity	100
Quantity Uom	S.F.
Potential Action	REPLACE ROOFING WITHOUT MAJOR EQUIPMENT REMOVAL
Urgency of Action	PRIORITY 5
Purpose of Action	LEVEL 2
Deficiency Photo1

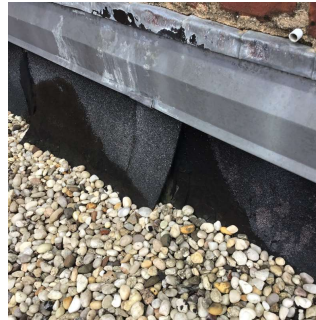
Violations	Roof 2 - Gymnasium No violations recorded.
Deficiency	BUILT-UP: FLASHING: BASE FLASHING DETERIORATED
Roof Plan reference

Deficiency Quantity	10
Quantity Uom	S.F.
Potential Action	REPAIR
Urgency of Action	PRIORITY 3
Purpose of Action	LEVEL 2

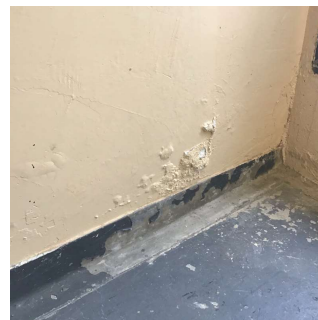
BH2
No violations recorded.

**BULKHEAD/PENTHOUSE WALLS/INTERIOR: PLASTER
CRACKS/SPALLING**

40
S.F.
REPLACE
PRIORITY 3
LEVEL 2

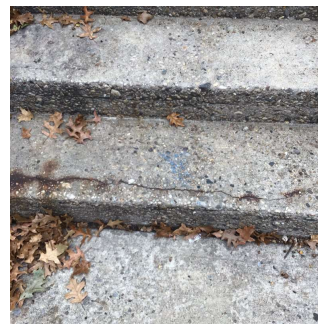
Facade E

CUPOLA/ SPIRES/ TOWERS	Does not Exist
DORMER	Does not Exist
DUNNAGE STEEL	Does not Exist
SKYLIGHT/ROOF VENT	Does not Exist
ROOF/GRAVITY TANK	Does not Exist
STAIRS/RAMPS: EXTERIOR	Inspected
BUILDING CHEEK/FLANK WALLS	Inspected
Condition	2 - Between Good and Fair
Deficiency	No deficiencies recorded
RAILINGS	Inspected
Condition	2 - Between Good and Fair
Deficiency	No deficiencies recorded
STAIRS/RAMPS	Inspected
Condition	5 - Poor
Deficiency	CONCRETE: CRACKS/SPALLING - MINOR

10
S.F.
REPAIR
PRIORITY 3
LEVEL 2

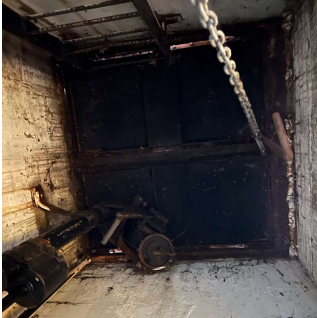
Question	Response
INTERIOR	
STRUCTURAL	
VAULTS-BUNKERS	
Vault/Ash Hoist Doors and Framing	
Deficiency Quantity	2
Quantity Uom	EACH
Potential Action	REPLACE
Urgency of Action	PRIORITY 4
Purpose of Action	LEVEL 2
Deficiency Photo1

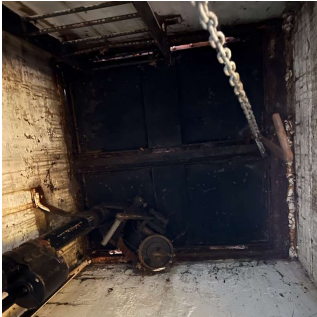
Violations	Ash Hoist Vault No violations recorded.
Deficiency	WATER INFILTRATION
Deficiency Location/Instance	Ash Hoist Vault
Deficiency Quantity	10
Quantity Uom	S.F.
Potential Action	REPAIR
Urgency of Action	PRIORITY 5
Purpose of Action	LEVEL 2
Deficiency Photo1

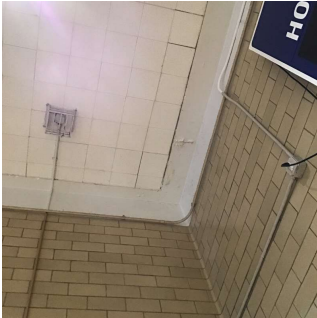
Question	Response
INTERIOR	
GYMNASIUM	
Ceiling	
Deficiency	PLASTER: CRACKS/SPALLING
Deficiency Location/Instance	Left Side, Near Windows
Deficiency Quantity	30
Quantity Uom	S.F.
Potential Action	REPLACE
Urgency of Action	PRIORITY 3
Purpose of Action	LEVEL 2
Deficiency Photo1

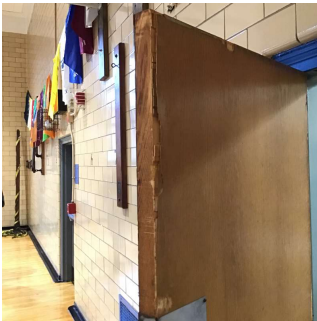
Violations	Left Side No violations recorded.
Door(s)	
Instance on 3rd Floor	Inspected
Condition	5 - Poor
Deficiency	WOOD: DETERIORATED DOOR
Deficiency Location/Instance	Storage Room, Office
Deficiency Quantity	3
Quantity Uom	EACH
Potential Action	MAINTENANCE
Urgency of Action	PRIORITY 3
Purpose of Action	LEVEL 2
Deficiency Photo1

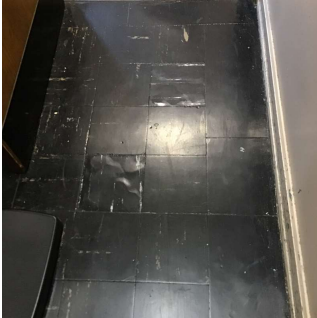
Violations	Storage Room No violations recorded.
Fixed Equipment	
Instance on 3rd Floor	Inspected
Condition	2 - Between Good and Fair
Deficiency	No deficiencies recorded
Floor Finish	
Instance on 3rd Floor	Inspected
Condition	2 - Between Good and Fair
Deficiency	VINYL TILES: BROKEN/DETERIORATED/MISSING TILES

Question	Response
INTERIOR	
GYMNASIUM	
Floor Finish	
Deficiency Location/Instance	Office
Deficiency Quantity	100
Quantity Uom	S.F.
Potential Action	REPLACE
Urgency of Action	PRIORITY 3
Purpose of Action	LEVEL 2
Deficiency Photo1

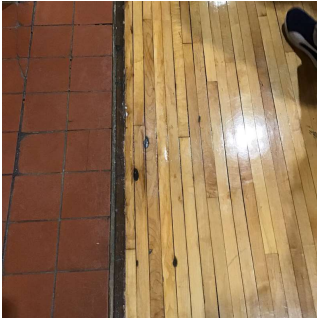
Violations	Office No violations recorded.
Deficiency	WOOD: DAMAGED/DETERIORATED
Deficiency Location/Instance	Near Drinking Fountain
Deficiency Quantity	10
Quantity Uom	S.F.
Potential Action	REPLACE
Urgency of Action	PRIORITY 3
Purpose of Action	LEVEL 2
Deficiency Photo1

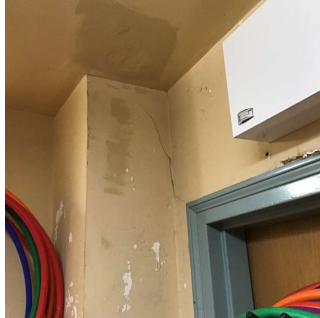
Left Side
Violations	No violations recorded.
Deficiency	PLASTER: CRACKS/SPALLING
Deficiency Location/Instance	Storage Room, Office
Deficiency Quantity	60
Quantity Uom	S.F.
Potential Action	REPLACE
Urgency of Action	PRIORITY 3
Purpose of Action	LEVEL 2
Deficiency Photo1

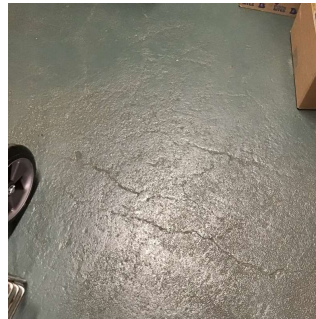
Instance on 1st Floor	Inspected
Condition	2 - Between Good and Fair
Deficiency	CONCRETE: CRACKS
Deficiency Location/Instance	Storage Room Near Kitchen
Deficiency Quantity	25
Quantity Uom	S.F.
Potential Action	REPLACE
Urgency of Action	PRIORITY 3
Purpose of Action	LEVEL 2
Deficiency Photo1

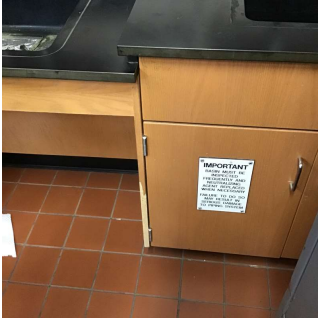
Question	Response
INTERIOR	
SCIENCE LAB	
Fixed Equipment	
Condition	3 - Fair
Deficiency	CABINETRY: MISSING/DAMAGED
Deficiency Location/Instance	Room 319
Deficiency Quantity	10
Quantity Uom	L.F.
Potential Action	REPLACE
Urgency of Action	PRIORITY 3
Purpose of Action	LEVEL 2
Deficiency Photo1

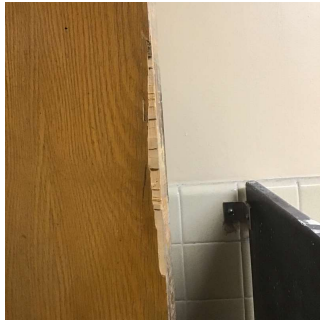
Violations	Room 121 No violations recorded.
Door(s)	
Condition	Inspected 5 - Poor
Deficiency	WOOD: DETERIORATED DOOR
Deficiency Location/Instance	Rooms 124, 121, 118, inside Rooms 324, 221
Deficiency Quantity	5
Quantity Uom	EACH
Potential Action	MAINTENANCE
Urgency of Action	PRIORITY 3
Purpose of Action	LEVEL 2
Deficiency Photo1
