NYC Department of Education
Building Condition Assessment Survey 2023 - 2024

Architectural Inspection

Asset: P.S. 201 - QUEENS, 65-11 155 STREET, New York, 11367

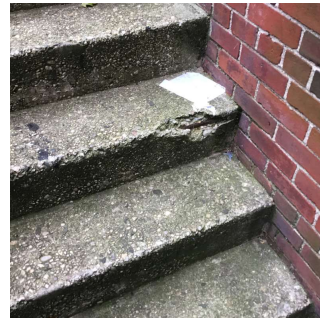
AW2

AREAWAY STAIRS: DETERIORATED MATERIAL SLIDE

25
S.F.
REPLACE
PRIORITY 3
LEVEL 2

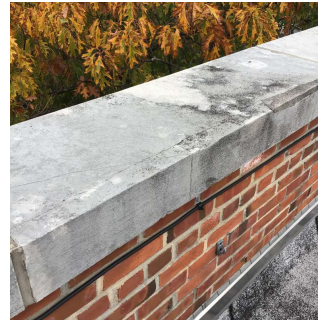
Roof 1

CAST STONE: DETERIORATED TRANSVERSE JOINTS

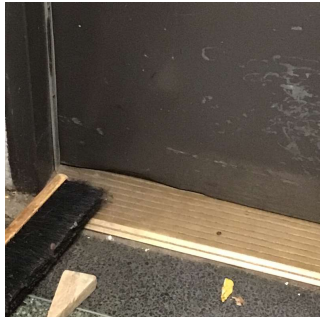
METAL: DETERIORATED DOOR - MAJOR DETERIORATION

REPLACE

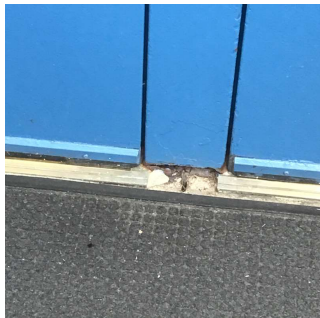
Violations	Facade L No violations recorded.
Deficiency	METAL: DETERIORATED DOOR AND FRAME - MAJOR DETERIORATION
Roof Plan reference

Deficiency Quantity	4
Quantity Uom	EACH
Potential Action	REPLACE
Urgency of Action	PRIORITY 4
Purpose of Action	LEVEL 2
Deficiency Photo1

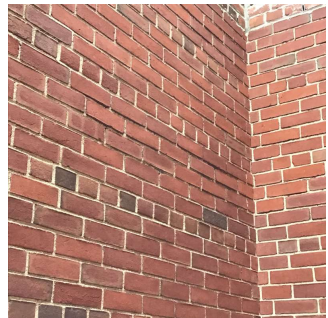
Question	Response
EXTERIOR	
DOORS	Inspected
TRANSOM/SIDE LIGHT	
Deficiency	No deficiencies recorded
EXTERIOR WALLS	Inspected
Material Type(s)	Masonry
Replacement Quantity	34,000
Replacement Uom	S.F.
Instance on All Facades	Inspected
Instance Condition	3 - Fair
Instance Quantity	34,000
Instance Quantity Uom	S.F.
Deficiency	BRICK: DETERIORATED JOINTS
Roof Plan reference

Deficiency Quantity	20
Quantity Uom	S.F.
Potential Action	REPOINT
Urgency of Action	PRIORITY 4
Purpose of Action	LEVEL 2
Deficiency Photo1

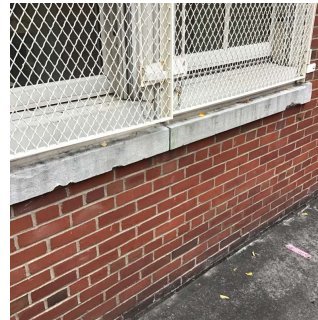
Violations	Facade L No violations recorded.
Deficiency	BRICK: DETERIORATED MASONRY SILLS - MINOR

REPAIR

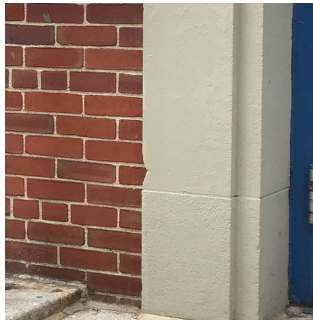
Facade A

STONE: CHIPPED/SPALLED/BROKEN PIECES - MINOR

REPAIR

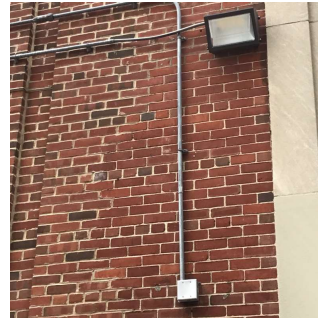
Facade A

BRICK: DETERIORATED JOINTS

PRIORITY 3
LEVEL 2

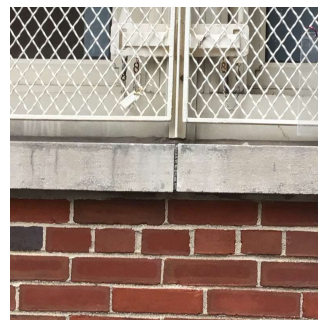
Facade A

BRICK: MASONRY SILLS - DETERIORATED JOINTS

30
L.F.
REPOINT
PRIORITY 3
LEVEL 2

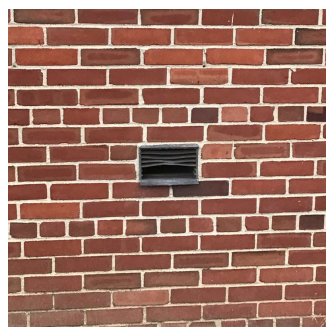
Question	Response
EXTERIOR	
EXTERIOR WALLS	Inspected
Violations	No violations recorded.
EXTERIOR SOFFITS	Does not Exist
LOADING DOCK	Does not Exist
LOUVER	Inspected
Condition	3 - Fair
Deficiency	BROKEN/ DENTED BLADES
Roof Plan reference

Deficiency Quantity	10
Quantity Uom	S.F.
Potential Action	REPLACE
Urgency of Action	PRIORITY 4
Purpose of Action	LEVEL 2
Deficiency Photo1

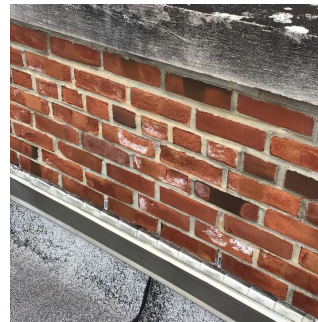
Roof 1

BRICK: MINOR CRACKS, SPALLING

REPAIR

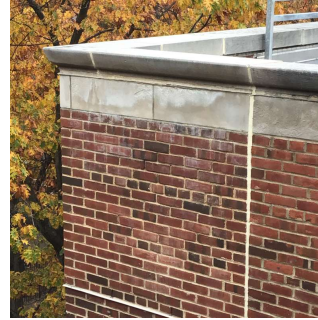
Facade A

STONE: MINOR CRACKS, SPALLING

REPAIR

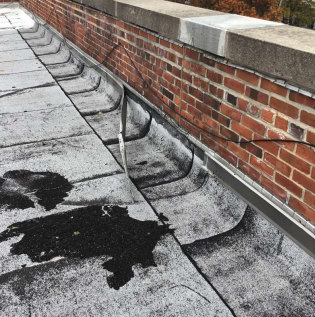
Question	Response
EXTERIOR	
ROOF	
Roofing	
ROOFING	
Installation Year	2000
Source of Installation	Custodial Staff
Deficiency	MODIFIED BITUMEN: FLASHING: CAP FLASHING DAMAGED
Roof Plan reference

Deficiency Quantity	20
Quantity Uom	L.F.
Potential Action	REPLACE
Urgency of Action	PRIORITY 4
Purpose of Action	LEVEL 2
Deficiency Photo1

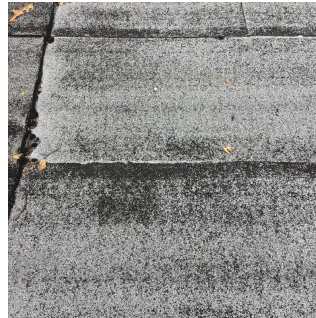
Violations	Roof 1 No violations recorded.
Deficiency	MODIFIED BITUMEN: ROOFING: DELAMINATION
Roof Plan reference

Deficiency Quantity	50
Quantity Uom	S.F.
Potential Action	REPLACE ROOFING WITHOUT MAJOR EQUIPMENT REMOVAL
Urgency of Action	PRIORITY 4
Purpose of Action	LEVEL 2

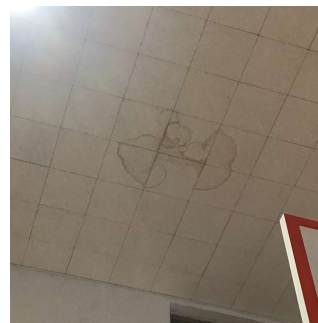
Roof 4 - Gymnasium (shown), Roof 1 - Stair DE/3

**MODIFIED BITUMEN: ROOFING: MAJOR ACTIVE ROOF
LEAKS IN INSTRUCTIONAL SPACE**

**REPLACE ROOFING WITHOUT MAJOR EQUIPMENT
REMOVAL**

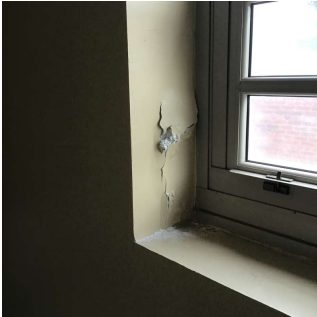
BULKHEAD/PENTHOUSE WALLS/INTERIOR: PLASTER
 CRACKS/SPALLING

REPLACE

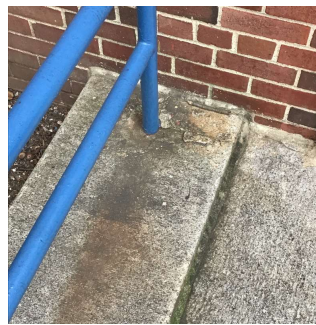
Facade A

STONE: CRACKS/SPALLING - MINOR

10
S.F.
REPAIR
PRIORITY 3
LEVEL 2

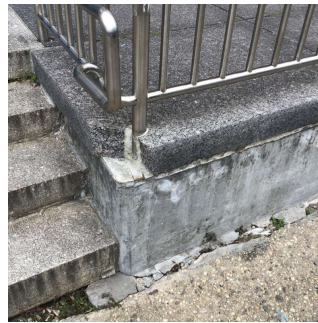
Facade H

STONE: CRACKS/SPALLING - MAJOR

30
S.F.
REPLACE
PRIORITY 4
LEVEL 2

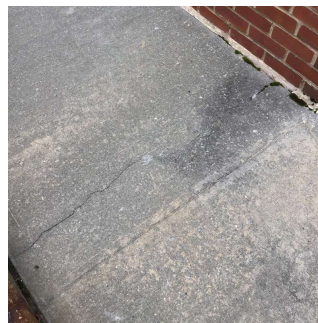
Facade F

CONCRETE: CRACKS/SPALLING - MINOR

REPAIR

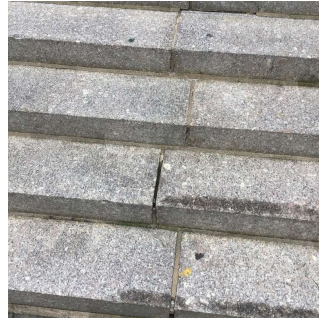
STONE: DETERIORATED JOINTS

Deficiency Quantity	100
Quantity Uom	L.F.
Potential Action	REPOINT
Urgency of Action	PRIORITY 3
Purpose of Action	LEVEL 2
Deficiency Photo1

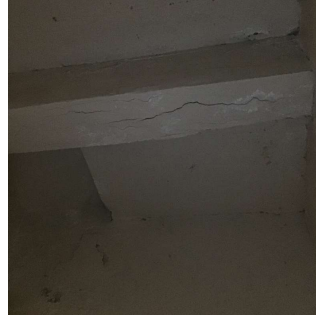
Violations	Boiler Room No violations recorded.
Slab Structure	
Material Type(s)	Inspected
Condition	3 - Fair
Deficiency	STEEL COLUMNS/BEAMS: DETERIORATED CONCRETE FIREPROOFING
Deficiency Location/Instance	Basement - Boiler Room

Deficiency Quantity	25
Quantity Uom	S.F.
Potential Action	REPAIR
Urgency of Action	PRIORITY 3
Purpose of Action	LEVEL 5

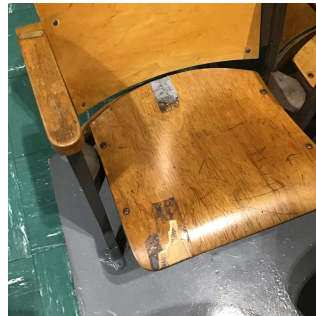
Seat Q/101

DAMAGED/BROKEN/INOPERABLE

REPLACE
