**NYC Department of Education**  
**Building Condition Assessment Survey 2023 - 2024**

Architectural Inspection

**Asset:** I.S. 204 - QUEENS, 36-41 28 STREET, New York, 11106

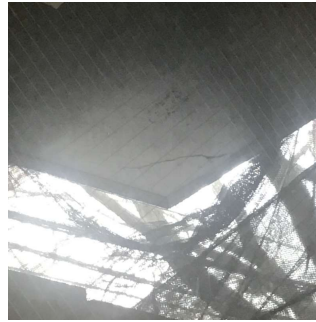
Facade A - Main Entrance  
No violations recorded.

CONCRETE: MAJOR CRACKS/SPALLING

REPAIR

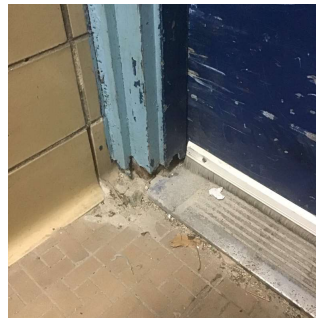
Facade F - Kitchen Exit  
No violations recorded.

**METAL: DETERIORATED DOOR AND FRAME - MAJOR DETERIORATION**

REPLACE

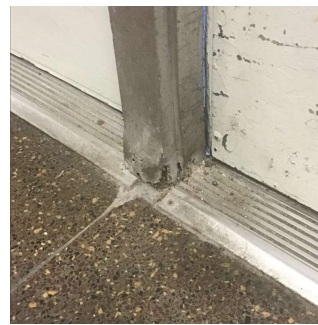
Facade A - Main Entrance  
No violations recorded.

**METAL CLAD: DETERIORATED DOOR AND FRAME - MAJOR DETERIORATION**

4  
EACH  
REPLACE  
PRIORITY 4  
LEVEL 2

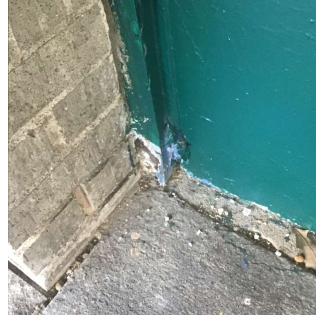
Facade A - Main Entrance  
No violations recorded.

METAL: DENTED, MAJOR RUSTING

30  
S.F.  
REPLACE

PRIORITY 4  
LEVEL 2

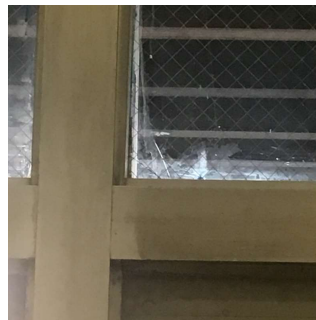
Facade A - Main Entrance  
No violations recorded.

**METAL: BROKEN GLASS**

10  
S.F.  
MAINTENANCE  
PRIORITY 3  
LEVEL 2

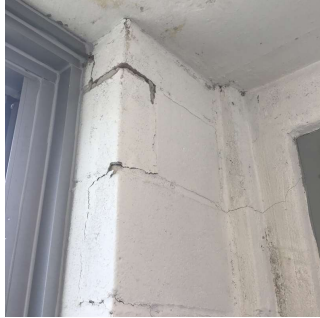
Inspected  
3 - Fair  
BULKHEAD/PENTHOUSE WALLS/INTERIOR: CMU  
CRACKS/SPALLING

30  
S.F.  
REPLACE

Question	Response
<b>EXTERIOR</b>	
<b>ROOF</b>	
<b>Specialties</b>	
<b>BULKHEAD/PENTHOUSE</b>	
Urgency of Action	PRIORITY 3
Purpose of Action	LEVEL 2
Deficiency Photo1

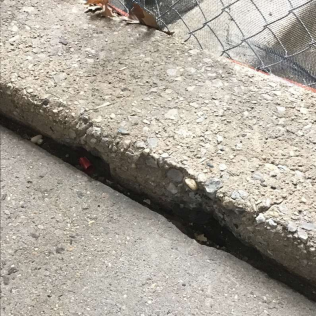
Question	Response
<b>EXTERIOR</b>	
<b>ROOF</b>	Inspected
Specialties	Inspected
<b>ROOF/GRAVITY TANK</b>	Does not Exist
<b>STAIRS/RAMPS: EXTERIOR</b>	Inspected
<b>BUILDING CHEEK/FLANK WALLS</b>	Inspected
Condition	2 - Between Good and Fair
Deficiency	CAST IN PLACE CONCRETE: CRACKS/SPALLING - MINOR
Roof Plan reference	<p>Q204</p>

Deficiency Quantity	10
Quantity Uom	S.F.
Potential Action	REPAIR
Urgency of Action	PRIORITY 3
Purpose of Action	LEVEL 2
Deficiency Photo1

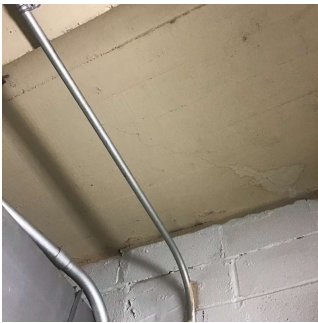
Question	Response
<b>INTERIOR</b>	Inspected
<b>POOLS</b>	Does not Exist
<b>STRUCTURAL</b>	Inspected
<b>COLUMNS/BEAMS/BEARING WALLS</b>	Inspected
Condition	2 - Between Good and Fair
Deficiency	No deficiencies recorded
<b>FLOOR STRUCTURE</b>	Inspected
Condition	3 - Fair
Deficiency	CONCRETE: CRACKS/SPALLED/REINFORCEMENT EXPOSED
Deficiency Location/Instance	Basement - Rooms B44, B52, B60
Deficiency Quantity	30
Quantity Uom	S.F.
Potential Action	REPAIR
Urgency of Action	PRIORITY 3
Purpose of Action	LEVEL 5
Deficiency Photo1

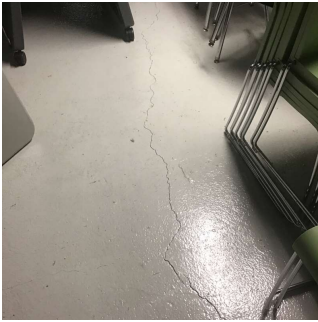
Violations	Basement - Room B44 No violations recorded.
Deficiency	CONCRETE SLAB ON GRADE: THRU CRACKS
Deficiency Location/Instance	Basement - Rooms B31, B52, B57, B60
Deficiency Quantity	300
Quantity Uom	S.F.
Potential Action	REPAIR
Urgency of Action	PRIORITY 3
Purpose of Action	LEVEL 5
Deficiency Photo1

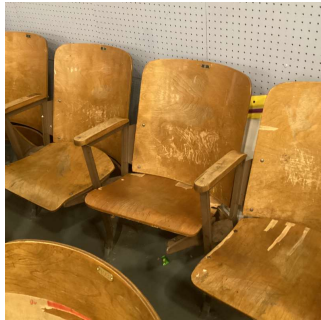
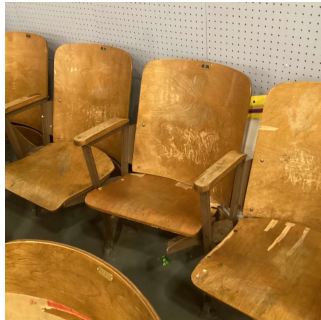
Seat U/6

Instance on 1st Floor (506 Seats)	Inspected
Condition	5 - Poor
Deficiency	DAMAGED/BROKEN/INOPERABLE
Deficiency Location/Instance	Seats U/6, I/8
Deficiency Quantity	2
Quantity Uom	EACH
Potential Action	REPLACE
Urgency of Action	PRIORITY 5
Purpose of Action	LEVEL 6
Deficiency Photo1

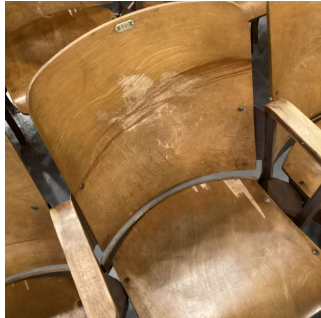
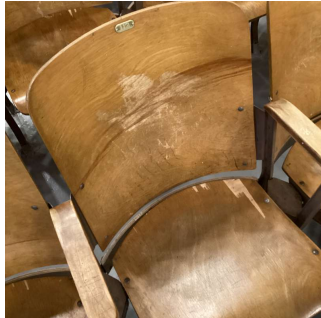
Seat F/112

Deficiency	DAMAGED/BROKEN/INOPERABLE
Deficiency Location/Instance	Seats F/103, 104, 105, 107, 112 and others
Deficiency Quantity	95
Quantity Uom	EACH
Potential Action	REPLACE
Urgency of Action	PRIORITY 3
Purpose of Action	LEVEL 2
Deficiency Photo1

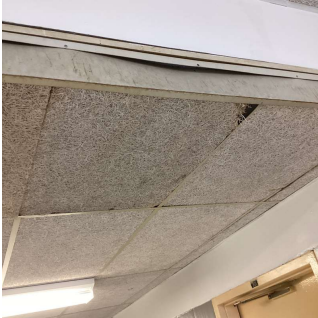
Question	Response
<b>INTERIOR</b>	
<b>CLASSROOMS/CORRIDORS/ADMIN SPACES</b>	
<b>Ceiling</b>	
Deficiency Location/Instance	Corridor near room 301
Deficiency Quantity	10
Quantity Uom	S.F.
Potential Action	REPLACE
Urgency of Action	PRIORITY 3
Purpose of Action	LEVEL 2
Deficiency Photo1

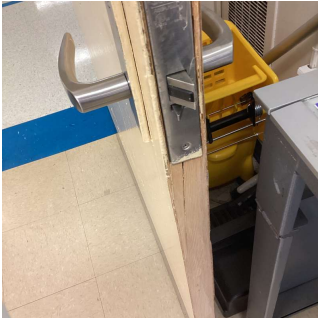
Violations	Corridor near room 301 No violations recorded.
<b>Door(s)</b>	Inspected
Condition	5 - Poor
Deficiency	WOOD: DETERIORATED DOOR
Deficiency Location/Instance	Rooms 317, 307, 252, 227, 225 and others
Deficiency Quantity	10
Quantity Uom	EACH
Potential Action	MAINTENANCE
Urgency of Action	PRIORITY 3
Purpose of Action	LEVEL 2
Deficiency Photo1

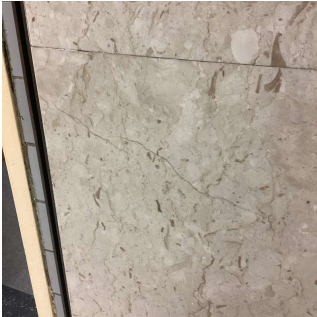
Question	Response
<b>INTERIOR</b>	
<b>CLASSROOMS/CORRIDORS/ADMIN SPACES</b>	
<b>Walls</b>	
Violations	Main Lobby No violations recorded.
Deficiency	STONE: CRACKS/SPALLING
Deficiency Location/Instance	Main Lobby
Deficiency Quantity	30
Quantity Uom	S.F.
Potential Action	REPLACE
Urgency of Action	PRIORITY 3
Purpose of Action	LEVEL 2
Deficiency Photo1

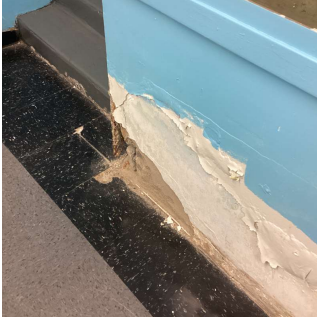
Violations	Main Lobby No violations recorded.
Deficiency	PLASTER: CRACKS/SPALLING
Deficiency Location/Instance	Room B22
Deficiency Quantity	20
Quantity Uom	S.F.
Potential Action	REPLACE
Urgency of Action	PRIORITY 3
Purpose of Action	LEVEL 2
Deficiency Photo1

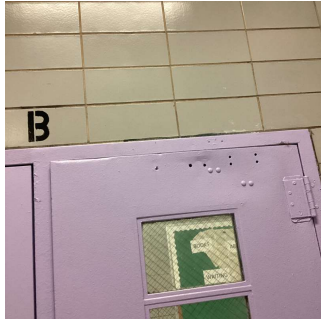
Deficiency	METAL: DETERIORATED DOOR
Deficiency Location/Instance	Stair B/Basement
Deficiency Quantity	1
Quantity Uom	EACH
Potential Action	MAINTENANCE
Urgency of Action	PRIORITY 3
Purpose of Action	LEVEL 2
Deficiency Photo1

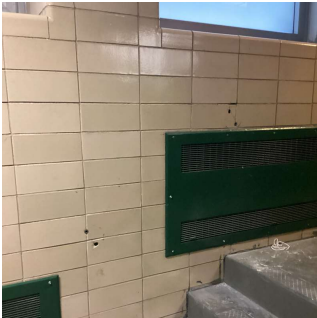
Violations	Stair C/Basement No violations recorded.
<b>Partition</b>	Does not Exist
<b>Railings</b>	Inspected
Condition	3 - Fair
Deficiency	METAL: MISSING
Deficiency Location/Instance	Boys Locker Room, Girls Locker Room
Deficiency Quantity	14
Quantity Uom	L.F.
Potential Action	REPLACE
Urgency of Action	PRIORITY 5
Purpose of Action	LEVEL 6
Deficiency Photo1

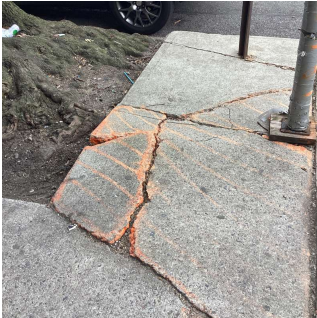
Question	Response
<b>SITE</b>	
<b>PAVING</b>	
<b>Site Sidewalks &amp; Walkways</b>	
<b>Concrete</b>	
Deficiency Quantity	75
Quantity Uom	S.F.
Potential Action	REPLACE
Urgency of Action	PRIORITY 3
Purpose of Action	LEVEL 2
Deficiency Photo1	 
	Exit 8
Violations	No violations recorded.
<b>Pavers</b>	Does not Exist
<b>DOT Sidewalk</b>	Inspected
<b>Asphalt</b>	Does not Exist
<b>Concrete</b>	Inspected
Condition	4 - Between Fair and Poor
Deficiency	HEAVING
Deficiency Location/Instance	28th Street
Deficiency Quantity	50
Quantity Uom	S.F.
Potential Action	REPLACE
Urgency of Action	PRIORITY 5
Purpose of Action	LEVEL 6
Deficiency Photo1

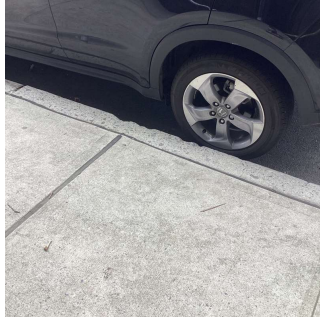
Priority Condition Exist Last Year?	Priority Category	Condition Description	Component Affected	Location Description	Person(s) Notified	Person(s) Title	PhotoImage
No	Tripping Hazard	Severely Damage Sidewalk resulting as potential tripping hazard	SITE   PAVING   DOT Sidewalk   Concrete	28th Street	Billy Fetter	Fireman

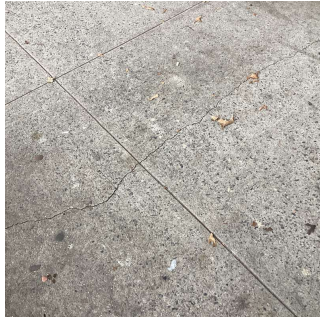
Violations	28th Street No violations recorded.
Deficiency	DAMAGED/DETERIORATED/MISSING SECTIONS
Deficiency Location/Instance	29st Street, 37th Avenue, 28th Street
Deficiency Quantity	750
Quantity Uom	S.F.
Potential Action	REPLACE
Urgency of Action	PRIORITY 3
Purpose of Action	LEVEL 2
Deficiency Photo1

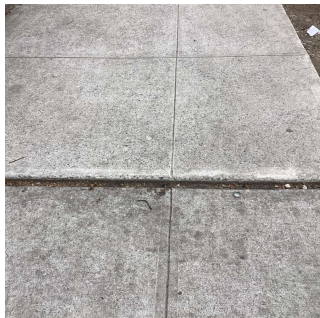
Violations	29st Street No violations recorded.
Deficiency	HEAVING
Deficiency Location/Instance	29th Street
Deficiency Quantity	50
Quantity Uom	S.F.
Potential Action	REPLACE
Urgency of Action	PRIORITY 3
Purpose of Action	LEVEL 2
Deficiency Photo1

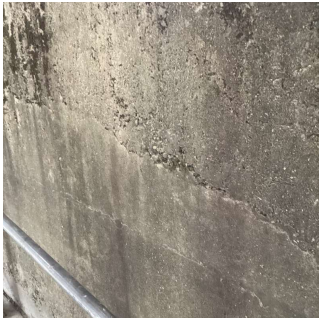
Violations	Near Schoolyard No violations recorded.
Deficiency	CAST IN PLACE CONCRETE: CRACKS/SPALLING - MAJOR
Deficiency Location/Instance	Near Schoolyard
Deficiency Quantity	25
Quantity Uom	S.F.
Potential Action	REPLACE
Urgency of Action	PRIORITY 3
Purpose of Action	LEVEL 2
Deficiency Photo1
