NYC Department of Education
Building Condition Assessment Survey 2023 - 2024

Architectural Inspection

Asset: P.S. 205 - QUEENS, 75-25 BELL BLVD, New York, 11364

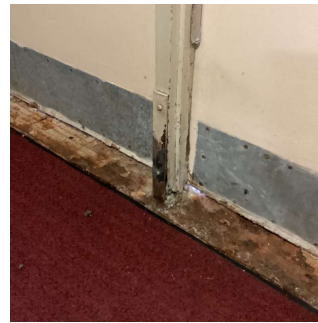
Facade E

METAL: DETERIORATED DOOR AND FRAME - MAJOR DETERIORATION

REPLACE

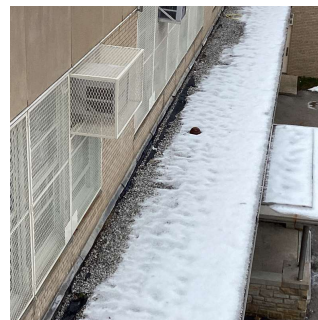
Roof 7

IRMA: ROOFING: MAJOR ACTIVE ROOF LEAKS IN INSTRUCTIONAL SPACE

200
S.F.
REPLACE ROOFING WITHOUT MAJOR EQUIPMENT
REMOVAL
PRIORITY 5
LEVEL 2

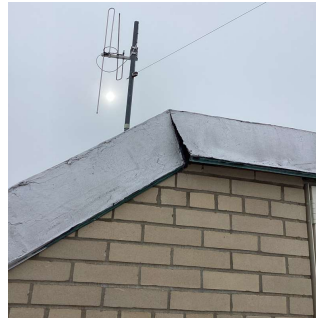
BH2

**BULKHEAD/PENTHOUSE WALLS/EXTERIOR:
CRACKS/SPALLING - MAJOR**

REPLACE

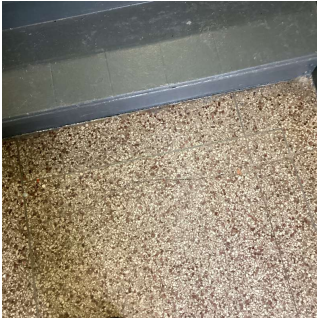
Question	Response
INTERIOR	
STAIRS/RAMPS: INTERIOR	
Stairs and Landings	
Deficiency	TERRAZZO: CRACKS
Deficiency Location/Instance	Stairs AB/2, C/1 Vestibule, D/2, E/2
Deficiency Quantity	40
Quantity Uom	S.F.
Potential Action	REPLACE
Urgency of Action	PRIORITY 3
Purpose of Action	LEVEL 2
Deficiency Photo1

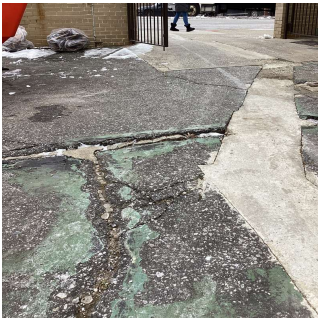
Condition	4 - Between Fair and Poor
Deficiency	HEAVING
Deficiency Location/Instance	Bell Boulevard courtyard
Deficiency Quantity	200
Quantity Uom	S.F.
Potential Action	REPLACE
Urgency of Action	PRIORITY 3
Purpose of Action	LEVEL 2
Deficiency Photo1

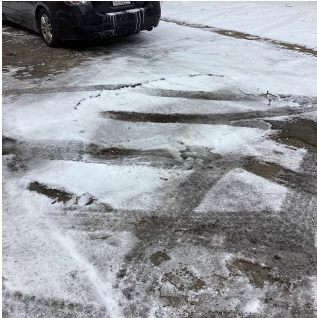
Question	Response
SITE	
PAVING	
Student Use	
Asphalt	
Violations	No violations recorded.
Deficiency	POTHOLES
Deficiency Location/Instance	Bell Boulevard courtyard
Deficiency Quantity	200
Quantity Uom	S.F.
Potential Action	REPAIR
Urgency of Action	PRIORITY 5
Purpose of Action	LEVEL 6
Deficiency Photo1

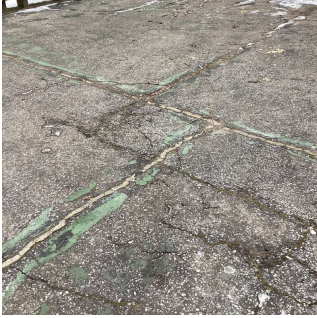
Violations	Bell Boulevard courtyard No violations recorded.
Deficiency	CRACKS - MAJOR
Deficiency Location/Instance	Bell Boulevard courtyard
Deficiency Quantity	2,200
Quantity Uom	S.F.
Potential Action	REPLACE
Urgency of Action	PRIORITY 3
Purpose of Action	LEVEL 2
Deficiency Photo1

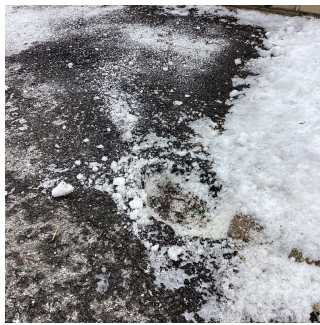
Yes	Tripping Hazard	Severely damaged asphalt pavement with large potholes is a potential tripping hazard.	SITE PLAYGROUNDS Pavement	Near Entrance	Julian Torres	Custodian

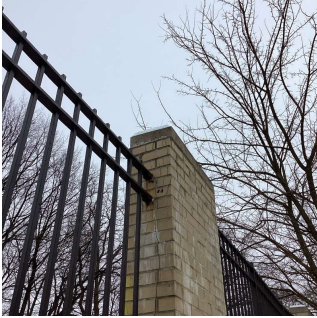
Priority Condition Exist Last Year?	Priority Category	Condition Description	Component Affected	Location Description	Person(s) Notified	Person(s) Title	PhotoImage
Yes	Potential Falling Debris	Severely damaged Brick Site wall is a potential safety hazard.	SITE SITE WALLS (NOT RETAINING WALLS)	217th Street	Julian Torres	Custodian

Violations	217th Street No violations recorded.
Deficiency	BRICK: BULGING/DISPLACED
Deficiency Location/Instance	217th Street
Deficiency Quantity	80
Quantity Uom	S.F.
Potential Action	REPLACE

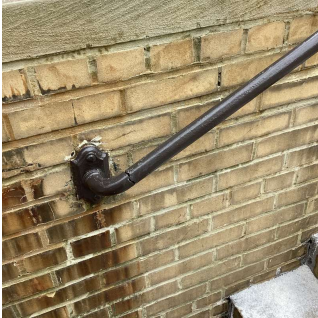
Question	Response
SITE	
STAIRS/RAMPS: EXTERIOR	Inspected
Railings	Inspected
Condition	3 - Fair
Deficiency	DAMAGED
Deficiency Location/Instance	77th Avenue
Deficiency Quantity	10
Quantity Uom	L.F.
Potential Action	REPLACE
Urgency of Action	PRIORITY 3
Purpose of Action	LEVEL 2
Deficiency Photo1
