**NYC Department of Education**  
**Building Condition Assessment Survey 2023 - 2024**

Architectural Inspection

Q206

**Asset:** P.S. 206 - QUEENS, 61-21 97TH PLACE, New York, 11374

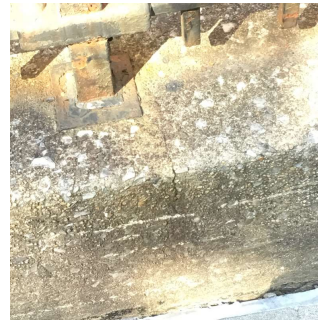
AW1

Question	Response
<b>Architectural</b>	
<b>EXTERIOR</b>	Inspected
<b>AREAWAY</b>	Inspected
Instance on AW1-AW2	Inspected
Instance Condition	4 - Between Fair and Poor
Instance Quantity	2
Instance Quantity Uom	EACH
Deficiency	AREAWAY WALLS: CRACKS AND SPALLING

REPAIR

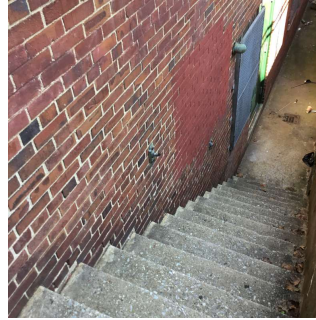
AW2

**AREAWAY STAIRS: DETERIORATED RAILINGS**

REPLACE

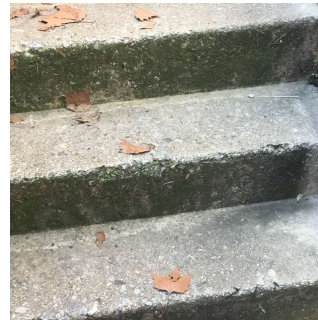
AW2

**AREAWAY STAIRS: DETERIORATED TREADS/RISERS/NOSINGS**

REPAIR

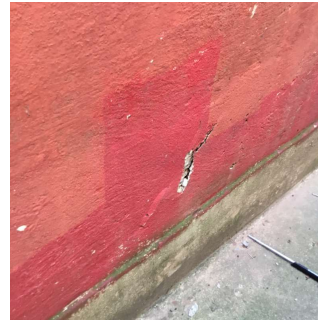
AW2

**AREAWAY WALLS: CRACKS AND SPALLING**

REPLACE

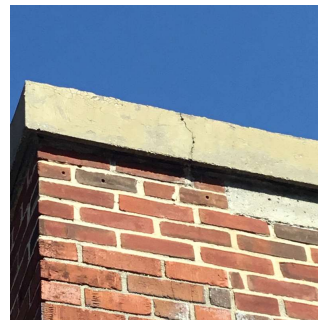
CH1

**BRICK: DETERIORATED CAP**

REPLACE

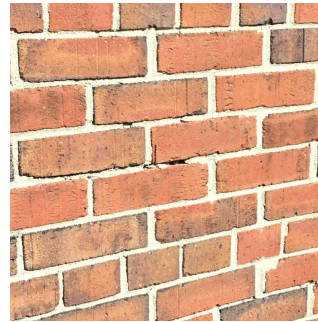
CH1

**BRICK: DETERIORATED JOINTS**

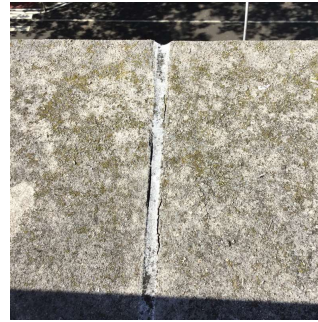
Roof 1

CAST STONE: DETERIORATED TRANSVERSE JOINTS

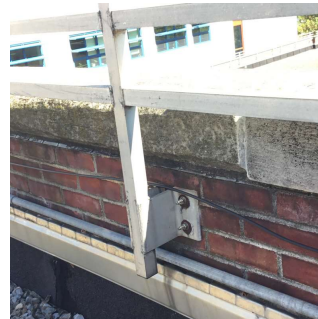
Roof 1

**CAST STONE: CRACKED/BROKEN PIECES**

REPLACE-IN-KIND

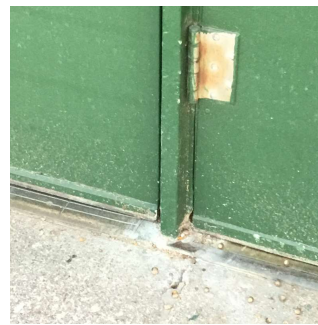
Facade J  
No violations recorded.

**METAL CLAD: DETERIORATED DOOR AND FRAME - MINOR DETERIORATION**

3  
EACH  
MAINTENANCE  
PRIORITY 3  
LEVEL 2

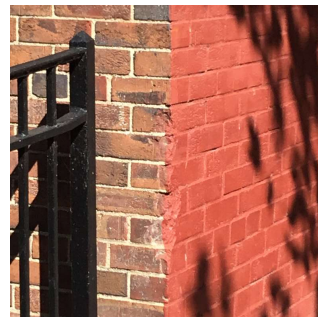
Facade Q

**BRICK: MINOR CRACKS AND SPALLING**

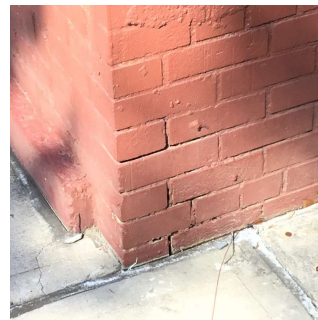
Facade K

**BRICK: DETERIORATED JOINTS**

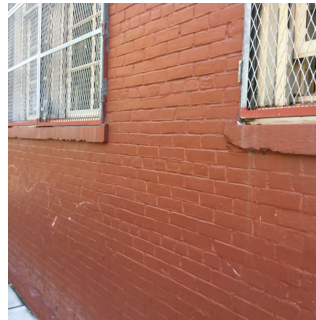
Facade N

**BRICK: DETERIORATED MASONRY SILLS - MAJOR**

REMOVE AND REPLACE

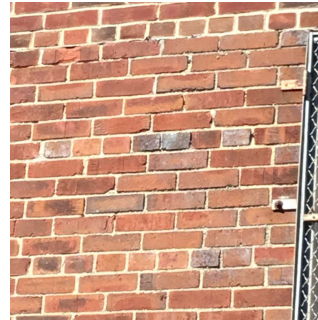
Facade M

**BRICK: DETERIORATED JOINTS**

PRIORITY 3  
LEVEL 2

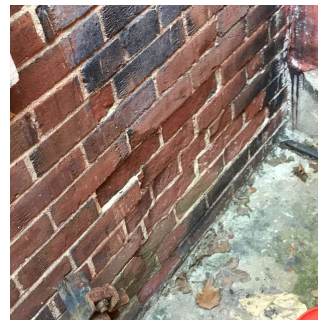
AW2

**BRICK: MAJOR / THRU CRACKS**

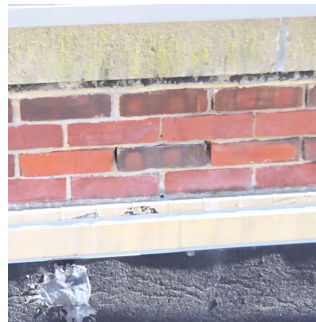
Roof 7  
 No violations recorded.

Inspected	
Material Type(s)	Masonry, Concrete
Replacement Quantity	7,200
Replacement Uom	C.F.
Instance on Original Building	Inspected
Instance Condition	3 - Fair
Instance Quantity	6,000
Instance Quantity Uom	C.F.
Deficiency	<b>BRICK: DETERIORATED JOINTS</b>
Roof Plan reference

40  
 S.F.  
 REPOINT  
 PRIORITY 4  
 LEVEL 2

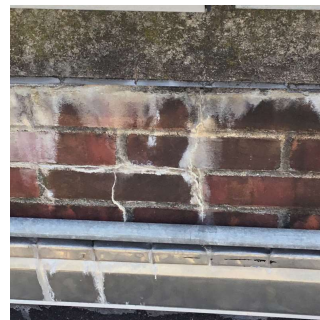
Roof 1

**BRICK: MINOR CRACKS, SPALLING**

30  
S.F.  
REPAIR  
PRIORITY 3  
LEVEL 2

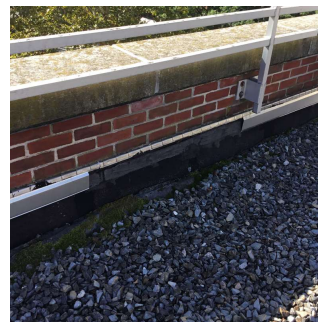
Roof 1  
No violations recorded.

Violations	No violations recorded.
Deficiency	<b>IRMA: FLASHING: CAP FLASHING MISSING</b>

10  
L.F.  
INSTALL NEW  
PRIORITY 4  
LEVEL 2

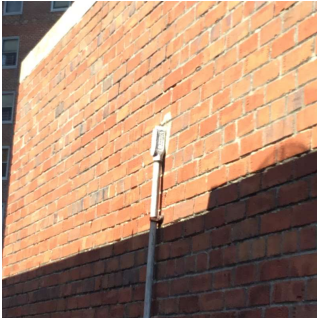
Violations	Roof 9 No violations recorded.
<b>Specialties</b>	Inspected
<b>BULKHEAD/PENTHOUSE</b>	Inspected
Condition	3 - Fair
Deficiency	BULKHEAD/PENTHOUSE WALLS/EXTERIOR: DETERIORATED JOINTS
Roof Plan reference	<p>Q206</p>

Deficiency Quantity	40
Quantity Uom	S.F.
Potential Action	REPOINT
Urgency of Action	PRIORITY 4
Purpose of Action	LEVEL 2
Deficiency Photo1

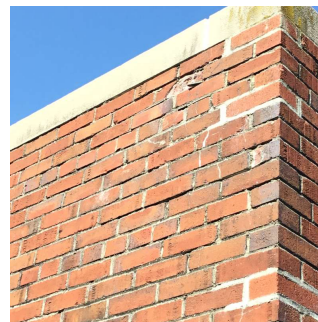
Violations	PH1 No violations recorded.
Deficiency	BULKHEAD/PENTHOUSE WALLS/EXTERIOR: CRACKS/SPALLING - MAJOR

20  
S.F.  
REPLACE  
PRIORITY 4  
LEVEL 2

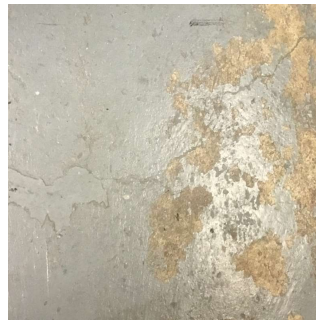
Boiler Room  
No violations recorded.

Deficiency	CONCRETE SLAB ON GRADE: THRU CRACKS
Deficiency Location/Instance	Basement
Deficiency Quantity	70
Quantity Uom	S.F.
Potential Action	REPAIR
Urgency of Action	PRIORITY 3
Purpose of Action	LEVEL 5
Deficiency Photo1

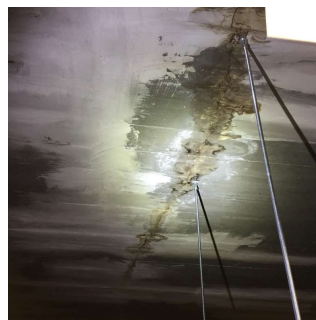
Deficiency	CONCRETE: CRACKS/SPALLED/REINFORCEMENT EXPOSED
Deficiency Location/Instance	Basement
Deficiency Quantity	300
Quantity Uom	S.F.
Potential Action	REPAIR
Urgency of Action	PRIORITY 3
Purpose of Action	LEVEL 5
Deficiency Photo1

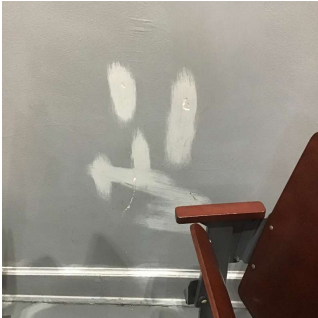
Question	Response
<b>INTERIOR</b>	
<b>AUDITORIUM</b>	
<b>Walls</b>	
Deficiency	PLASTER: CRACKS/SPALLING
Deficiency Location/Instance	Near Seat E/12
Deficiency Quantity	10
Quantity Uom	S.F.
Potential Action	REPLACE
Urgency of Action	PRIORITY 3
Purpose of Action	LEVEL 2
Deficiency Photo1

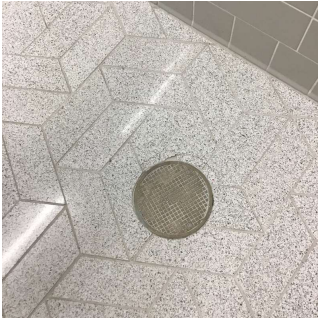
Violations	Room 200 No violations recorded.
<b>Floor Finish</b>	Inspected
Condition	3 - Fair
Deficiency	CERAMIC TILE: BROKEN/MISSING TILES
Deficiency Location/Instance	Corridor near Room 128
Deficiency Quantity	10
Quantity Uom	S.F.
Potential Action	REPLACE
Urgency of Action	PRIORITY 3
Purpose of Action	LEVEL 2
Deficiency Photo1

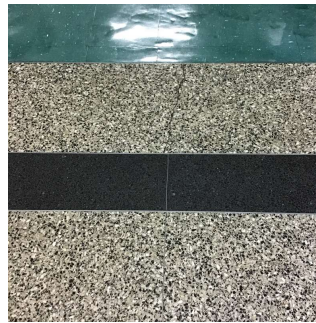
Corridor near Room 110

Violations	Corridor near Room 128 No violations recorded.
Deficiency	TERRAZZO: CRACKS
Deficiency Location/Instance	Corridor near Room 110, Near Left Side Gymnasium Entrance.
Deficiency Quantity	20
Quantity Uom	S.F.

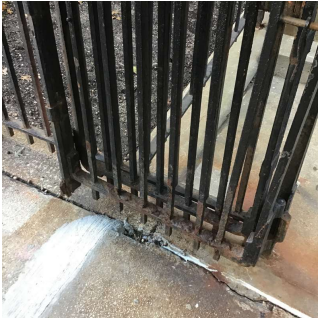
Question	Response
<b>SITE</b>	
<b>DRINKING FOUNTAINS</b>	
Deficiency	INOPERABLE
Deficiency Location/Instance	Near Park
Deficiency Quantity	1
Quantity Uom	EACH
Potential Action	MAINTENANCE
Urgency of Action	PRIORITY 3
Purpose of Action	LEVEL 2
Deficiency Photo1	 
Violations	Near Park No violations recorded.
<b>FENCES</b>	
Condition	Inspected 3 - Fair
Deficiency	WROUGHT IRON: RUST - MAJOR
Deficiency Location/Instance	97th place
Deficiency Quantity	100
Quantity Uom	S.F.
Potential Action	REPLACE
Urgency of Action	PRIORITY 3
Purpose of Action	LEVEL 2
Deficiency Photo1
