**NYC Department of Education**  
**Building Condition Assessment Survey 2023 - 2024**

Architectural Inspection

**Asset:** P.S./I.S. 208 - QUEENS, 74-30 COMMONWEALTH BLVD, New York, 11426

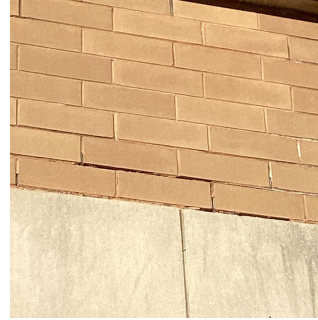
Facade C

CAST IN PLACE / PRE-CAST CONCRETE: DETERIORATED JOINTS

10  
L.F.  
REPOINT  
PRIORITY 3  
LEVEL 2

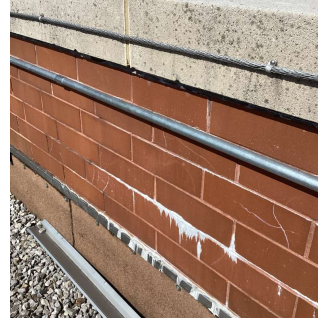
Roof 1 - Bulkhead 2

**BRICK: DETERIORATED JOINTS**

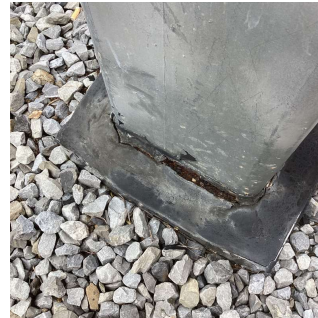
Roof 1

IRMA: FLASHING: CAP FLASHING MISSING

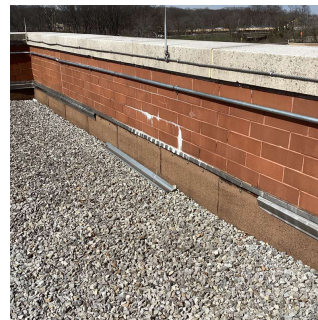
Roof 1 - Bulkhead 2

IRMA: ROOFING: DAMAGED INSULATION

50  
S.F.  
REPLACE  
PRIORITY 4  
LEVEL 2

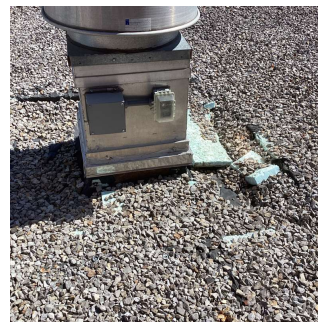
Roof 1  
No violations recorded.

IRMA: ROOFING: MAJOR ACTIVE ROOF LEAKS IN INSTRUCTIONAL SPACE

400  
S.F.  
REPLACE ROOFING WITHOUT MAJOR EQUIPMENT  
REMOVAL  
PRIORITY 5  
LEVEL 2

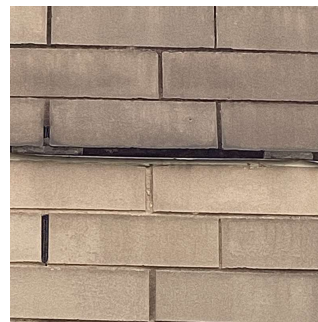
Roof 4 - Penthouse

**BULKHEAD/PENTHOUSE WALLS/EXTERIOR: DETERIORATED JOINTS**

20  
S.F.  
REPOINT  
PRIORITY 3  
LEVEL 2

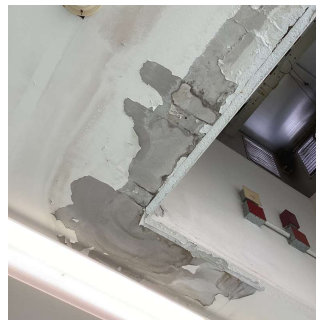
Roof 1 - Bulkhead 1

**BULKHEAD/PENTHOUSE ROOF: MAJOR LEAKAGE**

100  
S.F.  
REPLACE  
PRIORITY 5  
LEVEL 2

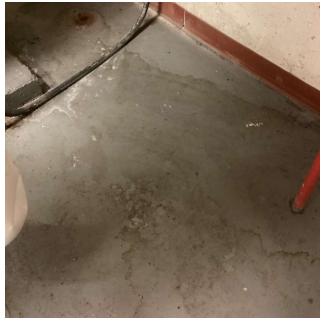
Basement - Room C2
Violations	No violations recorded.
Deficiency	CONCRETE SLAB ON GRADE: THRU CRACKS
Deficiency Location/Instance	Basement - Room C2

Deficiency Quantity	10
Quantity Uom	S.F.
Potential Action	REPAIR
Urgency of Action	PRIORITY 3

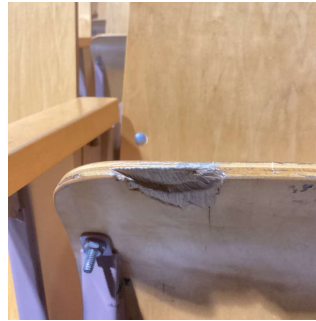
Seat B/115

DAMAGED/BROKEN/INOPERABLE

REPLACE

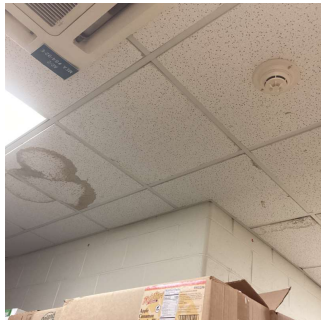
Violations	No violations recorded.
Deficiency	ACOUSTIC TILES: DAMAGED/MISSING
Deficiency Location/Instance	Room 108K
Deficiency Quantity	10
Quantity Uom	S.F.
Potential Action	REPLACE
Urgency of Action	PRIORITY 3
Purpose of Action	LEVEL 2
