NYC Department of Education
Building Condition Assessment Survey 2023 - 2024

Architectural Inspection

Asset: P.S. 209 - QUEENS, 16-10 UTOPIA PKWY, New York, 11357

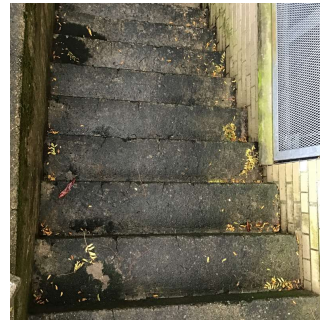
Question	Response
Architectural	
EXTERIOR	Inspected
AREAWAY	Inspected
Instance on AW1 - AW3	Inspected
Instance Condition	3 - Fair
Instance Quantity	3
Instance Quantity Uom	EACH
Deficiency	AREAWAY STAIRS: DETERIORATED TREADS/RISERS/NOSINGS

REPAIR

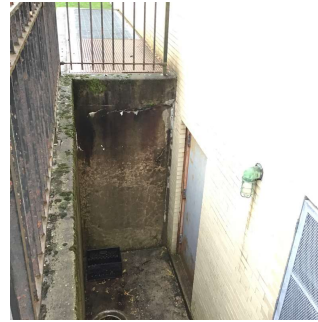
AW2
No violations recorded.

AREAWAY WALLS: CRACKS AND SPALLING

REPAIR

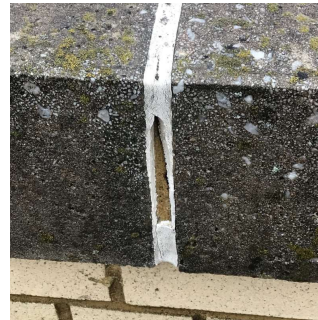
Roof 1 and 2
No violations recorded.

CAST STONE: DETERIORATED TRANSVERSE JOINTS

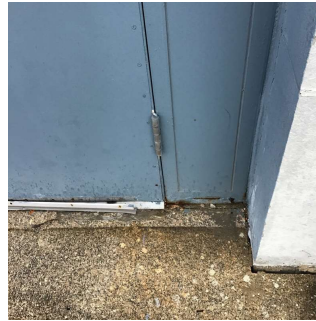
Facade B, G and I

METAL CLAD: DETERIORATED DOOR - MAJOR DETERIORATION

7
EACH
REPLACE
PRIORITY 4
LEVEL 2

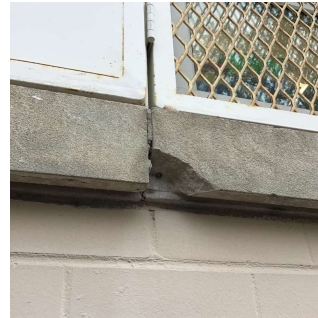
Facade D

BRICK: DETERIORATED MASONRY SILLS - MAJOR

REMOVE AND REPLACE

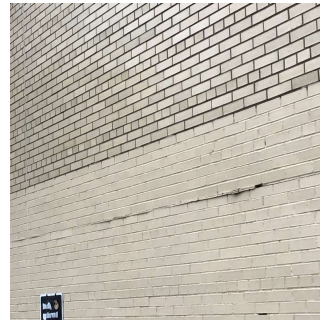
16th Road

BRICK: DETERIORATED JOINTS

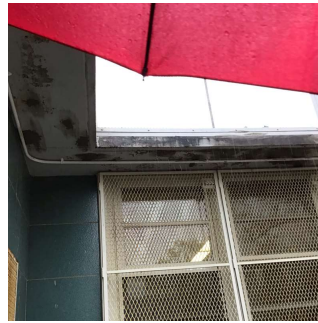
Facade C and D

CONCRETE: DETERIORATED

Quantity Uom	S.F.
Potential Action	REPLACE
Urgency of Action	PRIORITY 4
Purpose of Action	LEVEL 2
Deficiency Photo1

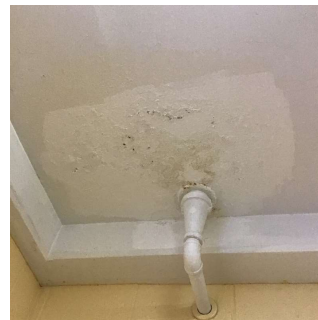
Roof 1 - Room 319

BUILT-UP: ROOFING: MAJOR ACTIVE ROOF LEAKS IN INSTRUCTIONAL SPACE

REPLACE ROOFING WITHOUT MAJOR EQUIPMENT REMOVAL

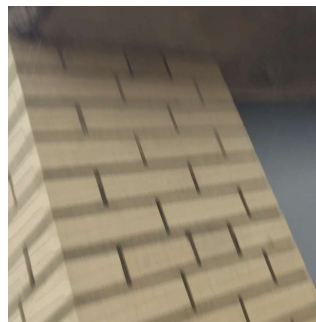
BH1 and 2
 No violations recorded.

**BULKHEAD/PENTHOUSE WALLS/EXTERIOR: DETERIORATED
JOINTS**

400
 S.F.
 REPOINT
 PRIORITY 3
 LEVEL 2

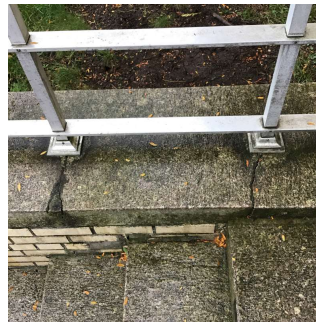
Facade G - Entrance 5 and 6

Deficiency	STONE: CRACKS/SPALLING - MAJOR
------------	--------------------------------

Deficiency Quantity	30
Quantity Uom	S.F.
Potential Action	REPLACE
Urgency of Action	PRIORITY 4
Purpose of Action	LEVEL 2

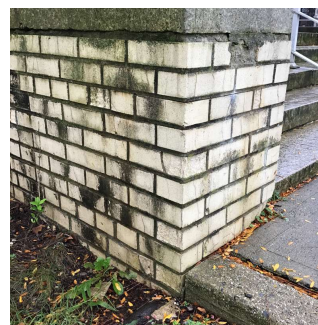
Facade G - Entrance 5 and 6

BRICK: CRACKS/SPALLING - MAJOR

REPLACE

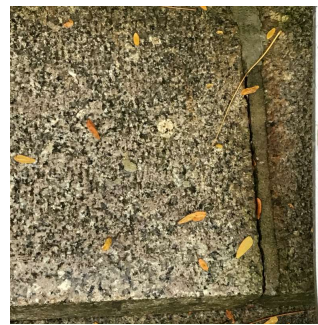
Facade G - Entrance 5 and 6
No violations recorded.

STONE: DETERIORATED JOINTS

10
L.F.
REPOINT
PRIORITY 3
LEVEL 2

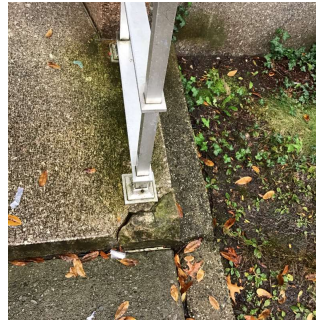
16th Avenue - Exit 7, 8

CONCRETE: CRACKS/SPALLING - MAJOR

20
S.F.
REPLACE
PRIORITY 4
LEVEL 2

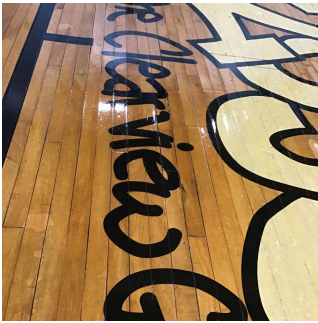
Deficiency	WOOD: DAMAGED/DETERIORATED
Deficiency Location/Instance	Near the Drinking Fountain (minor warping)
Deficiency Quantity	20
Quantity Uom	S.F.
Potential Action	REPLACE
Urgency of Action	PRIORITY 3
Purpose of Action	LEVEL 2

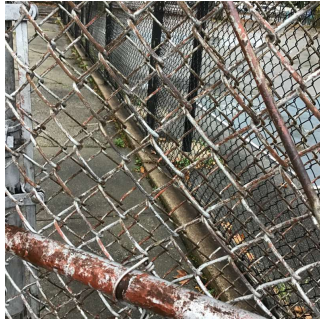
Violations	16th Road No violations recorded.
Deficiency	CHAIN LINK: RUST - MAJOR
Deficiency Location/Instance	16th Avenue
Deficiency Quantity	200
Quantity Uom	S.F.
Potential Action	REPLACE
Urgency of Action	PRIORITY 3
Purpose of Action	LEVEL 2
Deficiency Photo1
