NYC Department of Education
Building Condition Assessment Survey 2023 - 2024

Architectural Inspection

Asset: P.S. 212 - QUEENS, 34-25 82ND STREET, New York, 11372

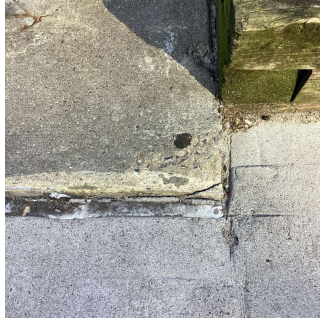
Question	Response
Architectural	
EXTERIOR	Inspected
AREAWAY	Inspected
Instance on AW1-AW3	Inspected
Instance Condition	3 - Fair
Instance Quantity	3
Instance Quantity Uom	EACH
Deficiency	AREAWAY WALLS: CRACKS AND SPALLING
Roof Plan reference	Q212

Deficiency Quantity	30
Quantity Uom	S.F.

Question	Response
EXTERIOR	
AREAWAY	
Potential Action	REPAIR
Urgency of Action	PRIORITY 3
Purpose of Action	LEVEL 2
Deficiency Photo1

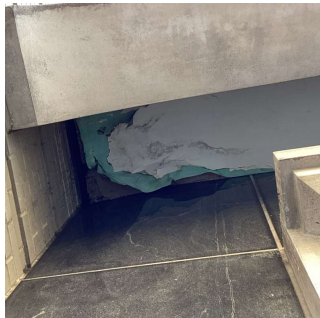
Violations	AW1 No violations recorded.
AWNINGS AND CANOPIES	
Condition	Inspected 3 - Fair
Deficiency	CONCRETE: MAJOR CRACKS/SPALLING
Roof Plan reference	Q212
Deficiency Quantity	20
Quantity Uom	S.F.
Potential Action	REPAIR
Urgency of Action	PRIORITY 5
Purpose of Action	LEVEL 6
Deficiency Photo1

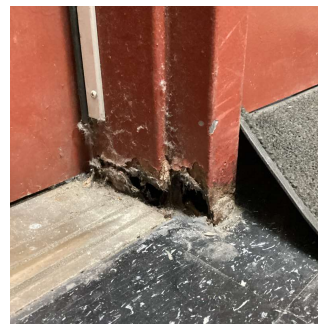
Facade A

Question	Response
EXTERIOR	
COPING	
Deficiency Photo1	 
Violations	Roof 2 No violations recorded.
Deficiency	CAST STONE: DISINTEGRATING / FREEZE THAW
Roof Plan reference	Q212  
Deficiency Quantity	80
Quantity Uom	L.F.
Potential Action	REPLACE-IN-KIND
Urgency of Action	PRIORITY 4
Purpose of Action	LEVEL 2
Deficiency Photo1	 
Violations	Roof 2 No violations recorded.
CORNICE	Inspected
Condition	2 - Between Good and Fair
Deficiency	No deficiencies recorded
DOORS	Inspected
DOORS AND FRAMES	Inspected
Condition	4 - Between Fair and Poor
Deficiency	METAL: DETERIORATED DOOR AND FRAME - MAJOR DETERIORATION

3
EACH
REPLACE
PRIORITY 4
LEVEL 2

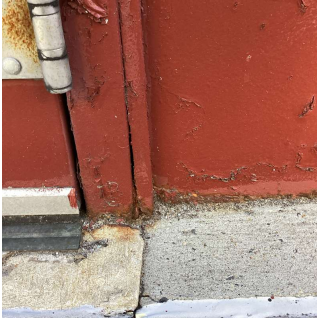
METAL: DENTED, MAJOR RUSTING

10
S.F.
REPLACE

Question	Response
EXTERIOR	
DOORS	
TRANSOM/SIDE LIGHT	
Urgency of Action	PRIORITY 4
Purpose of Action	LEVEL 2
Deficiency Photo1

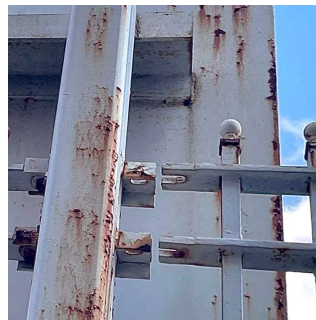
Plaza Deck

Deficiency RAILINGS/PANELS: DETERIORATED, MAJOR RUSTING

30
 S.F.
 REPLACE
 PRIORITY 4
 LEVEL 2

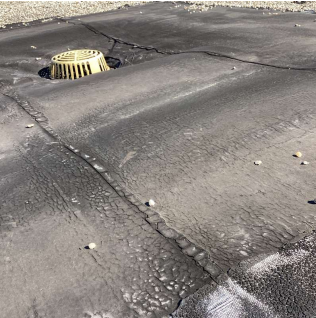
Question	Response
EXTERIOR	
ROOF	
Roofing	
ROOFING	
	Roof 2
Instance Quantity	12,000
Instance Quantity Uom	S.F.
Does the roof have major mechanical equipment sitting on Dunnage Steel less than 18" above the Roofing?	No
Does this roof instance have a Sustainable Roof System?	No
Do solar panels exist on these roofs?	No
Is/Are the roof(s) suitable for Solar Panel installation?	No
Installation Year	2000
Source of Installation	Custodial Staff
Deficiency	BUILT-UP: ROOFING: DELAMINATION
Roof Plan reference	Q212

Deficiency Quantity	40
Quantity Uom	S.F.
Potential Action	REPLACE ROOFING WITHOUT MAJOR EQUIPMENT REMOVAL
Urgency of Action	PRIORITY 4
Purpose of Action	LEVEL 2
Deficiency Photo1

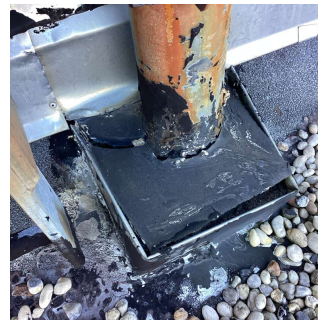
Roof 2

BUILT-UP: FLASHING: PITCH POCKET DETERIORATED - MAJOR

1
EACH
REPLACE
PRIORITY 4
LEVEL 2

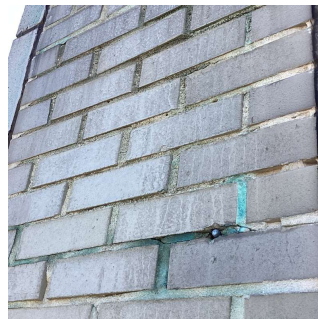
BULKHEAD/PENTHOUSE WALLS/EXTERIOR: DETERIORATED JOINTS

40
S.F.
REPOINT
PRIORITY 3
LEVEL 2

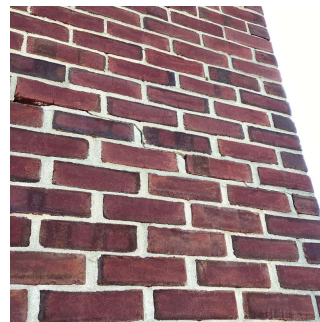
BULKHEAD/PENTHOUSE WALLS/EXTERIOR:
CRACKS/SPALLING - MAJOR

20
S.F.
REPLACE
PRIORITY 4
LEVEL 2

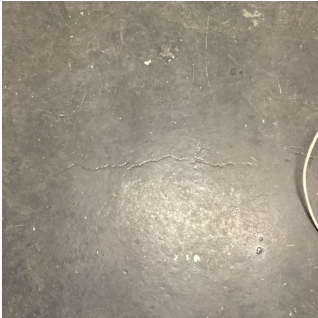
Question	Response
INTERIOR	
STRUCTURAL	Inspected
COLUMNS/BEAMS/BEARING WALLS	Inspected
Condition	2 - Between Good and Fair
Deficiency	No deficiencies recorded
FLOOR STRUCTURE	Inspected
Condition	3 - Fair
Deficiency	CONCRETE: CRACKS/SPALLED/REINFORCEMENT EXPOSED
Deficiency Location/Instance	PH, Fire Pump Room, Electrical Panel Room
Deficiency Quantity	40
Quantity Uom	S.F.
Potential Action	REPAIR
Urgency of Action	PRIORITY 3
Purpose of Action	LEVEL 5
Deficiency Photo1

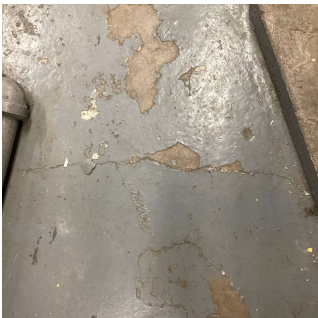
Violations	PH No violations recorded.
Deficiency	CONCRETE SLAB ON GRADE: THRU CRACKS
Deficiency Location/Instance	Boiler Room
Deficiency Quantity	40
Quantity Uom	S.F.
Potential Action	REPAIR
Urgency of Action	PRIORITY 3
Purpose of Action	LEVEL 5
Deficiency Photo1

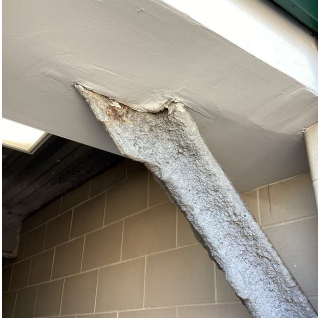
Question	Response
INTERIOR	
STRUCTURAL	
FOUNDATION WALLS	
Quantity Uom	S.F.
Potential Action	REPAIR
Urgency of Action	PRIORITY 3
Purpose of Action	LEVEL 5
Deficiency Photo1	 
Violations	Boiler Room No violations recorded.
ROOF STRUCTURE	
Condition	Inspected
Deficiency	2 - Between Good and Fair
Deficiency Location/Instance	STEEL COLUMNS/BEAMS: DETERIORATED/MISSING SPRAY-ON FIREPROOFING
Deficiency Quantity	BH1, PH
Quantity Uom	10
Potential Action	S.F.
Urgency of Action	REPLACE
Purpose of Action	PRIORITY 3
Deficiency Photo1	LEVEL 5

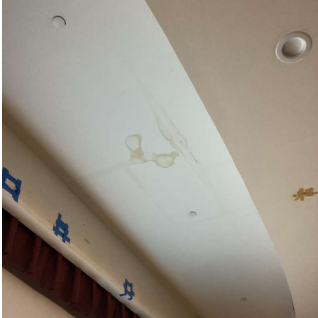
Violations	BH1 No violations recorded.
VAULTS-BUNKERS	
Does not Exist	
AUDITORIUM	
Inspected	
Instance on 1st Floor (300 Seats)	Inspected
Ceiling	
Instance on 1st Floor (300 Seats)	Inspected
Condition	2 - Between Good and Fair
Deficiency	GYPSUM BOARD: DAMAGED/DETERIORATED
Deficiency Location/Instance	Left and Right Side, Near Stage, Center
Deficiency Quantity	60
Quantity Uom	S.F.
Potential Action	REPLACE

Question	Response
INTERIOR	
AUDITORIUM	
Ceiling	
Urgency of Action	PRIORITY 3
Purpose of Action	LEVEL 2
Deficiency Photo1

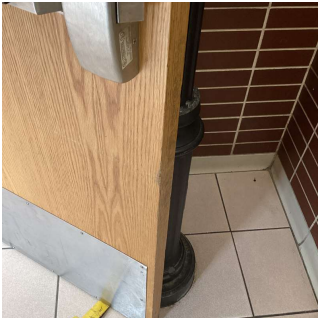
Near Stage
Violations	No violations recorded.
Door(s)	
Instance on 1st Floor (300 Seats)	Inspected
Condition	3 - Fair
Deficiency	WOOD: DETERIORATED DOOR
Deficiency Location/Instance	Main Entrance
Deficiency Quantity	1
Quantity Uom	EACH
Potential Action	MAINTENANCE
Urgency of Action	PRIORITY 3
Purpose of Action	LEVEL 2
Deficiency Photo1

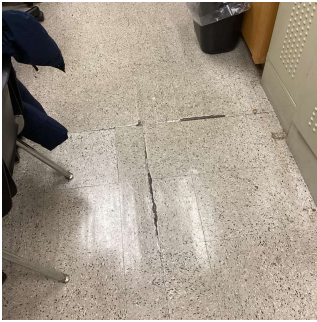
Seat J/1
Violations	No violations recorded.
Floor Finish	
Instance on 1st Floor (300 Seats)	Inspected
Condition	2 - Between Good and Fair
Deficiency	VINYL TILES: DETERIORATED SUBSTRATE
Deficiency Location/Instance	Room 133, Near Entrance
Deficiency Quantity	40
Quantity Uom	S.F.
Potential Action	REPLACE
Urgency of Action	PRIORITY 3
Purpose of Action	LEVEL 2
Deficiency Photo1

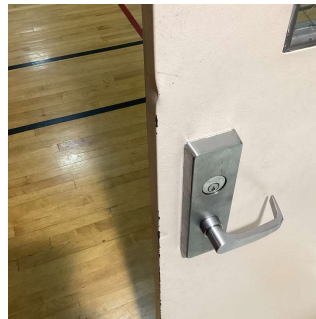
Instance on Sub-Basement	Inspected
Condition	3 - Fair
Deficiency	METAL: DETERIORATED DOOR
Deficiency Location/Instance	Main Entrance
Deficiency Quantity	1
Quantity Uom	EACH
Potential Action	MAINTENANCE
Urgency of Action	PRIORITY 3
Purpose of Action	LEVEL 2
Deficiency Photo1

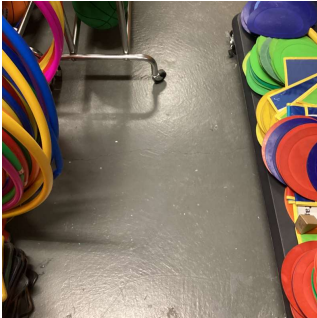
Near Drinking Fountain
Violations	No violations recorded.
Deficiency	CONCRETE: CRACKS
Deficiency Location/Instance	Storage Room
Deficiency Quantity	25
Quantity Uom	S.F.
Potential Action	REPLACE
Urgency of Action	PRIORITY 3
Purpose of Action	LEVEL 2
Deficiency Photo1

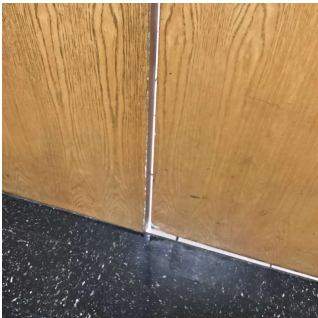
Stair B/Sub-Basement
Violations	No violations recorded.
Door(s)	Inspected
Condition	5 - Poor
Deficiency	WOOD: DETERIORATED DOOR
Deficiency Location/Instance	Stairs A/1, B/1, C/1
Deficiency Quantity	4
Quantity Uom	EACH
Potential Action	MAINTENANCE
Urgency of Action	PRIORITY 3
Purpose of Action	LEVEL 2
Deficiency Photo1

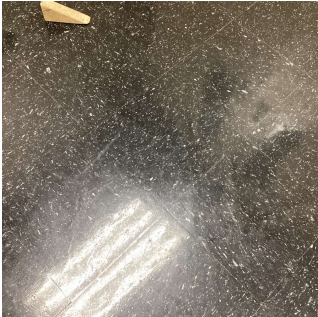
Stair B/Sub-Basement
Violations	No violations recorded.
Deficiency	VINYL TILES: DETERIORATED SUBSTRATE
Deficiency Location/Instance	Stairs A/1, 2, B/2, 4, C/1 and others
Deficiency Quantity	50
Quantity Uom	S.F.
Potential Action	REPLACE
Urgency of Action	PRIORITY 3
Purpose of Action	LEVEL 2
Deficiency Photo1

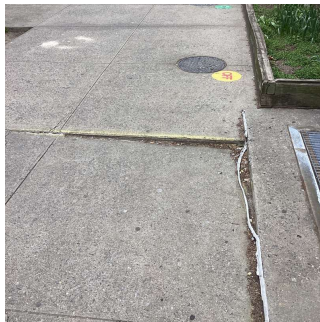
83rd Street
Violations	No violations recorded.
Pavers	Does not Exist
DOT Sidewalk	Inspected
Asphalt	Does not Exist
Concrete	Inspected
Condition	4 - Between Fair and Poor
Deficiency	HEAVING
Deficiency Location/Instance	82nd Street
Deficiency Quantity	175
Quantity Uom	S.F.
Potential Action	REPLACE
Urgency of Action	PRIORITY 3
Purpose of Action	LEVEL 2
Deficiency Photo1

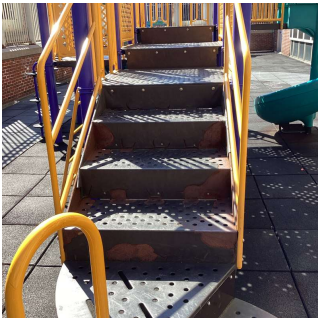
Violations	Near Exit 3 No violations recorded.
Play Equipment	
Instance on 2nd Floor Plaza Deck	Inspected
Condition	5 - Poor
Deficiency	BROKEN/DETERIORATED/MISSING
Deficiency Location/Instance	North Side
Deficiency Quantity	1
Quantity Uom	EACH
Potential Action	REPLACE
Urgency of Action	PRIORITY 3
Purpose of Action	LEVEL 2
Deficiency Photo1

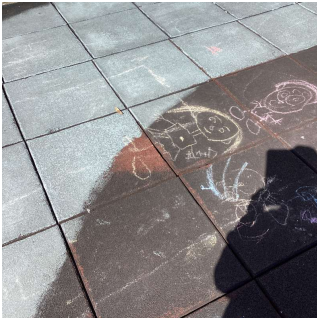
Near Entrance
Violations	No violations recorded.
Instance on 2nd Floor Plaza Deck	Inspected
Condition	3 - Fair
Deficiency	DETERIORATED/MISSING
Deficiency Location/Instance	Near Entrance, Center, Rear
Deficiency Quantity	50
Quantity Uom	S.F.
Potential Action	REPLACE
Urgency of Action	PRIORITY 3
Purpose of Action	LEVEL 2
Deficiency Photo1
