NYC Department of Education
Building Condition Assessment Survey 2023 - 2024

Architectural Inspection

Asset: P.S. 214 - QUEENS, 31-15 140 STREET, New York, 11354

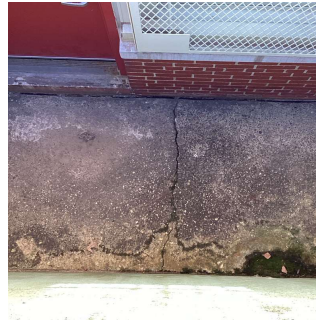
AW2

| Question | Response |
|---|---|
| Deficiency | AREAWAY SLAB: CRACKS AND SPALLING |

| Question | Response |
|---|---|
| Potential Action | REPLACE |

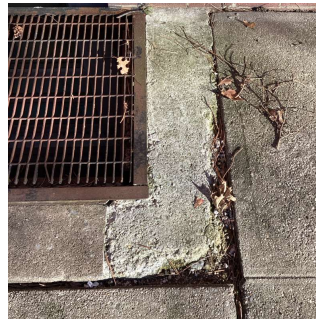
AW1

AREAWAY WALLS: CRACKS AND SPALLING

REPLACE

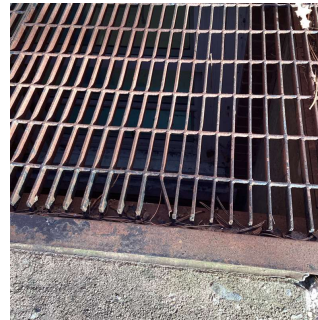
AW1

AREAWAY GRATINGS: MAJOR RUSTING / OR BROKEN

REPLACE

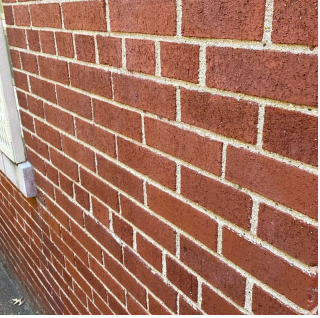
| Question | Response |
|---|---|
| Deficiency | BRICK: DETERIORATED JOINTS |

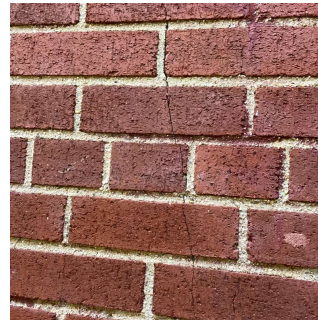
Facade K

| Question | Response |
|---|---|
| Deficiency | BRICK: MINOR CRACKS AND SPALLING |

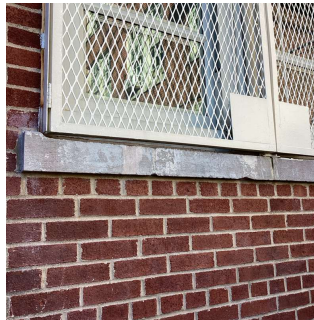
Facade J

BRICK: DETERIORATED MASONRY SILLS - MINOR

REPAIR

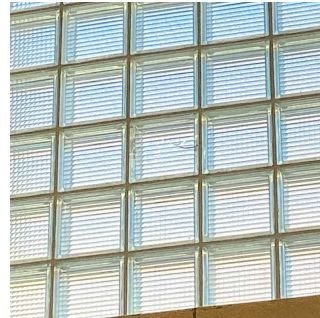
Facade E - Gymnasium

GLASS BLOCK: CHIPPED/ BROKEN PIECES

REPLACE-IN-KIND

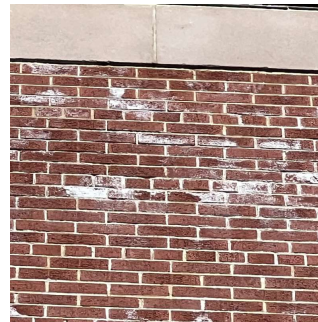
Roof 1

BRICK: DETERIORATED JOINTS

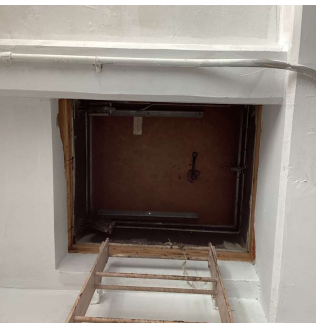
| Question | Response |
|---|--|
| Deficiency | DETERIORATED |

| Question | Response |
|---|--|
| Potential Action | REPLACE |

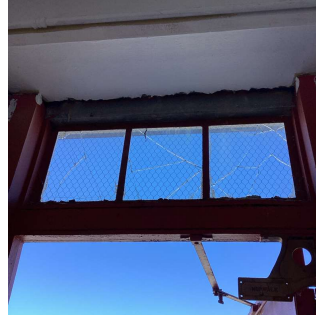
PH

| Question | Response |
|---|--|
| Deficiency | BULKHEAD/PENTHOUSE WINDOWS: DAMAGED, DETERIORATED WINDOWS |

| Question | Response |
|---|--|
| Potential Action | REPLACE |

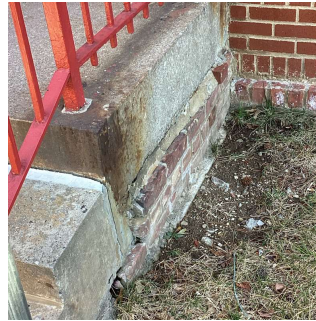
Facade A

| Question | Response |
|---|--|
| Deficiency | BRICK: BULGING/DISPLACED |

| Question | Response |
|---|--|
| Potential Action | REPLACE |

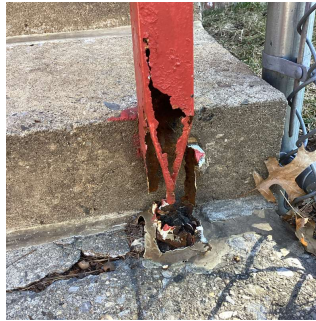
Facade A

RUST - MAJOR

REPLACE

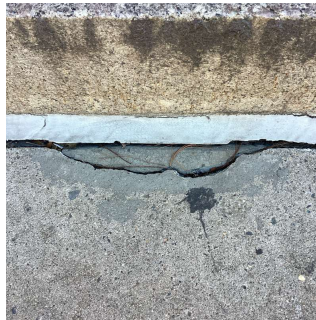
Facade A

CONCRETE: CRACKS/SPALLING - MAJOR

REPLACE

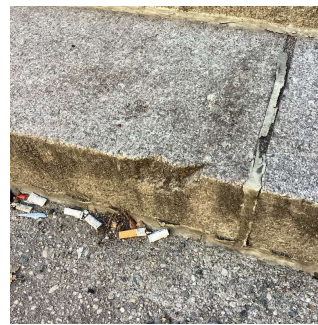
Facade J

STONE: CRACKS/SPALLING - MINOR

10
S.F.
REPAIR
PRIORITY 3
LEVEL 2

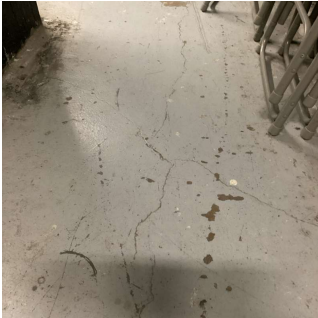
| Question | Response |
|---|--|
| Deficiency | CONCRETE SLAB ON GRADE: THRU CRACKS |
| Deficiency Location/Instance | Basement - Fan Room |

| Question | Response |
|---|--|
| Potential Action | REPAIR |

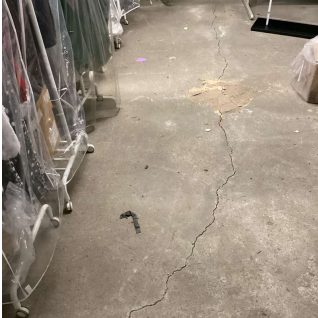
| Question | Response |
|---|--|
| Deficiency | CONCRETE SLAB ON GRADE: THRU CRACKS |
| Deficiency Location/Instance | Basement - Storage Area near Electrical Panel Room |

| Question | Response |
|---|--|
| Potential Action | REPLACE |

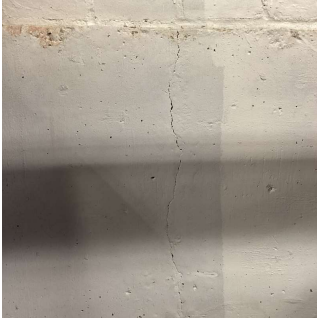
| Question | Response |
|---|--|
| | Basement - Boiler Room |

| Question | Response |
|---|--|
| Deficiency | CONCRETE: CRACKED/SPALLED/REINFORCEMENT EXPOSED |
| Deficiency Location/Instance | Basement - Boiler Room |

| Question | Response |
|---|--|
| Potential Action | REPAIR |

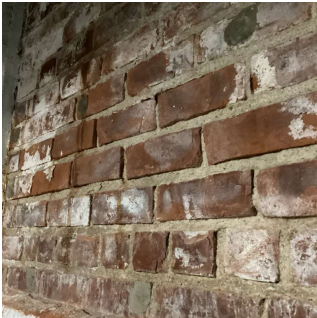
| Question | Response |
|---|--|
| | Basement - Fan Room |

| Question | Response |
|---|--|
| Deficiency | BRICK: DETERIORATED JOINTS |
| Deficiency Location/Instance | Basement - Fan Room |

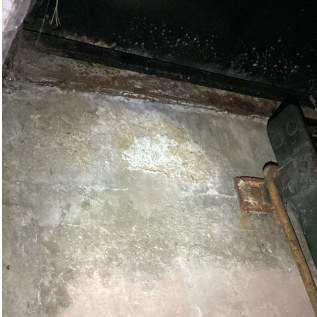
| Question | Response |
|---|--|
| Deficiency | CRACKS, SPALLING |
| Deficiency Location/Instance | Vault |

| Question | Response |
|---|--|
| Potential Action | REPAIR |

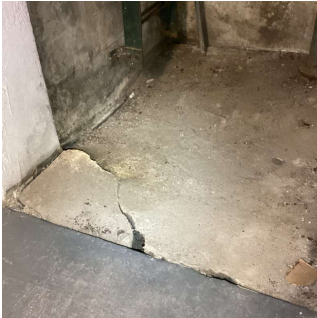
| Question | Response |
|---|--|
| Deficiency | CONCRETE SLAB ON GRADE: THRU CRACKS |
| Deficiency Location/Instance | Vault |

| Question | Response |
|---|--|
| Potential Action | REPLACE |

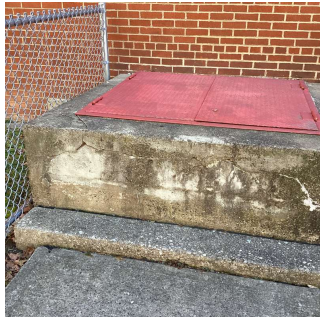
| Question | Response |
|---|--|
| Deficiency | CONCRETE: CRACKS/SPALLED/REINFORCEMENT EXPOSED |
| Deficiency Location/Instance | Vault |

| Question | Response |
|---|--|
| Potential Action | REPAIR |

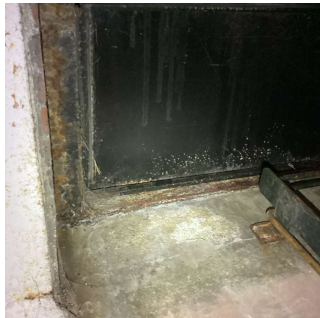
| Question | Response |
|--|--|
| Deficiency | DETERIORATED/DAMAGED VAULT/ASH HOIST DOORS AND FRAMING |
| Deficiency Location/Instance | Vault |

| Question | Response |
|--|--|
| Potential Action | REPLACE |

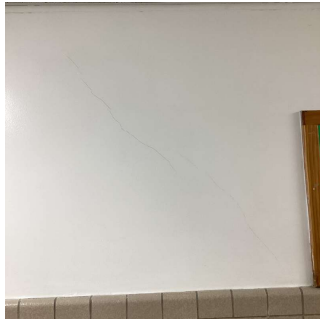
| Question | Response |
|--|--|
| Deficiency | PLASTER: CRACKS/SPALLING |
