**NYC Department of Education**  
**Building Condition Assessment Survey 2023 - 2024**

Architectural Inspection

**Asset:** J.H.S. 216 - QUEENS, 64-20 175 STREET, New York, 11365

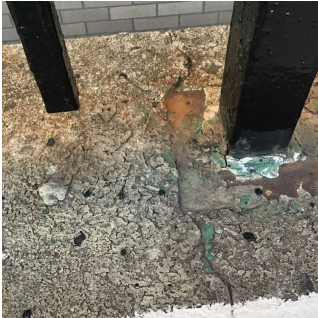
Question	Response
<b>Architectural</b>	
<b>EXTERIOR</b>	Inspected
<b>AREAWAY</b>	Inspected
Instance on AW1-AW9	Inspected
Instance Condition	3 - Fair
Instance Quantity	9
Instance Quantity Uom	EACH
Deficiency	AREAWAY WALLS: CRACKS AND SPALLING
Roof Plan reference	
Deficiency Quantity	50
Quantity Uom	S.F.
Potential Action	REPAIR
Urgency of Action	PRIORITY 3
Purpose of Action	LEVEL 2

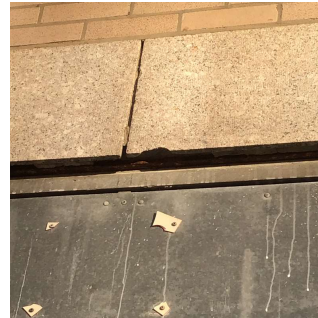
Facade D

STONE: CHIPPED/SPALLED/BROKEN PIECES - MINOR

REPAIR

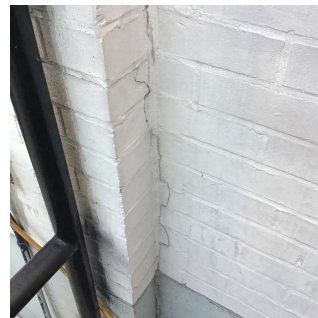
Facade B

**BRICK: MINOR CRACKS AND SPALLING**

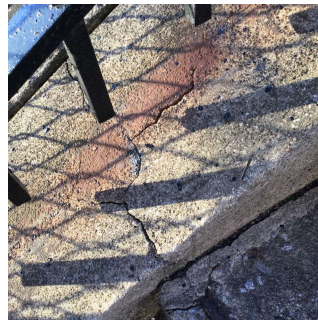
Facade F

Deficiency	CAST IN PLACE CONCRETE: CRACKS/SPALLING - MINOR
------------	---

REPAIR

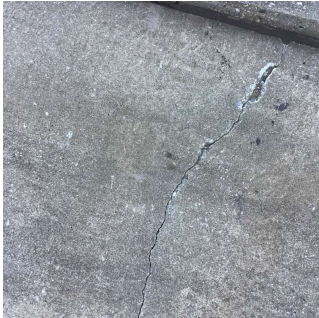
Violations	Facade G
Violations	No violations recorded.
Deficiency	STONE: CRACKS/SPALLING - MAJOR
Roof Plan reference	<p align="center">64th Avenue</p> <p align="center">Q216</p>

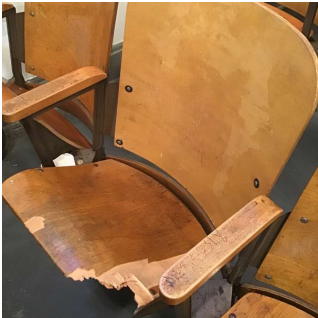
Violations	Seat F/10 No violations recorded.
Deficiency	DAMAGED/BROKEN/INOPERABLE

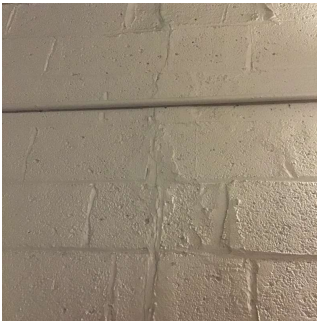
Stage Area
Violations	No violations recorded.
Deficiency	PLASTER: CRACKS/SPALLING
Deficiency Location/Instance	Near Entrance, Stage Left Side
Deficiency Quantity	20
Quantity Uom	S.F.
Potential Action	REPLACE
Urgency of Action	PRIORITY 3
Purpose of Action	LEVEL 2
Deficiency Photo1

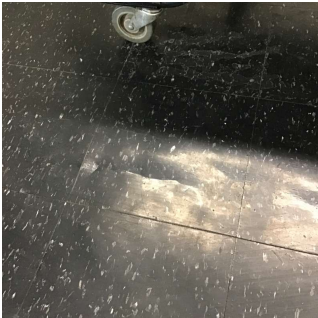
Cage Area
Violations	No violations recorded.
Deficiency	TERRAZZO: CRACKS
Deficiency Location/Instance	Near Exit 7
Deficiency Quantity	20
Quantity Uom	S.F.
Potential Action	REPLACE
Urgency of Action	PRIORITY 3
Purpose of Action	LEVEL 2

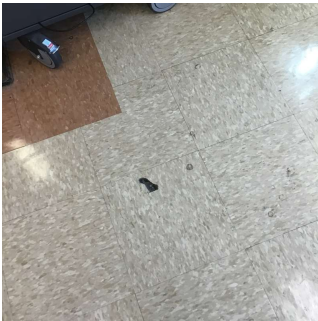
Violations	Room 301 No violations recorded.
<b>Walls</b>	Inspected
Condition	2 - Between Good and Fair
Deficiency	GLAZED BLOCK: CRACKS/SPALLING
Deficiency Location/Instance	Corridor near Stair A/Basement, Room 316, Main Entrance, Cafeteria

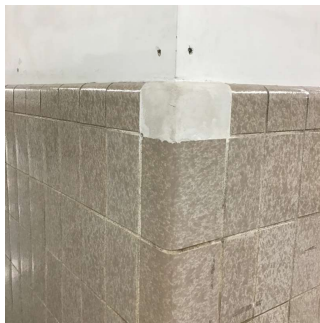
Corridor near Stair A/Basement
Violations	No violations recorded.
Deficiency	PLASTER: CRACKS/SPALLING
Deficiency Location/Instance	Rooms 217, 241, 302, 312, 346, and others.
Deficiency Quantity	100
Quantity Uom	S.F.
Potential Action	REPLACE
Urgency of Action	PRIORITY 3
Purpose of Action	LEVEL 2
Deficiency Photo1

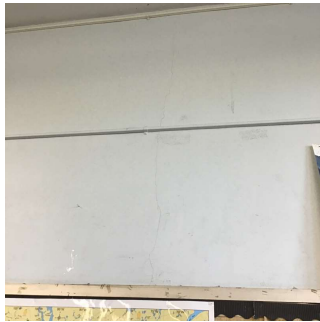
Room 312
Violations	No violations recorded.
<b>Specialties</b>	Does not Exist
<b>GYMNASIUM</b>	Inspected
Instance on 1st Floor	Inspected
<b>Ceiling</b>	
Instance on 1st Floor	Inspected
Condition	2 - Between Good and Fair
Deficiency	PLASTER: CRACKS/SPALLING
Deficiency Location/Instance	Drinking Fountain Area
Deficiency Quantity	10
Quantity Uom	S.F.
Potential Action	REPLACE
Urgency of Action	PRIORITY 3
Purpose of Action	LEVEL 2

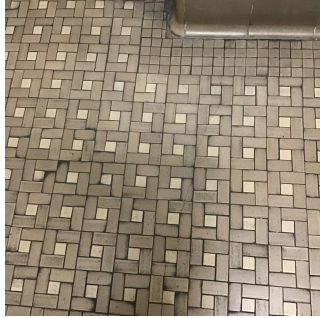
Violations	Room 110 No violations recorded.
<b>Stalls</b>	
Condition	Inspected 5 - Poor
Deficiency	RUST - MAJOR
Deficiency Location/Instance	Rooms 110, 116, Kitchen
Deficiency Quantity	3
Quantity Uom	EACH
Potential Action	REPLACE
Urgency of Action	PRIORITY 3
Purpose of Action	LEVEL 2
Deficiency Photo1

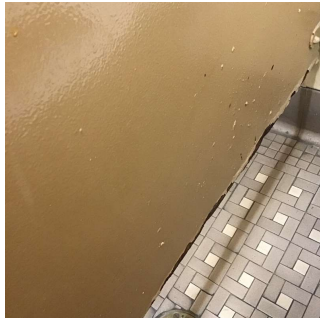
Violations	Room 116 No violations recorded.
<b>Walls</b>	
Condition	Inspected 2 - Between Good and Fair
Deficiency	PLASTER: CRACKS/SPALLING
Deficiency Location/Instance	Rooms B31, 341, Kitchen
Deficiency Quantity	20
Quantity Uom	S.F.
Potential Action	REPLACE
Urgency of Action	PRIORITY 3
Purpose of Action	LEVEL 2

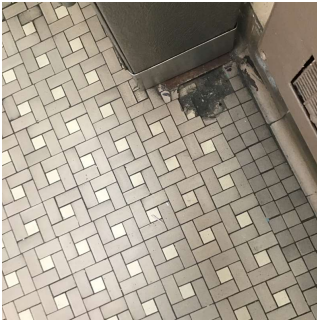
Violations	Room 205 No violations recorded.
<b>Stalls</b>	Inspected
Condition	5 - Poor
Deficiency	RUST - MAJOR
Deficiency Location/Instance	Room 305
Deficiency Quantity	4
Quantity Uom	EACH
Potential Action	REPLACE
Urgency of Action	PRIORITY 3
Purpose of Action	LEVEL 2

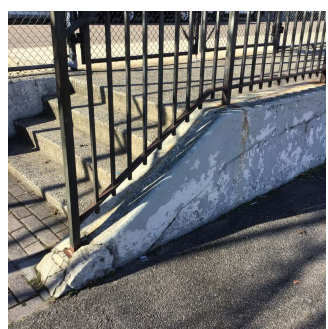
Violations	Near 174th Street No violations recorded.
<b>Stairs/ramps</b>	Inspected
Condition	2 - Between Good and Fair
Deficiency	CAST IN PLACE CONCRETE: CRACKS/SPALLING - MAJOR
Deficiency Location/Instance	Near Exit 4
Deficiency Quantity	10
Quantity Uom	S.F.
Potential Action	REPLACE
Urgency of Action	PRIORITY 3
Purpose of Action	LEVEL 2
Deficiency Photo1
