NYC Department of Education
Building Condition Assessment Survey 2023 - 2024

Architectural Inspection

Asset: P.S. 219 - QUEENS, 144-39 GRAVETT ROAD, New York, 11367

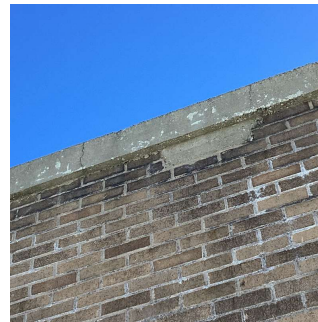
CHI

BRICK: DETERIORATED CAP

REPLACE

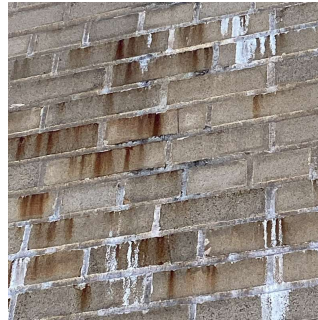
CH2
No violations recorded.

BRICK: MINOR CRACKS AND SPALLING

PRIORITY 3
LEVEL 2

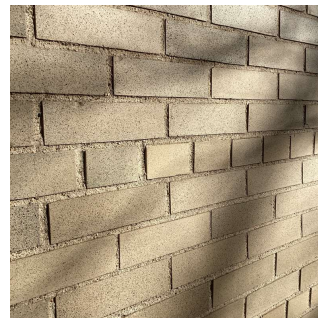
BRICK: DETERIORATED JOINTS

4,000
S.F.
REPOINT
PRIORITY 3
LEVEL 2

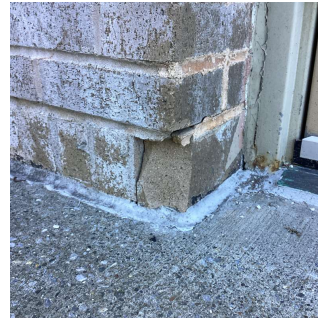
Facade C

BRICK: MAJOR / THRU CRACKS

PRIORITY 4
LEVEL 2

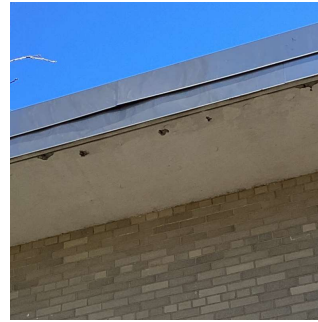
Facade G

CONCRETE: MINOR CRACKS/SPALLING

40
S.F.
REPAIR
PRIORITY 3
LEVEL 2

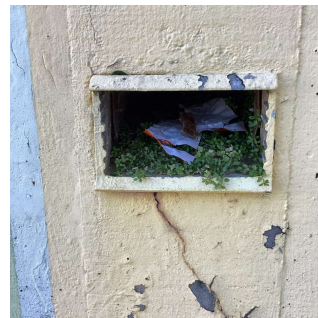
BROKEN/ DENTED BLADES

REPLACE

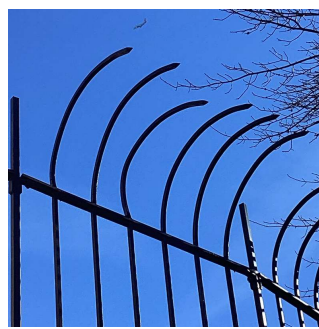
Question	Response
EXTERIOR	
LOUVER	Inspected
	Facade Q
Violations	No violations recorded.
PARAPETS	Does not Exist
PLAZA DECK	Does not Exist
ROOF	Inspected
Roofing	Inspected
Replacement Quantity	72,000
Replacement Uom	S.F.
ROOF HATCH/SMOKE HATCH	Inspected
Condition	1 - Good
Deficiency	No deficiencies recorded
LEADERS, GUTTERS, DOWNSPOUTS, SCUPPERS	Inspected
Condition	1 - Good
Deficiency	No deficiencies recorded
ROOF BARRIER/FENCE	Inspected
Condition	3 - Fair
Deficiency	BEAR CLAW/METAL BAR: DETERIORATED, MAJOR RUSTING
Roof Plan reference

Deficiency Quantity	20
Quantity Uom	S.F.
Potential Action	REPLACE
Urgency of Action	PRIORITY 4
Purpose of Action	LEVEL 2
Deficiency Photo1

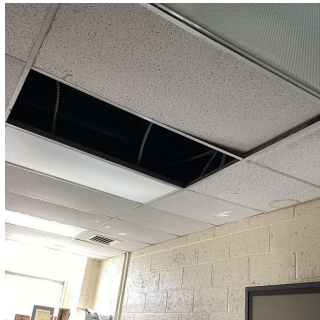
Roof 2 - Room 127 (Roof 1 - Corridor near Stair C/2 similar)
Violations	No violations recorded.

Roof 1
Instance Quantity	62,000
Instance Quantity Uom	S.F.
Does the roof have major mechanical equipment sitting on Dunnage Steel less than 18" above the Roofing?	No
Does this roof instance have a Sustainable Roof System?	Yes
Sustainable Roof Type	White Roof
Sustainable Roof Location (Roof Number)	Roofs 1-3
Do solar panels exist on these roofs?	No
Is/Are the roof(s) suitable for Solar Panel installation?	Yes
Installation Year	2019
Source of Installation	Custodial Staff
Deficiency	MODIFIED BITUMEN: ROOFING: MAJOR ACTIVE ROOF LEAKS IN INSTRUCTIONAL SPACE
Roof Plan reference

Deficiency Quantity	200
Quantity Uom	S.F.
Potential Action	REPLACE ROOFING WITHOUT MAJOR EQUIPMENT REMOVAL
Urgency of Action	PRIORITY 5
Purpose of Action	LEVEL 2
Deficiency Photo1

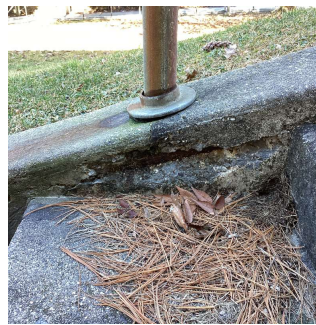
Facade C
 No violations recorded.

CUPOLA/ SPIRES/ TOWERS	Does not Exist
DORMER	Does not Exist
DUNNAGE STEEL	Inspected
Condition	2 - Between Good and Fair
Deficiency	No deficiencies recorded
SKYLIGHT/ROOF VENT	Inspected
Material Type(s)	Glass
Condition	1 - Good
Deficiency	No deficiencies recorded
ROOF/GRAVITY TANK	Does not Exist
STAIRS/RAMPS: EXTERIOR	Inspected
BUILDING CHEEK/FLANK WALLS	Inspected
Condition	3 - Fair
Deficiency	CAST IN PLACE CONCRETE: CRACKS/SPALLING - MAJOR

10
 S.F.
 REPLACE
 PRIORITY 4
 LEVEL 2

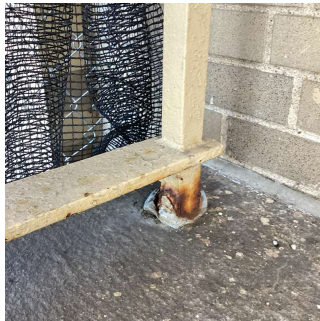
RUST - MAJOR

10
 L.F.
 REPLACE
 PRIORITY 4
 LEVEL 2

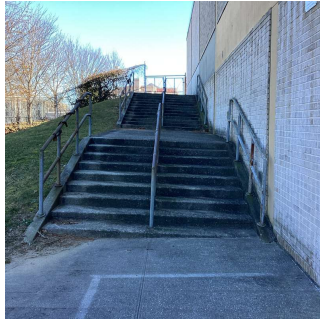
Violations	Facade L No violations recorded.
STAIRS/RAMPS	
Condition	Inspected 5 - Poor
Deficiency	CONCRETE: DETERIORATED SUBSTRATE
Roof Plan reference

Deficiency Quantity	200
Quantity Uom	S.F.
Potential Action	REPLACE SUBSTRATE AND RESET
Urgency of Action	PRIORITY 4
Purpose of Action	LEVEL 2
Deficiency Photo1

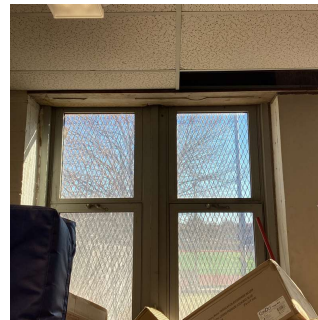
Facade C - Room 289

Deficiency	ALUMINUM - OTHER: AIR/WATER INFILTRATION

REPLACE TRIM, SILLS OR WEATHERSTRIPPING

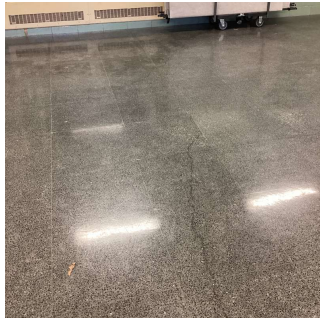
Violations	Room 156 No violations recorded.
Floor Finish	Inspected
Condition	3 - Fair
Deficiency	TERRAZZO: CRACKS
Deficiency Location/Instance	Corridor near Exit 17&18, Corridor near Room 112-1, Exits 17 Vestibule, 16 Vestibule
Deficiency Quantity	300
Quantity Uom	S.F.
Potential Action	REPLACE
Urgency of Action	PRIORITY 3
Purpose of Action	LEVEL 2
Deficiency Photo1

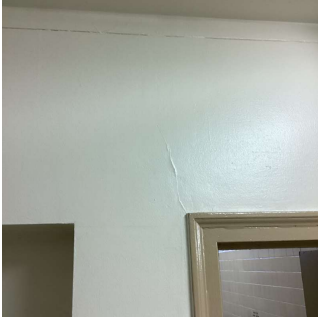
Violations	Room 289 No violations recorded.
Deficiency	PLASTER: CRACKS/SPALLING
Deficiency Location/Instance	Corridor near Rooms 110, 116
Deficiency Quantity	20
Quantity Uom	S.F.
Potential Action	REPLACE
Urgency of Action	PRIORITY 3
Purpose of Action	LEVEL 2
Deficiency Photo1

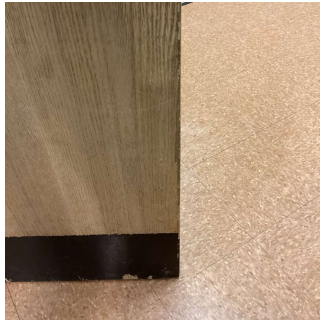
Room 186
Violations	No violations recorded.
Door(s)	
Instance on 1st Floor	Inspected
Condition	5 - Poor
Deficiency	WOOD: DETERIORATED DOOR
Deficiency Location/Instance	Main Entrance
Deficiency Quantity	4
Quantity Uom	EACH
Potential Action	MAINTENANCE
Urgency of Action	PRIORITY 3
Purpose of Action	LEVEL 2
Deficiency Photo1

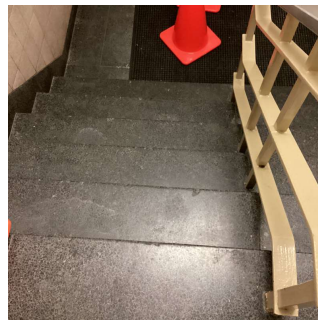
Exit 19 Vestibule

Deficiency	TERRAZZO: CRACKS
Deficiency Location/Instance	Exits 17&18, 19, 20 Vestibules
Deficiency Quantity	30
Quantity Uom	S.F.
Potential Action	REPLACE
Urgency of Action	PRIORITY 3
Purpose of Action	LEVEL 2
Deficiency Photo1

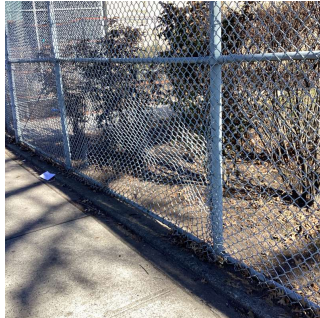
Gravett Road
Violations	No violations recorded.
Deficiency	CHAIN LINK: DAMAGED/DETERIORATED
Deficiency Location/Instance	Main Street, Gravett Road
Deficiency Quantity	100
Quantity Uom	S.F.
Potential Action	REPLACE
Urgency of Action	PRIORITY 3
Purpose of Action	LEVEL 2
Deficiency Photo1
