NYC Department of Education
Building Condition Assessment Survey 2023 - 2024

Architectural Inspection

Q223

Asset: P.S. 223 - QUEENS, 125-20 SUTPHIN BLVD, New York, 11436

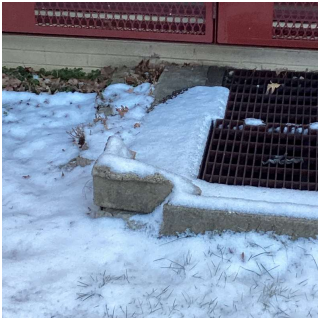
Question	Response
Architectural	
EXTERIOR	Inspected
AREAWAY	Inspected
Instance on AW1	Inspected
Instance Condition	3 - Fair
Instance Quantity	1
Instance Quantity Uom	EACH
Deficiency	AREAWAY WALLS: CRACKS AND SPALLING
Roof Plan reference

Deficiency Quantity	10
Quantity Uom	S.F.
Potential Action	REPLACE

Question	Response
EXTERIOR	
AREAWAY	
Urgency of Action	PRIORITY 4
Purpose of Action	LEVEL 2
Deficiency Photo1

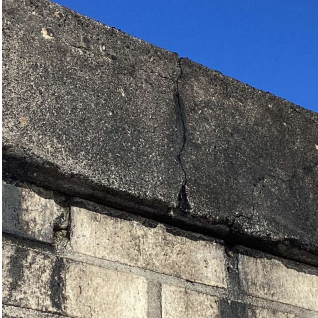
Violations	Facade B - AW1 No violations recorded.
AWNINGS AND CANOPIES	
Condition	Inspected 2 - Between Good and Fair
Deficiency	No deficiencies recorded
CHIMNEY	
Material Type(s)	Inspected Masonry
Condition	2 - Between Good and Fair
Deficiency	BRICK: DETERIORATED CAP
Roof Plan reference

Deficiency Quantity	10
Quantity Uom	L.F.
Potential Action	REPLACE
Urgency of Action	PRIORITY 3
Purpose of Action	LEVEL 2
Deficiency Photo1

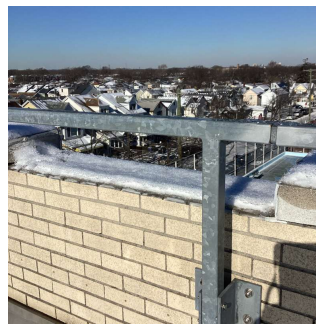
Roof 1
 No violations recorded.

CAST STONE: CRACKED/BROKEN PIECES

30
 L.F.
 REPLACE-IN-KIND
 PRIORITY 4
 LEVEL 2

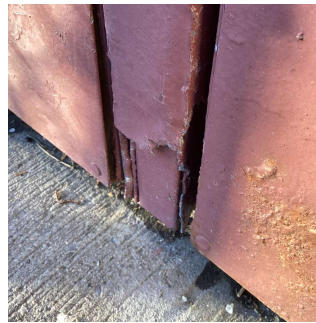
Facade A

METAL CLAD: DETERIORATED DOOR AND FRAME - MAJOR DETERIORATION

3
 EACH
 REPLACE
 PRIORITY 4
 LEVEL 2

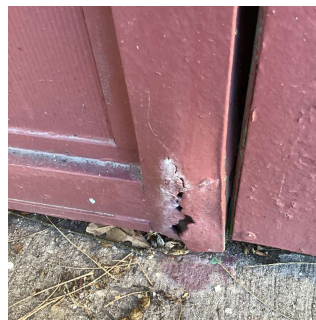
Facade A

METAL: DENTED, MAJOR RUSTING

REPLACE

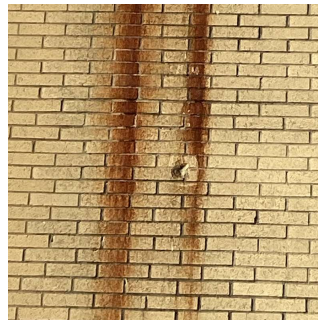
Facade A

Material Type(s)	Concrete, Masonry
Replacement Quantity	24,000
Replacement Uom	S.F.
Instance on All Facades	Inspected
Instance Condition	3 - Fair
Instance Quantity	24,000
Instance Quantity Uom	S.F.
Deficiency	BRICK: MINOR CRACKS AND SPALLING
Roof Plan reference

Deficiency Quantity	10
Quantity Uom	S.F.
Potential Action	RESTITCH
Urgency of Action	PRIORITY 3
Purpose of Action	LEVEL 2
Deficiency Photo1

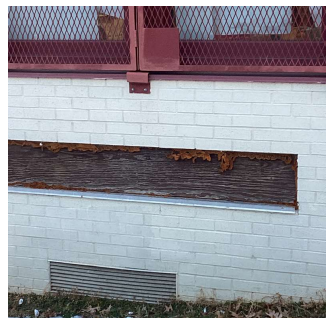
Question	Response
EXTERIOR	
LOUVER	
Condition	3 - Fair
Deficiency	BROKEN/ DENTED BLADES
Roof Plan reference

Deficiency Quantity	30
Quantity Uom	S.F.
Potential Action	REPLACE
Urgency of Action	PRIORITY 4
Purpose of Action	LEVEL 2
Deficiency Photo1

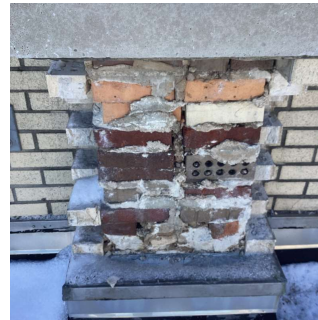
Roof 1

Violations	Facade B No violations recorded.
PARAPETS	
Material Type(s)	Inspected Masonry
Replacement Quantity	7,000
Replacement Uom	C.F.
Instance on All Facades	Inspected
Instance Condition	3 - Fair
Instance Quantity	7,000
Instance Quantity Uom	C.F.
Deficiency	BRICK: MAJOR DETERIORATION/CRACKS

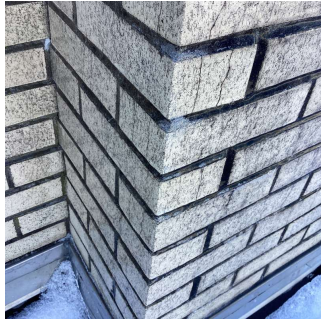
BRICK: MINOR CRACKS, SPALLING

REPAIR

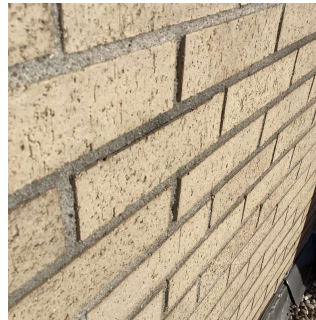
Roof 1 - Bulkhead 2

BULKHEAD/PENTHOUSE WALLS/EXTERIOR: DETERIORATED JOINTS

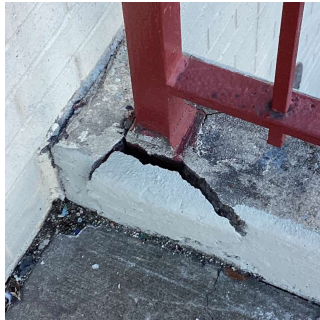
Roof 1
Violations	No violations recorded.
SKYLIGHT/ROOF VENT	Does not Exist
ROOF/GRAVITY TANK	Does not Exist
STAIRS/RAMPS: EXTERIOR	Inspected
BUILDING CHEEK/FLANK WALLS	Inspected
Condition	3 - Fair
Deficiency	CAST IN PLACE CONCRETE: CRACKS/SPALLING - MAJOR
Roof Plan reference

Deficiency Quantity	10
Quantity Uom	S.F.
Potential Action	REPLACE
Urgency of Action	PRIORITY 4
Purpose of Action	LEVEL 2
Deficiency Photo1

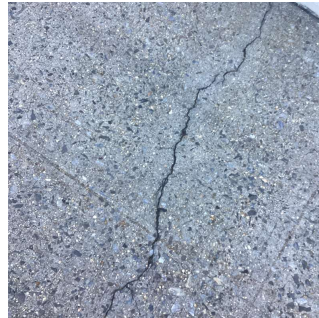
Question	Response
EXTERIOR	
STAIRS/RAMPS: EXTERIOR	
RAILINGS	Inspected
Condition	2 - Between Good and Fair
Deficiency	No deficiencies recorded
STAIRS/RAMPS	Inspected
Condition	3 - Fair
Deficiency	CONCRETE: CRACKS/SPALLING - MINOR
Roof Plan reference

Deficiency Quantity	20
Quantity Uom	S.F.
Potential Action	REPAIR
Urgency of Action	PRIORITY 3
Purpose of Action	LEVEL 2
Deficiency Photo1

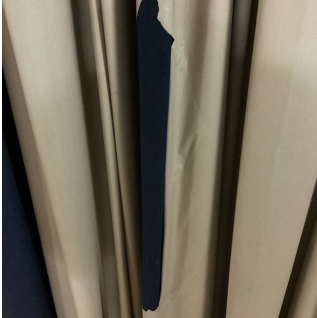
Deficiency	No deficiencies recorded
Stage Curtains	
Instance on 1st Floor (225 Seats)	Inspected
Condition	3 - Fair
Deficiency	WORN/DETERIORATED
Deficiency Location/Instance	Right Side Main Curtain
Deficiency Quantity	100
Quantity Uom	S.F.

Question	Response
INTERIOR	
AUDITORIUM	
Stage	
Stage Curtains	
Potential Action	REPLACE
Urgency of Action	PRIORITY 3
Purpose of Action	LEVEL 2
Deficiency Photo1

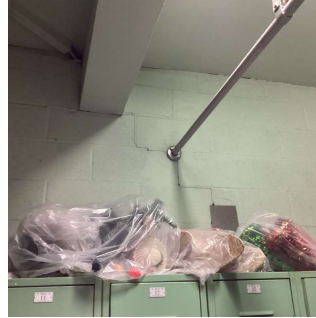
Near Drinking Fountain
Violations	No violations recorded.
Sliding-folding Partition	
Instance on 1st Floor - Students	Not Required
Instance on 1st Floor - Staff (750 SF)	Does not Exist
Stage	
Instance on 1st Floor - Students	Does not Exist
Instance on 1st Floor - Staff (750 SF)	Does not Exist
Walls	
Instance on 1st Floor - Students	Inspected
Condition	2 - Between Good and Fair
Deficiency	MASONRY: CRACKS/SPALLING

Deficiency Location/Instance	Storage Room
Deficiency Quantity	10
Quantity Uom	S.F.
Potential Action	REPLACE

Urgency of Action
Purpose of Action
Deficiency Photo1

PRIORITY 3
LEVEL 2

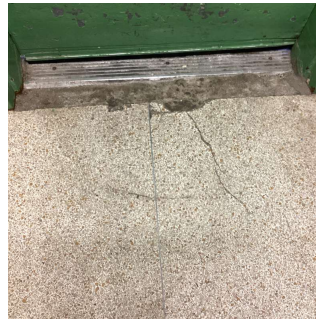
Deficiency TERRAZZO: CRACKS

Deficiency Location/Instance Exit 7 Vestibule

Potential Action REPLACE

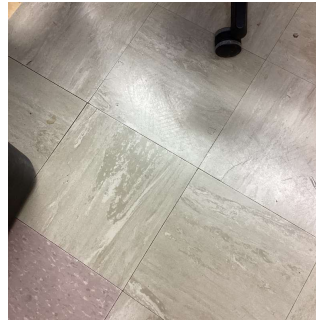
Deficiency VINYL TILES: BROKEN/DETERIORATED/MISSING TILES

Deficiency Location/Instance Office

Potential Action REPLACE

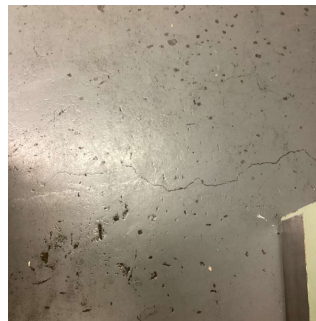
Storage Room

CONCRETE: CRACKS

REPLACE

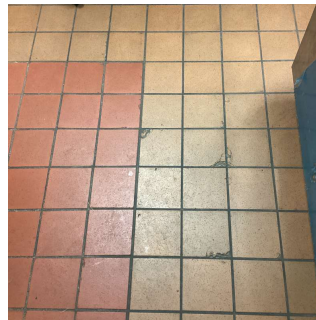
Near Staff Servery

QUARRY TILE: BROKEN/MISSING TILES

REPLACE

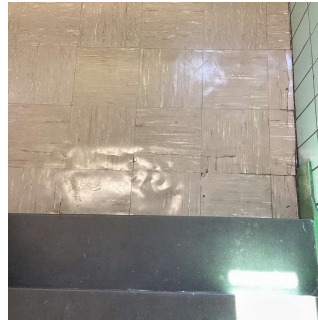
Stair E/3

VINYL TILES: DETERIORATED SUBSTRATE

REPLACE

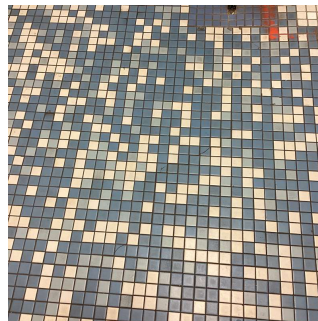
Room 300 Boys

Deficiency	CERAMIC TILE: BROKEN/MISSING TILES
Deficiency Location/Instance	Rooms 209 Boys, 213 Boys, 300 Boys, In Room 120
Deficiency Quantity	40
Quantity Uom	S.F.
Potential Action	REPLACE
Urgency of Action	PRIORITY 3
Purpose of Action	LEVEL 2
Deficiency Photo1

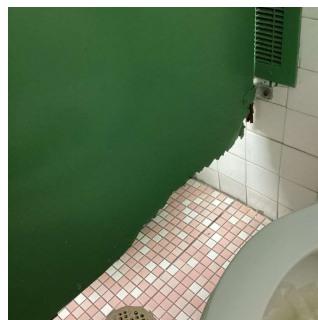
Deficiency	RUST - MAJOR
Deficiency Location/Instance	Rooms 200 Girls, 203 Girls, 313 Boys, 313 Girls
Deficiency Quantity	6
Quantity Uom	EACH
Potential Action	REPLACE
Urgency of Action	PRIORITY 3
Purpose of Action	LEVEL 2
Deficiency Photo1

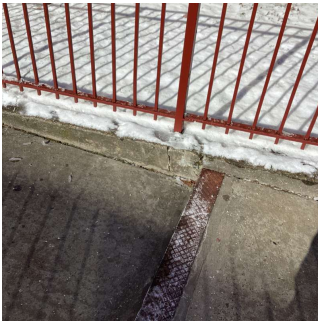
Violations	147th Street No violations recorded.
Deficiency	CAST IN PLACE CONCRETE: CRACKS/SPALLING - MINOR
Deficiency Location/Instance	147th Street
Deficiency Quantity	20
Quantity Uom	S.F.
Potential Action	REPAIR
Urgency of Action	PRIORITY 3
Purpose of Action	LEVEL 2
Deficiency Photo1	No photo recorded
Violations	No violations recorded.
SEATING	Inspected
Benches	Inspected
Concrete	Does not Exist
Metal/Wood/Plastic	Inspected
Condition	1 - Good
Deficiency	No deficiencies recorded
Bleachers	Does not Exist
SITE WALLS (NOT RETAINING WALLS)	Does not Exist
STAIRS/RAMPS: EXTERIOR	Inspected
Railings	Inspected
Condition	2 - Between Good and Fair
Deficiency	No deficiencies recorded
Site Cheek/flank Walls	Inspected
Condition	2 - Between Good and Fair
Deficiency	CAST IN PLACE CONCRETE: CRACKS/SPALLING - MAJOR
Deficiency Location/Instance	South side of Building
Deficiency Quantity	10
