**NYC Department of Education**  
**Building Condition Assessment Survey 2023 - 2024**

Architectural Inspection

**Asset:** P.S. 225 - QUEENS, 1-90 BEACH 110 STREET, New York, 11694

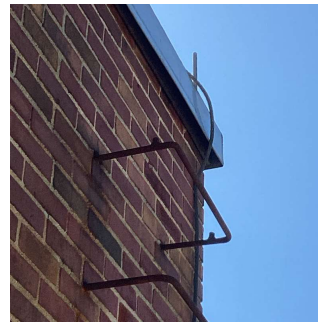
Roof 1

**BRICK: DETERIORATED LADDER**

REPLACE

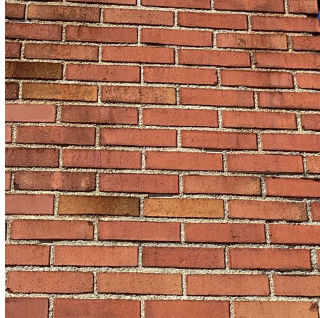
**BRICK: DETERIORATED JOINTS**

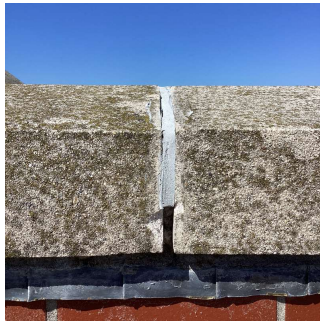
Violations	Roof 1 No violations recorded.
<b>COPING</b>	
Condition	Inspected 3 - Fair
Deficiency	CAST STONE: DETERIORATED TRANSVERSE JOINTS
Roof Plan reference

Deficiency Quantity	50
Quantity Uom	L.F.
Potential Action	MAINTENANCE
Urgency of Action	PRIORITY 3
Purpose of Action	LEVEL 2
Deficiency Photo1

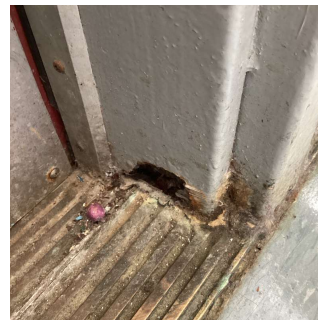
Facade J  
No violations recorded.

**METAL: DETERIORATED DOOR AND FRAME - MAJOR DETERIORATION**

4  
EACH  
REPLACE  
PRIORITY 4  
LEVEL 2

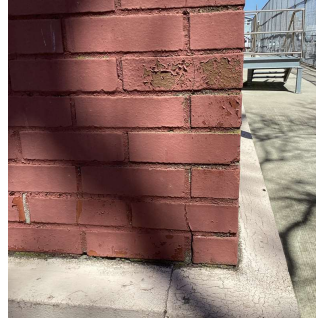
Facade H

Question	Response
<b>EXTERIOR</b>	
<b>DOORS</b>	
<b>LINTELS</b>	Inspected
Condition	2 - Between Good and Fair
Deficiency	No deficiencies recorded
<b>TRANSOM/SIDE LIGHT</b>	Inspected
Condition	2 - Between Good and Fair
Deficiency	No deficiencies recorded
<b>EXTERIOR WALLS</b>	Inspected
Material Type(s)	Masonry, Concrete
Replacement Quantity	23,000
Replacement Uom	S.F.
Instance on All Facades	Inspected
Instance Condition	5 - Poor
Instance Quantity	23,000
Instance Quantity Uom	S.F.
Deficiency	<b>BRICK: CRACKS/DISPLACED/SPALLED BRICK AT BUILDING CORNERS</b>
Roof Plan reference

Deficiency Quantity	10
Quantity Uom	S.F.
Potential Action	REMOVE AND REBUILD
Urgency of Action	PRIORITY 4
Purpose of Action	LEVEL 2

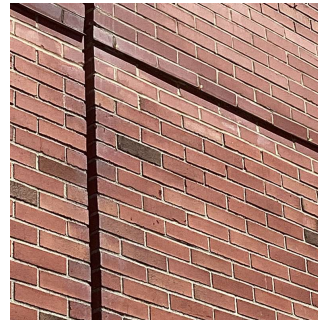
Facade D

**BRICK: DETERIORATED JOINTS**

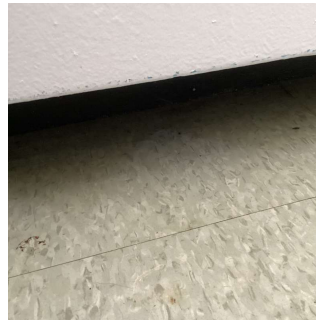
**BRICK: WATER INFILTRATION IN INSTRUCTIONAL SPACE**

Facade C - Room 169, also Rooms on 1st - 3rd Floor and Facade A - 1st - 3rd Floor

REPAIR

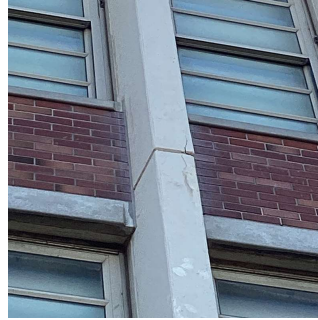
Facade A

**CAST IN PLACE / PRE-CAST CONCRETE: MINOR  
CRACKS/SPALLING**

S.F.  
REPAIR  
PRIORITY 3  
LEVEL 2

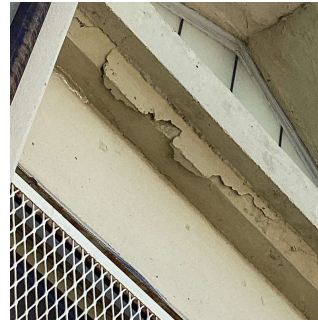
Facade K

**CAST IN PLACE / PRE-CAST CONCRETE: MAJOR  
CRACKS/SPALLING**

50  
S.F.  
REPLACE  
PRIORITY 4  
LEVEL 2

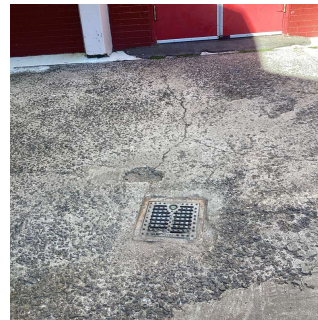
Facade K

**DETERIORATED CONCRETE PLATFORM WITH CRACKED, SPALLED CONCRETE OR EXPOSED REINFORCING**

REPAIR

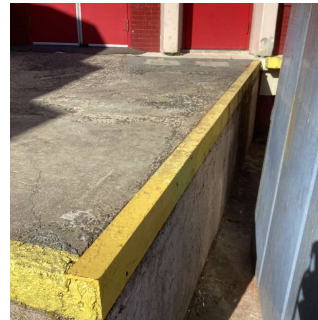
Facade K

5  
 EACH  
 REPLACE  
 PRIORITY 4  
 LEVEL 2

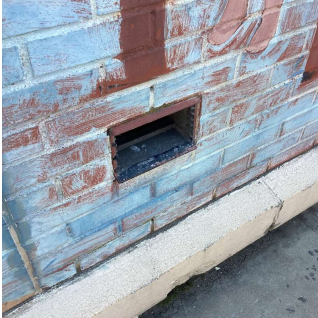
BROKEN/ DENTED BLADES

Question	Response
<b>EXTERIOR</b>	
<b>LOUVER</b>	
Deficiency Quantity	10
Quantity Uom	S.F.
Potential Action	REPLACE
Urgency of Action	PRIORITY 4
Purpose of Action	LEVEL 2
Deficiency Photo1

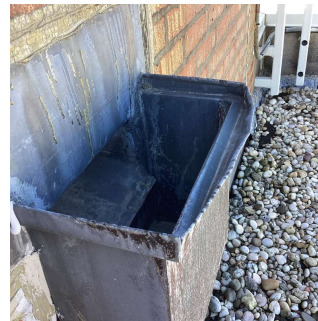
Roof 1

DAMAGED/MISSING

REPLACE

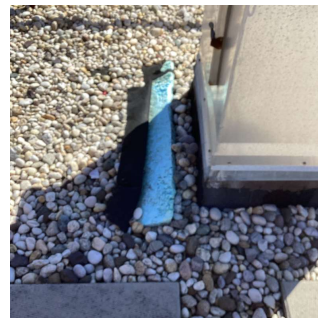
IRMA: ROOFING: DAMAGED INSULATION

REPLACE

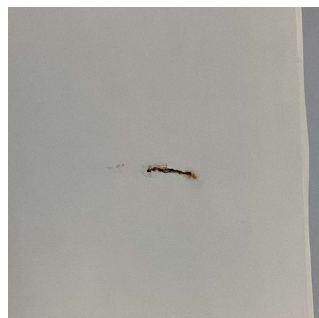
Question	Response
<b>EXTERIOR</b>	
<b>ROOF</b>	
<b>Roofing</b>	
<b>ROOFING</b>	Inspected
	Roof 1
Violations	No violations recorded.
Deficiency	IRMA: ROOFING: MAJOR ACTIVE ROOF LEAKS IN INSTRUCTIONAL SPACE
Roof Plan reference

Deficiency Quantity	100
Quantity Uom	S.F.
Potential Action	REPLACE ROOFING WITHOUT MAJOR EQUIPMENT REMOVAL
Urgency of Action	PRIORITY 5
Purpose of Action	LEVEL 2
Deficiency Photo1

Roof 3 - Gymnasium
Violations	No violations recorded.
Instance on Metal: Roof 4	Inspected
Instance Condition	5 - Poor
Instance Photo

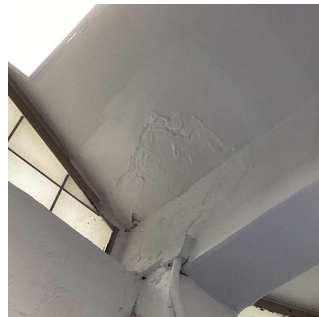
Question	Response
<b>EXTERIOR</b>	
<b>ROOF</b>	
<b>Roofing</b>	
<b>ROOFING</b>	
Installation Year	2006
Source of Installation	Custodial Staff
Deficiency	METAL: ROOFING: MAJOR ACTIVE ROOF LEAKS IN INSTRUCTIONAL SPACE
Roof Plan reference

Deficiency Quantity	100
Quantity Uom	S.F.
Potential Action	REPLACE
Urgency of Action	PRIORITY 5
Purpose of Action	LEVEL 2
Deficiency Photo1

Violations	Roof 4 - Cafeteria No violations recorded.
<b>ROOFING DRAINS</b>	
Condition	Inspected 2 - Between Good and Fair
Deficiency	No deficiencies recorded
<b>Specialties</b>	
Inspected	
<b>BULKHEAD/PENTHOUSE</b>	
Condition	Inspected 3 - Fair
Deficiency	BULKHEAD/PENTHOUSE WALLS/INTERIOR: SALT GLAZED BRICK DETERIORATED JOINTS

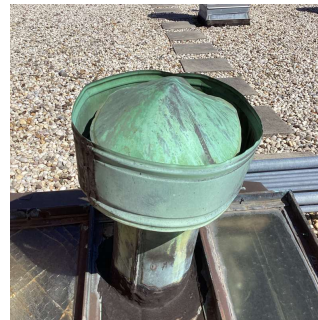
Roof 1

**SHAFT VENTS DAMAGED**

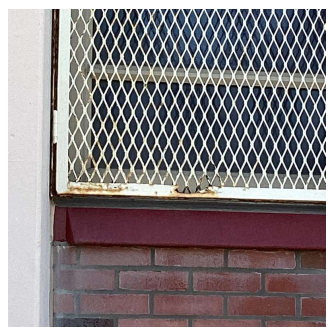
Question	Response
<b>EXTERIOR</b>	
<b>WINDOWS</b>	
Replacement Uom	S.F.
<b>EXTERIOR GUARDS</b>	
Condition	3 - Fair
Deficiency	RUST - MAJOR
Roof Plan reference

Deficiency Quantity	30
Quantity Uom	S.F.
Potential Action	REPLACE
Urgency of Action	PRIORITY 4
Purpose of Action	LEVEL 2
Deficiency Photo1

Violations	Facade A No violations recorded.
<b>LINTELS</b>	
Condition	Inspected
Deficiency	2 - Between Good and Fair No deficiencies recorded
<b>WINDOWS</b>	
Material Type(s)	Inspected Aluminum
Instance on Aluminum - Double Hung: All Facades	Inspected
Instance Condition	4 - Between Fair and Poor
Instance Quantity	9,000
Instance Quantity Uom	S.F.

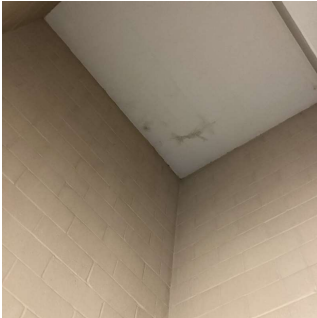
Question	Response
<b>INTERIOR</b>	
<b>AUDITORIUM</b>	
<b>Ceiling</b>	
Deficiency	PLASTER: CRACKS/SPALLING
Deficiency Location/Instance	Stage Room Right and Left side, Back Stage
Deficiency Quantity	40
Quantity Uom	S.F.
Potential Action	REPLACE
Urgency of Action	PRIORITY 3
Purpose of Action	LEVEL 2
Deficiency Photo1

Stage Room Left side
Violations	No violations recorded.
<b>Door(s)</b>	
Instance on 1st Floor (411 Seats)	Inspected
Condition	3 - Fair
Deficiency	METAL: DETERIORATED DOOR
Deficiency Location/Instance	Stage Room Left side
Deficiency Quantity	1
Quantity Uom	EACH
Potential Action	MAINTENANCE
Urgency of Action	PRIORITY 3
Purpose of Action	LEVEL 2
Deficiency Photo1

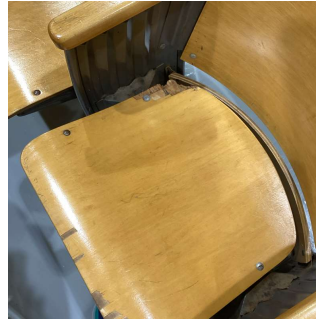
Seat P/105

Stage Room Left side
Violations	No violations recorded.
<b>Fixed H/C Lift</b>	
Instance on 1st Floor (411 Seats)	Does not Exist
<b>Fixed Seating</b>	
Instance on 1st Floor (411 Seats)	Inspected
Condition	5 - Poor
Deficiency	DAMAGED/BROKEN/INOPERABLE

Deficiency Location/Instance	Seats P/105
Deficiency Quantity	1

Quantity Uom	EACH
Potential Action	REPLACE
Urgency of Action	PRIORITY 5
Purpose of Action	LEVEL 6
Deficiency Photo1

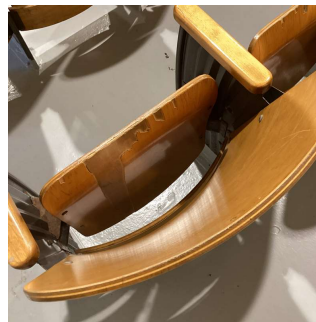
Seat R/12

Deficiency	DAMAGED/BROKEN/INOPERABLE
Deficiency Location/Instance	Seats G/6, R/7, 12, L/101, O/6, and others
Deficiency Quantity	276
Quantity Uom	EACH
Potential Action	REPLACE
Urgency of Action	PRIORITY 3
Purpose of Action	LEVEL 2
Deficiency Photo1

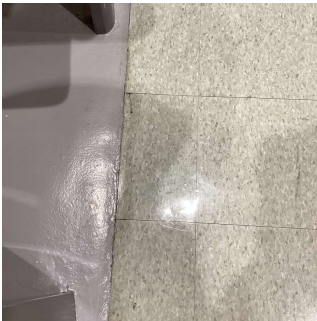
Instance on 1st Floor (411 Seats)	Inspected
Condition	2 - Between Good and Fair
Deficiency	VINYL TILES: BROKEN/DETERIORATED/MISSING TILES
Deficiency Location/Instance	Near Seats A/1, B/101, D/101, R/6, Lateral Left Side
Deficiency Quantity	120
Quantity Uom	S.F.
Potential Action	REPLACE
Urgency of Action	PRIORITY 3
Purpose of Action	LEVEL 2

Near Seat R/6
Violations	No violations recorded.
<b>Sliding-folding Partition</b>	
Instance on 1st Floor (411 Seats)	Does not Exist
<b>Stage</b>	
Instance on 1st Floor (411 Seats)	Inspected
<b>Stage</b>	Inspected
Instance on 1st Floor (411 Seats)	Inspected
Condition	3 - Fair
Deficiency	DAMAGED STEPS
Deficiency Location/Instance	Right and Left Side
Deficiency Quantity	30
Quantity Uom	S.F.
Potential Action	REPLACE
Urgency of Action	PRIORITY 3
Purpose of Action	LEVEL 2
Deficiency Photo1

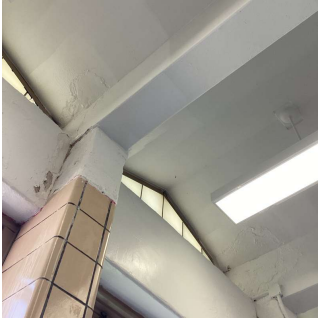
Question	Response
<b>INTERIOR</b>	
<b>CAFETERIA</b>	
<b>Ceiling</b>	
Instance on 1st Floor	Inspected
Condition	2 - Between Good and Fair
Deficiency	PLASTER: CRACKS/SPALLING - ACTIVE LEAK
Deficiency Location/Instance	Near Windows
Deficiency Quantity	30
Quantity Uom	S.F.
Potential Action	REPLACE
Urgency of Action	PRIORITY 5
Purpose of Action	LEVEL 2
Deficiency Photo1

Violations	Near Windows No violations recorded.
Deficiency	ACOUSTIC TILES ON PLASTER: DAMAGED/MISSING
Deficiency Location/Instance	Near Center, Serving , Windows, Emergency Exits
Deficiency Quantity	30
Quantity Uom	S.F.
Potential Action	REPLACE
Urgency of Action	PRIORITY 3
Purpose of Action	LEVEL 2
Deficiency Photo1

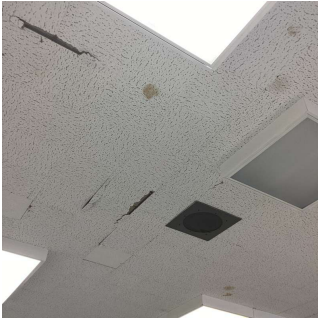
Violations	Near center No violations recorded.
<b>Door(s)</b>	
Instance on 1st Floor	Inspected
Condition	3 - Fair
Deficiency	METAL: DETERIORATED DOOR
Deficiency Location/Instance	Entrance Gymnasium
Deficiency Quantity	1
Quantity Uom	EACH
