NYC Department of Education
Building Condition Assessment Survey 2023 - 2024

Architectural Inspection

Asset: I.S. 226 - QUEENS, 121-10 ROCKAWAY BLVD, New York, 11420

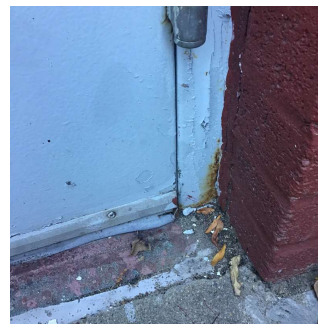
Facade F
No violations recorded.

Question	Response
EXTERIOR	
CHIMNEY	
Deficiency Photo1	 
Violations	Roof 1 No violations recorded.
COPING	Inspected
Condition	1 - Good
Deficiency	No deficiencies recorded
CORNICE	Does not Exist
DOORS	Inspected
DOORS AND FRAMES	Inspected
Condition	5 - Poor
Deficiency	METAL CLAD: DETERIORATED DOOR AND FRAME - MAJOR DETERIORATION
Roof Plan reference	Q226  
Deficiency Quantity	3
Quantity Uom	EACH
Potential Action	REPLACE
Urgency of Action	PRIORITY 4
Purpose of Action	LEVEL 2
Deficiency Photo1	 
Violations	Facade B No violations recorded.
Deficiency	METAL: DETERIORATED DOOR AND FRAME - MINOR DETERIORATION

1
EACH
MAINTENANCE
PRIORITY 3
LEVEL 2

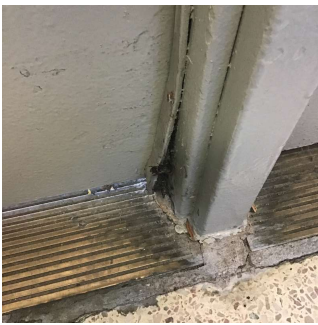
METAL: DETERIORATED DOOR AND FRAME - MAJOR DETERIORATION

Violations	Facade A No violations recorded.
DOOR HARDWARE	Inspected
Condition	3 - Fair
Deficiency	No deficiencies recorded
LINTELS	Inspected
Condition	2 - Between Good and Fair
Deficiency	No deficiencies recorded
TRANSOM/SIDE LIGHT	Inspected
Condition	2 - Between Good and Fair
Deficiency	No deficiencies recorded
EXTERIOR WALLS	Inspected
Material Type(s)	Masonry, Concrete
Replacement Quantity	50,000
Replacement Uom	S.F.
Instance on All Facades	Inspected
Instance Condition	2 - Between Good and Fair
Instance Quantity	50,000
Instance Quantity Uom	S.F.
Deficiency	No deficiencies recorded
EXTERIOR SOFFITS	Inspected
Condition	2 - Between Good and Fair
Deficiency	No deficiencies recorded
LOADING DOCK	Does not Exist
LOUVER	Inspected
Condition	2 - Between Good and Fair
Deficiency	No deficiencies recorded
PARAPETS	Inspected
Material Type(s)	Masonry, Concrete, Metal

8
EACH
REPLACE
PRIORITY 4
LEVEL 2

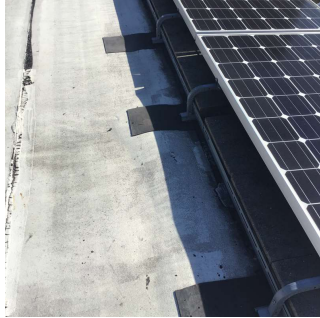
Installation Year	2012
Source of Installation	Custodial Staff
Deficiency	MODIFIED BITUMEN: ROOFING: DELAMINATION
Roof Plan reference	Q226

Violations	Roof 1 No violations recorded.
Instance on Built-Up: Roof 3	Inspected
Instance Condition	3 - Fair
Instance Photo

Deficiency Quantity	30
Quantity Uom	S.F.
Potential Action	REPLACE ROOFING WITHOUT MAJOR EQUIPMENT REMOVAL
Urgency of Action	PRIORITY 4

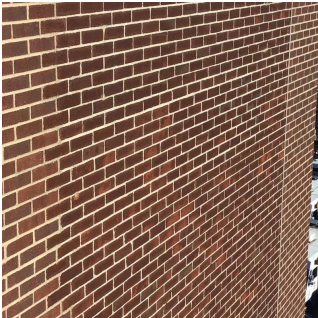
BULKHEAD/PENTHOUSE WALLS/EXTERIOR: DETERIORATED JOINTS

Violations	Roof 1 - Bulkhead 1 No violations recorded.
CUPOLA/ SPIRES/ TOWERS	Does not Exist
DORMER	Does not Exist
DUNNAGE STEEL	Inspected
Condition	2 - Between Good and Fair
Deficiency	No deficiencies recorded
SKYLIGHT/ROOF VENT	Does not Exist
ROOF/GRAVITY TANK	Does not Exist
STAIRS/RAMPS: EXTERIOR	Inspected
BUILDING CHEEK/FLANK WALLS	Inspected
Condition	2 - Between Good and Fair
Deficiency	No deficiencies recorded
RAILINGS	Inspected
Condition	2 - Between Good and Fair
Deficiency	No deficiencies recorded
STAIRS/RAMPS	Inspected
Condition	3 - Fair
Deficiency	CONCRETE: CRACKS/SPALLING - MINOR
Roof Plan reference	Q226

Question	Response
EXTERIOR	
ROOF	
Specialties	
BULKHEAD/PENTHOUSE	
Quantity Uom	S.F.
Potential Action	REPOINT
Urgency of Action	PRIORITY 3
Purpose of Action	LEVEL 2
Deficiency Photo1

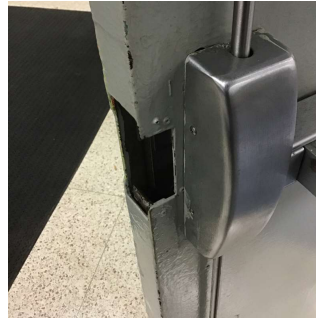
Question	Response
INTERIOR	
STRUCTURAL	
FOUNDATION WALLS	
Quantity Uom	S.F.
Potential Action	REPAIR
Urgency of Action	PRIORITY 3
Purpose of Action	LEVEL 5
Deficiency Photo1	 
Violations	Basement - Boiler Room Pit No violations recorded.
ROOF STRUCTURE	Inspected
Condition	2 - Between Good and Fair
Deficiency	No deficiencies recorded
VAULTS-BUNKERS	Does not Exist
AUDITORIUM	Inspected
Instance on 1st Floor (634 Seats)	Inspected
Ceiling	
Instance on 1st Floor (634 Seats)	Inspected
Condition	2 - Between Good and Fair
Deficiency	PLASTER: CRACKS/SPALLING
Deficiency Location/Instance	Left Stage
Deficiency Quantity	10
Quantity Uom	S.F.
Potential Action	REPLACE
Urgency of Action	PRIORITY 3
Purpose of Action	LEVEL 2
Deficiency Photo1	 
Violations	Left Stage No violations recorded.
Door(s)	
Instance on 1st Floor (634 Seats)	Inspected
Condition	4 - Between Fair and Poor
Deficiency	METAL: DETERIORATED DOOR
Deficiency Location/Instance	Near Main Entrance

Deficiency Quantity	2
Quantity Uom	EACH
Potential Action	MAINTENANCE
Urgency of Action	PRIORITY 3
Purpose of Action	LEVEL 2
Deficiency Photo1

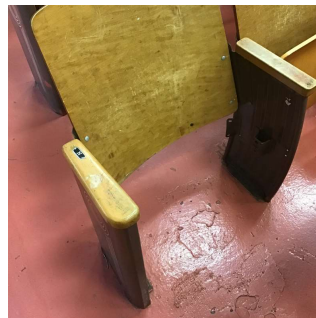
N/14

Deficiency	DAMAGED/BROKEN/INOPERABLE
Deficiency Location/Instance	Seat N/14, Q/14
Deficiency Quantity	2
Quantity Uom	EACH
Potential Action	REPLACE
Urgency of Action	PRIORITY 5
Purpose of Action	LEVEL 6
Deficiency Photo1

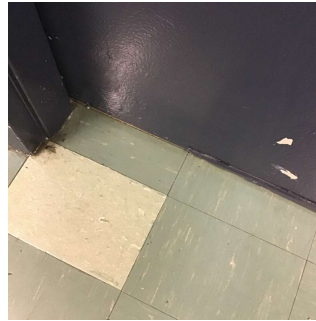
Near Main Entrance
Violations	No violations recorded.
Door(s)	Inspected
Condition	5 - Poor
Deficiency	METAL: DETERIORATED DOOR
Deficiency Location/Instance	Room 245
Deficiency Quantity	1
Quantity Uom	EACH
Potential Action	MAINTENANCE
Urgency of Action	PRIORITY 3
Purpose of Action	LEVEL 2

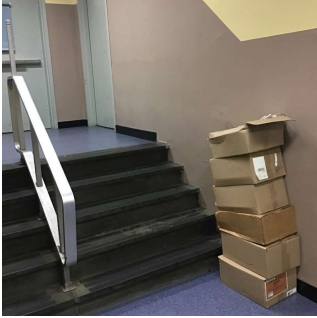
Violations	Stair D/1 No violations recorded.
Partition	Does not Exist
Railings	Inspected
Condition	3 - Fair
Deficiency	METAL: MISSING
Deficiency Location/Instance	Auditorium Right Side Exit
Deficiency Quantity	10
Quantity Uom	L.F.
Potential Action	REPLACE
Urgency of Action	PRIORITY 5
Purpose of Action	LEVEL 6
Deficiency Photo1

Violations	Auditorium Right Side Exit No violations recorded.
Deficiency	METAL: BROKEN BRACKET
Deficiency Location/Instance	Stair D/1
Deficiency Quantity	2
Quantity Uom	EACH
Potential Action	REPLACE
Urgency of Action	PRIORITY 5
Purpose of Action	LEVEL 6

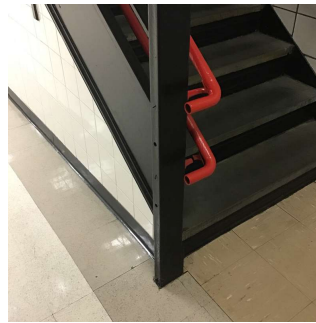
No	Protruding Elements	Broken handrail resulting potential safety hazard	INTERIOR STAIRS/RAMP S: INTERIOR Railings	Stair D/1	John Rabuse	Fireman

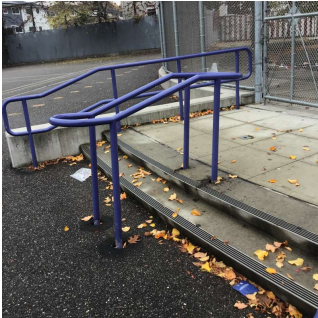
No	Protruding Elements	Improperly anchored handrail resulting in potential safety hazard	SITE STAIRS/RAMP S: EXTERIOR Railings	122nd Street Exit	John Rabuse	Fireman

Near Playground
Violations	No violations recorded.
STAIRS/RAMPS: EXTERIOR	Inspected
Railings	Inspected
Condition	2 - Between Good and Fair
Deficiency	DAMAGED
Deficiency Location/Instance	122nd Street Exit

122nd Street Exit
Violations	No violations recorded.
Site Cheek/flank Walls	Inspected
Condition	2 - Between Good and Fair
Deficiency	No deficiencies recorded
Stairs/ramps	Inspected
Condition	2 - Between Good and Fair
Deficiency	No deficiencies recorded
ARTWORK	Inspected
Instance	Interior - Auditorium - 21001
Instance Photo
