**NYC Department of Education**  
**Building Condition Assessment Survey 2023 - 2024**

Architectural Inspection

**Asset:** I.S. 227 - QUEENS, 32-02 JUNCTION BLVD, New York, 11369

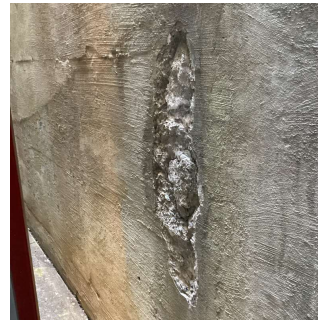
AW1

Question	Response
<b>Architectural</b>	
<b>EXTERIOR</b>	Inspected
<b>AREAWAY</b>	Inspected
Instance on AW1, AW2	Inspected
Instance Condition	3 - Fair
Instance Quantity	2
Instance Quantity Uom	EACH
Deficiency	AREAWAY WALLS: CRACKS AND SPALLING

REPLACE

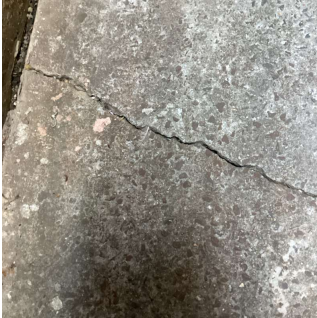
**AREAWAY SLAB: CRACKS AND SPALLING**

Violations	AW1 No violations recorded.
<b>AWNINGS AND CANOPIES</b>	Does not Exist
<b>CHIMNEY</b>	Inspected
Material Type(s)	Masonry
Condition	3 - Fair
Deficiency	<b>BRICK: DETERIORATED JOINTS</b>
Roof Plan reference

REPLACE

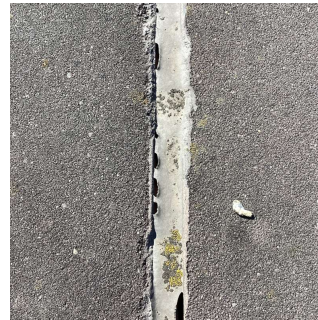
Roof 1

Violations	CH No violations recorded.
<b>COPING</b>	Inspected
Condition	2 - Between Good and Fair
Deficiency	<b>CAST STONE: DETERIORATED TRANSVERSE JOINTS</b>

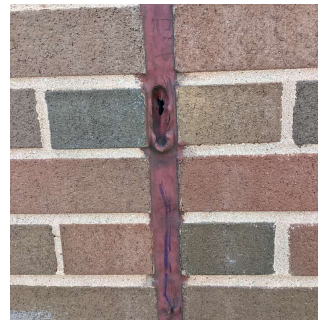
Facade B

**BRICK: DETERIORATED CONTROL/EXPANSION JOINTS**

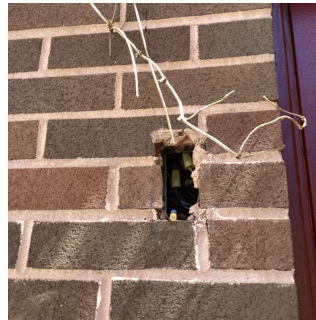
Facade D

**BRICK: MAJOR / THRU CRACKS**

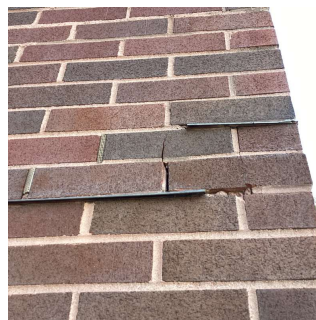
**BRICK: DETERIORATED JOINTS**

10  
S.F.  
REPOINT  
PRIORITY 3  
LEVEL 2

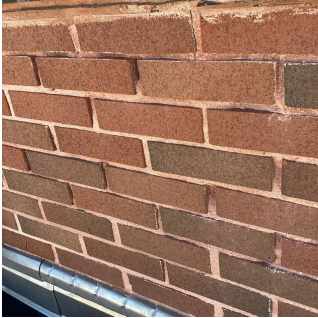
Deficiency Quantity	180
Quantity Uom	S.F.

Question	Response
<b>EXTERIOR</b>	
<b>PARAPETS</b>	
Potential Action	REPOINT
Urgency of Action	PRIORITY 3
Purpose of Action	LEVEL 2
Deficiency Photo1

Roof 1
Violations	No violations recorded.
<b>PLAZA DECK</b>	Does not Exist
<b>ROOF</b>	Inspected
<b>Roofing</b>	Inspected
Replacement Quantity	52,000
Replacement Uom	S.F.
<b>ROOF HATCH/SMOKE HATCH</b>	Inspected
Condition	2 - Between Good and Fair
Deficiency	No deficiencies recorded
<b>LEADERS, GUTTERS, DOWNSPOUTS, SCUPPERS</b>	Inspected
Condition	3 - Fair
Deficiency	DAMAGED/MISSING
Roof Plan reference

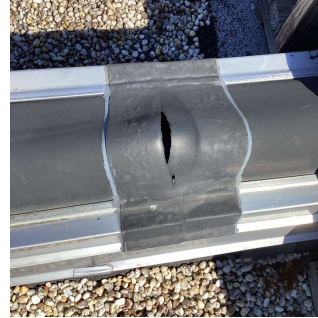
Roof 1
Instance Quantity	51,000
Instance Quantity Uom	S.F.
Does the roof have major mechanical equipment sitting on Dunnage Steel less than 18" above the Roofing?	No
Does this roof instance have a Sustainable Roof System?	No
Do solar panels exist on these roofs?	Yes
Solar Panel Location (Roof Number)	Roof 1, 2
Installation Year	2009
Source of Installation	Custodial Staff
Deficiency	<b>BUILT-UP: ROOFING: OPEN SEAMS</b>
Roof Plan reference	Q227

Deficiency Quantity	20
Quantity Uom	L.F.
Potential Action	REPAIR
Urgency of Action	PRIORITY 4

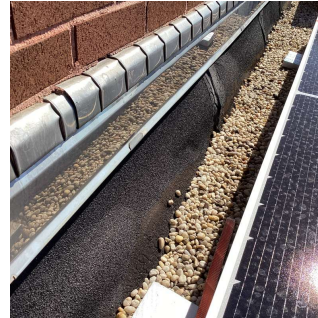
Roof 1

**BUILT-UP: FLASHING: BASE FLASHING DETERIORATED**

**REMOVE AND REPLACE**

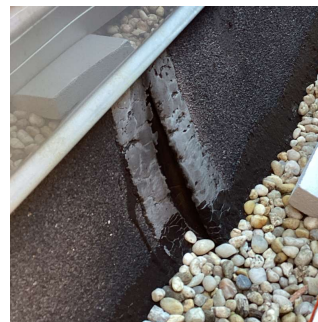
Roof 1  
No violations recorded.

**BUILT-UP: FLASHING: DETERIORATED JOINTS**

60  
L.F.  
MAINTENANCE  
PRIORITY 3  
LEVEL 2

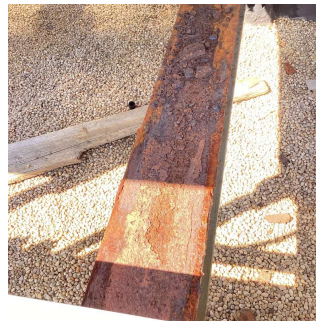
Roof 1

**MAJOR RUSTING**

REPLACE

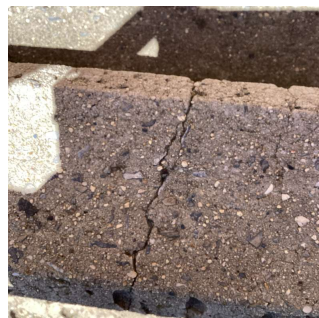
**CAST IN PLACE CONCRETE: CRACKS/SPALLING - MINOR**

Question	Response
<b>EXTERIOR</b>	
<b>STAIRS/RAMPS: EXTERIOR</b>	
<b>BUILDING CHEEK/FLANK WALLS</b>	
Quantity Uom Potential Action Urgency of Action Purpose of Action Deficiency Photo1	S.F. REPAIR PRIORITY 3 LEVEL 2

Violations	Facade C No violations recorded.
Deficiency Roof Plan reference	CAST IN PLACE CONCRETE: CRACKS/SPALLING - MAJOR

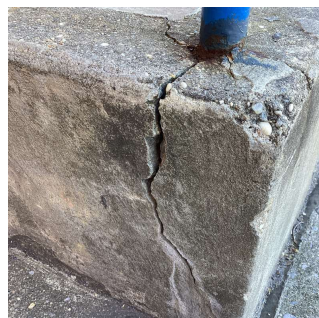
Deficiency Quantity Quantity Uom Potential Action Urgency of Action Purpose of Action Deficiency Photo1	20 S.F. REPLACE PRIORITY 4 LEVEL 2

Violations	Facade A No violations recorded.
<b>RAILINGS</b>	
Condition	Inspected 5 - Poor
Deficiency	RUST - MAJOR

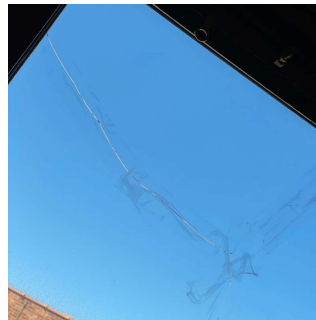
Facade D - Room 426

Violations	Facade A No violations recorded.
<b>WINDOWS</b>	Inspected
Replacement Quantity	7,400
Replacement Uom	S.F.
<b>EXTERIOR GUARDS</b>	Inspected
Condition	2 - Between Good and Fair
Deficiency	No deficiencies recorded
<b>LINTELS</b>	Inspected
Condition	2 - Between Good and Fair
Deficiency	No deficiencies recorded
<b>WINDOWS</b>	Inspected
Material Type(s)	Aluminum
Instance on Aluminum - Other: All Facades	Inspected
Instance Condition	2 - Between Good and Fair
Instance Quantity	5,400
Instance Quantity Uom	S.F.
Are these windows insulated	Yes
Installation Year	2009
Source of Installation	Custodial Staff
Deficiency	ALUMINUM - OTHER: BROKEN PANE

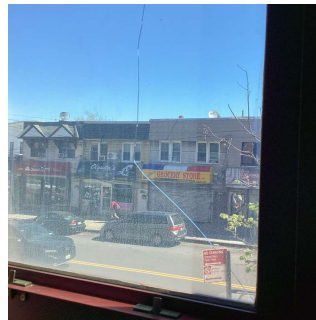
Facade B - Room 213A  
No violations recorded.

ALUMINUM - DOUBLE HUNG: BROKEN PANE

30  
S.F.  
MAINTENANCE  
PRIORITY 3  
LEVEL 2

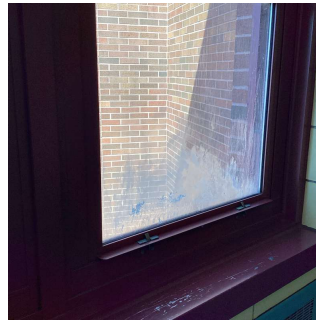
Facade D - Corridor near Elevator Bank A  
No violations recorded.

**ALUMINUM - DOUBLE HUNG: DETERIORATED**

30  
S.F.  
REPLACE WINDOW  
PRIORITY 4  
LEVEL 2

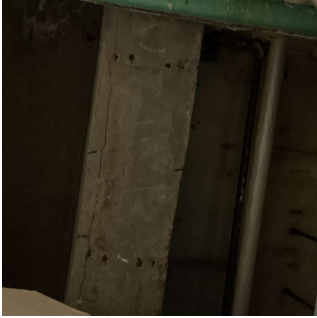
Violations	Basement - Room 26 No violations recorded.
Deficiency	<b>STEEL COLUMNS/BEAMS: DETERIORATED CONCRETE FIREPROOFING</b>
Deficiency Location/Instance	Basement - Room 26
Deficiency Quantity	10
Quantity Uom	S.F.
Potential Action	REPLACE
Urgency of Action	PRIORITY 3
Purpose of Action	LEVEL 5
Deficiency Photo1

Violations	Basement - Room 26 No violations recorded.
<b>FLOOR STRUCTURE</b>	
Condition	Inspected 3 - Fair
Deficiency	<b>CONCRETE: CRACKS/SPALLED/REINFORCEMENT EXPOSED</b>
Deficiency Location/Instance	Basement - Room B31

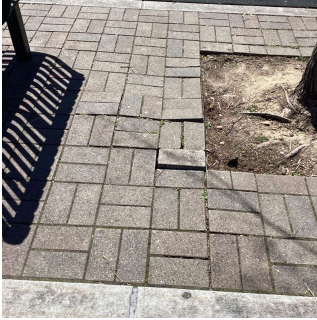
Violations	Schoolyard No violations recorded.
<b>Concrete</b>	Inspected
Condition	2 - Between Good and Fair
Deficiency	No deficiencies recorded
<b>Pavers</b>	Inspected
Condition	2 - Between Good and Fair
Deficiency	HEAVING
Deficiency Location/Instance	Schoolyard
Deficiency Quantity	20
Quantity Uom	S.F.
Potential Action	REPLACE
Urgency of Action	PRIORITY 3
Purpose of Action	LEVEL 2
Deficiency Photo1

Violations	Schoolyard No violations recorded.
<b>Site Sidewalks &amp; Walkways</b>	Inspected
<b>Asphalt</b>	Inspected
Condition	4 - Between Fair and Poor
Deficiency	POTHoles
Deficiency Location/Instance	Exit 10 Near Schoolyard
