**NYC Department of Education**  
**Building Condition Assessment Survey 2023 - 2024**

Architectural Inspection

**Asset:** P.S. 228 (ECC) - QUEENS, 32-63 93RD STREET, New York, 11369

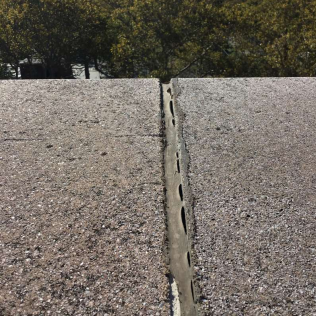
Question	Response
<b>EXTERIOR</b>	
<b>COPING</b>	
Roof Plan reference	<p>Q228</p>

Deficiency Quantity	30
Quantity Uom	L.F.
Potential Action	MAINTENANCE
Urgency of Action	PRIORITY 3
Purpose of Action	LEVEL 2
Deficiency Photo1

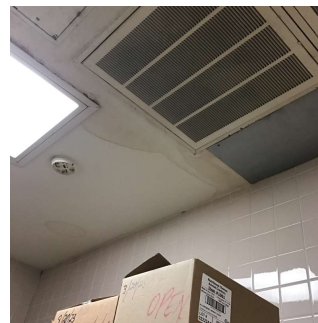
Facade B - Kitchen Dry Storage Room 108

BRICK: WATER INFILTRATION IN NON-INSTRUCTIONAL SPACE

Deficiency Quantity

100

PRIORITY 5

REPAIR

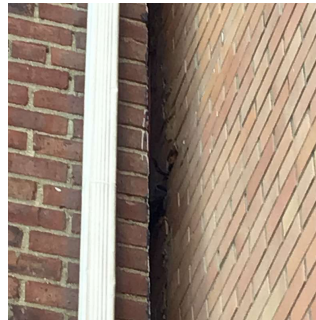
Facade B

BRICK: MAJOR / THRU CRACKS

PRIORITY 4

REMOVE AND REBUILD

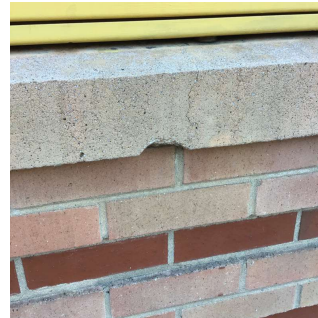
Facade D

BRICK: DETERIORATED MASONRY SILLS - MINOR

PRIORITY 3  
LEVEL 2

REPAIR

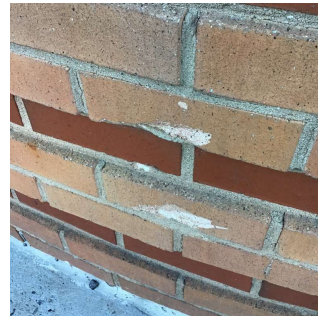
Facade A

**BRICK: MINOR CRACKS AND SPALLING**

PRIORITY 3

RESTITCH

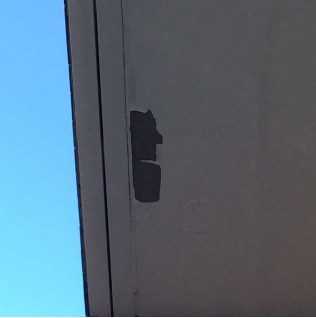
Question	Response
<b>EXTERIOR</b>	
<b>EXTERIOR WALLS</b>	Inspected
Violations	No violations recorded.
<b>EXTERIOR SOFFITS</b>	Inspected
Condition	3 - Fair
Deficiency	CONCRETE: WATER PENETRATION
Roof Plan reference	Q228

Deficiency Quantity	10
Quantity Uom	S.F.
Potential Action	REPAIR
Urgency of Action	PRIORITY 5
Purpose of Action	LEVEL 2
Deficiency Photo1

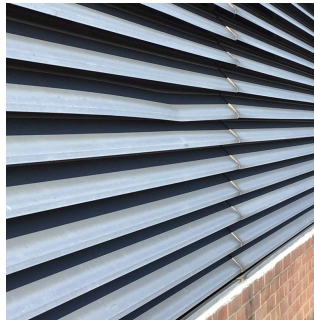
Roof 1

Violations	Facade A No violations recorded.
<b>LOADING DOCK</b>	Does not Exist
<b>LOUVER</b>	Inspected
Condition	3 - Fair
Deficiency	BROKEN/ DENTED BLADES

REPLACE

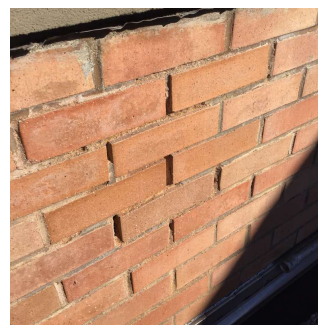
Roof 1  
No violations recorded.

BRICK: DETERIORATED JOINTS

30  
S.F.  
REPOINT  
PRIORITY 4  
LEVEL 2

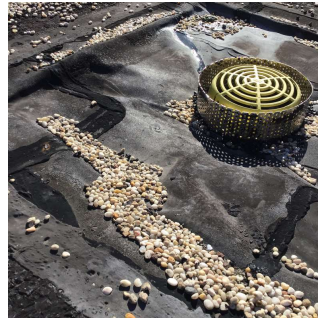
Roof 1
Instance Quantity	7,500
Instance Quantity Uom	S.F.
Does the roof have major mechanical equipment sitting on Dunnage Steel less than 18" above the Roofing?	No
Does this roof instance have a Sustainable Roof System?	No
Do solar panels exist on these roofs?	No
Is/Are the roof(s) suitable for Solar Panel installation?	No
Installation Year	2001
Source of Installation	Custodial Staff
Deficiency	<b>BUILT-UP: ROOFING: DELAMINATION</b>

Deficiency Quantity	100
Quantity Uom	S.F.
Potential Action	REPLACE ROOFING WITHOUT MAJOR EQUIPMENT REMOVAL
Urgency of Action	PRIORITY 4
Purpose of Action	LEVEL 2

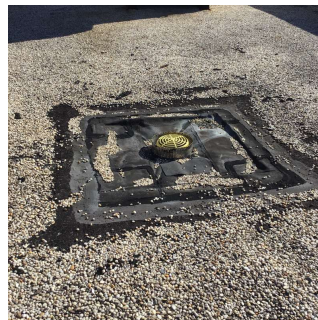
Roof 1

**BUILT-UP: ROOFING: LOSS OF GRAVEL**

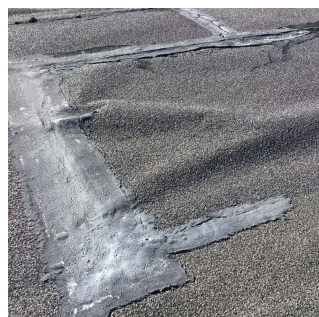
Question	Response
<b>EXTERIOR</b>	
<b>ROOF</b>	
<b>Roofing</b>	
<b>ROOFING</b>	
Roof Plan reference	 
Deficiency Quantity	100
Quantity Uom	S.F.
Potential Action	REPLACE ROOFING WITHOUT MAJOR EQUIPMENT REMOVAL
Urgency of Action	PRIORITY 5
Purpose of Action	LEVEL 2
Deficiency Photo1	 
Violations	Roof 1 - Room 307 No violations recorded.
Instance on Modified Bitumen: Roof 2	Inspected
Instance Condition	5 - Poor
Instance Photo	 
	Roof 2
Instance Quantity	4,000
Instance Quantity Uom	S.F.
Does the roof have major mechanical equipment sitting on Dunnage Steel less than 18" above the Roofing?	No
Does this roof instance have a Sustainable Roof System?	No
Do solar panels exist on these roofs?	No
Is/Are the roof(s) suitable for Solar Panel installation?	No
Installation Year	2001
Source of Installation	Custodial Staff
Deficiency	MODIFIED BITUMEN: ROOFING: DELAMINATION

<p>Deficiency Quantity</p> <p>Quantity Uom</p> <p>Potential Action</p> <p>Urgency of Action</p> <p>Purpose of Action</p> <p>Deficiency Photo1</p>	<p>200</p> <p>S.F.</p> <p>REPLACE ROOFING WITHOUT MAJOR EQUIPMENT REMOVAL</p> <p>PRIORITY 4</p> <p>LEVEL 2</p>
<p>Violations</p>

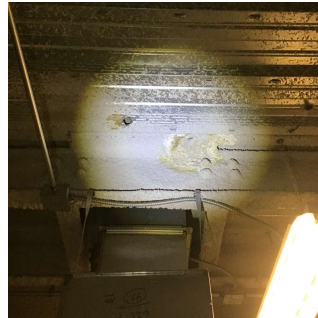
Roof 2 - Penthouse

<p>Roof 2</p> <p>No violations recorded.</p>
<p>Deficiency</p>	<p>MODIFIED BITUMEN: ROOFING: MAJOR ACTIVE ROOF LEAKS IN NON-INSTRUCTIONAL SPACE</p>
<p>Roof Plan reference</p>	<p align="center">Q228</p>

<p>Deficiency Quantity</p> <p>Quantity Uom</p> <p>Potential Action</p> <p>Urgency of Action</p> <p>Purpose of Action</p>	<p>100</p> <p>S.F.</p> <p>REPLACE ROOFING WITHOUT MAJOR EQUIPMENT REMOVAL</p> <p>PRIORITY 5</p> <p>LEVEL 2</p>

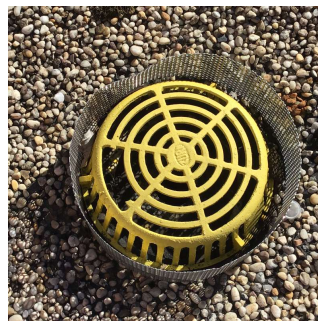
Roof 1

DETERIORATED

REPLACE

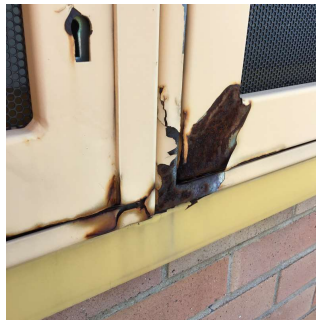
Penthouse  
 No violations recorded.

BULKHEAD/PENTHOUSE WINDOWS: DAMAGED,  
DETERIORATED WINDOWS

180  
 S.F.  
 REPLACE  
 PRIORITY 4  
 LEVEL 2

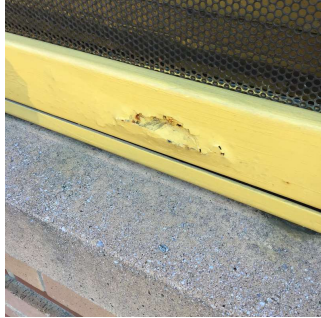
Question	Response
<b>EXTERIOR</b>	
<b>ROOF</b>	
<b>Specialties</b>	
<b>BULKHEAD/PENTHOUSE</b>	
Deficiency Photo1	 
Violations	Roof 1 - Penthouse No violations recorded.
<b>CUPOLA/ SPIRES/ TOWERS</b>	Does not Exist
<b>DORMER</b>	Does not Exist
<b>DUNNAGE STEEL</b>	Does not Exist
<b>SKYLIGHT/ROOF VENT</b>	Does not Exist
<b>ROOF/GRAVITY TANK</b>	Does not Exist
<b>STAIRS/RAMPS: EXTERIOR</b>	Does not Exist
<b>WINDOWS</b>	Inspected
Replacement Quantity	2,500
Replacement Uom	S.F.
<b>EXTERIOR GUARDS</b>	Inspected
Condition	3 - Fair
Deficiency	RUST - MAJOR
Roof Plan reference	<p>Q228</p>  
Elevation	 
Deficiency Quantity	80
Quantity Uom	S.F.
Potential Action	REPLACE

Question	Response
<b>EXTERIOR</b>	
<b>WINDOWS</b>	
<b>EXTERIOR GUARDS</b>	
Urgency of Action	PRIORITY 4
Purpose of Action	LEVEL 2
Deficiency Photo1

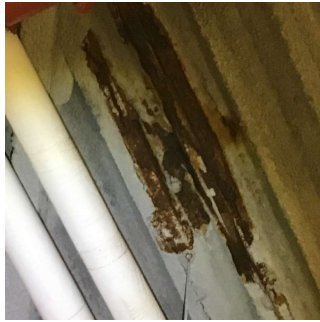
Structural Condition Type	Condition Description	Component Affected	Location Description	Person(s) Notified	Person(s) Title	PhotoImage
Deteriorated Steel	Deteriorated metal deck floor structure is a potential hazard.	INTERIOR   STRUCTURAL   FLOOR STRUCTURE	Basement - Boiler Room	Lulli Debrosse	Handyman

<p>Penthouse</p> <p>No violations recorded.</p>
Violations	
<b>FLOOR STRUCTURE</b>	
Condition	<p>Inspected</p> <p>3 - Fair</p>
Deficiency	METAL DECK AND CONCRETE: DETERIORATED
Deficiency Location/Instance	Basement - Boiler Room
Deficiency Quantity	50
Quantity Uom	S.F.
Potential Action	REPAIR
Urgency of Action	PRIORITY 5
Purpose of Action	LEVEL 6
Deficiency Photo1

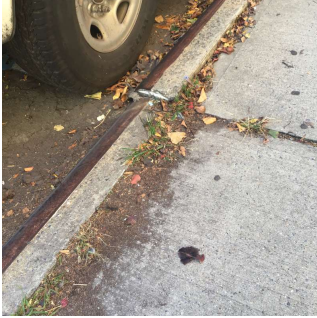
Question	Response
<b>SITE</b>	
<b>FENCES</b>	
Deficiency Photo1	 
Violations	Along Northern Boulevard No violations recorded.
<b>IRRIGATION SYSTEM</b>	Does not Exist
<b>PAVING</b>	Inspected
<b>Student Non-Use</b>	Does not Exist
<b>Student Use</b>	Does not Exist
<b>Site Sidewalks &amp; Walkways</b>	Inspected
<b>Asphalt</b>	Does not Exist
<b>Concrete</b>	Inspected
Condition	3 - Fair
Deficiency	CRACKS - MAJOR
Deficiency Location/Instance	Main Entrance
Deficiency Quantity	75
Quantity Uom	S.F.
Potential Action	REPLACE
Urgency of Action	PRIORITY 3
Purpose of Action	LEVEL 2
Deficiency Photo1	 
Violations	Main Entrance No violations recorded.
<b>Pavers</b>	Does not Exist
<b>DOT Sidewalk</b>	Inspected
<b>Asphalt</b>	Does not Exist
<b>Concrete</b>	Inspected
Condition	4 - Between Fair and Poor
Deficiency	DAMAGED CURBS
Deficiency Location/Instance	Along Northern Boulevard
Deficiency Quantity	10
Quantity Uom	L.F.
Potential Action	REPLACE

Question	Response
<b>SITE</b>	
<b>PAVING</b>	
<b>DOT Sidewalk</b>	
<b>Concrete</b>	
Urgency of Action	PRIORITY 3
Purpose of Action	LEVEL 2
Deficiency Photo1

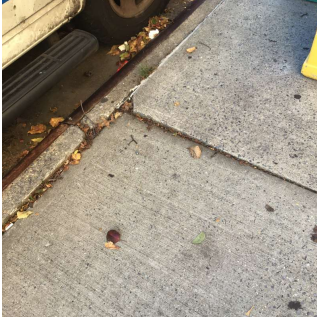
Violations	Northern Boulevard No violations recorded.
Deficiency	HEAVING
Deficiency Location/Instance	Along Northern Boulevard
Deficiency Quantity	50
Quantity Uom	S.F.
Potential Action	REPLACE
Urgency of Action	PRIORITY 3
Purpose of Action	LEVEL 2
Deficiency Photo1

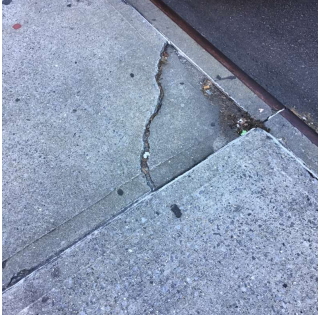
Violations	Along Northern Boulevard No violations recorded.
Deficiency	DAMAGED/DETERIORATED/MISSING SECTIONS
Deficiency Location/Instance	Along 93rd Street
Deficiency Quantity	625
Quantity Uom	S.F.
Potential Action	REPLACE
Urgency of Action	PRIORITY 3
Purpose of Action	LEVEL 2

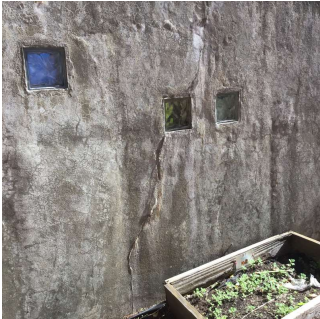
Question	Response
<b>SITE</b>	
<b>SITE WALLS (NOT RETAINING WALLS)</b>	
Deficiency	CAST IN PLACE CONCRETE: CRACKS/SPALLING - MAJOR
Deficiency Location/Instance	Playground Wall, Playground Entrance
Deficiency Quantity	20
Quantity Uom	S.F.
Potential Action	REPLACE
Urgency of Action	PRIORITY 3
Purpose of Action	LEVEL 2
Deficiency Photo1
