NYC Department of Education
Building Condition Assessment Survey 2023 - 2024

Architectural Inspection

Asset: P.S. 232 - QUEENS, 153-23 83 STREET, New York, 11414

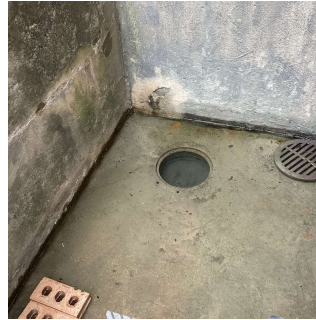
Question	Response
Architectural	
EXTERIOR	Inspected
AREAWAY	Inspected
Instance on AW1	Under Construction
Instance Quantity	1
Instance Quantity Uom	EACH
Instance on AW2	Inspected
Instance Condition	3 - Fair
Instance Quantity	1
Instance Quantity Uom	EACH
Deficiency	AREAWAY DRAINS: CLOGGED
Roof Plan reference

1
EACH
MAINTENANCE
PRIORITY 5
LEVEL 2

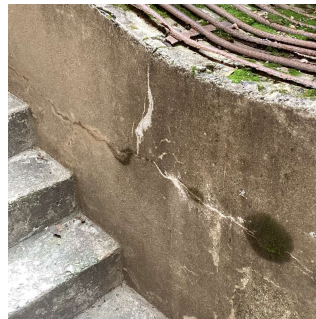
AW2

AREAWAY WALLS: CRACKS AND SPALLING

30
S.F.
REPAIR
PRIORITY 3
LEVEL 2

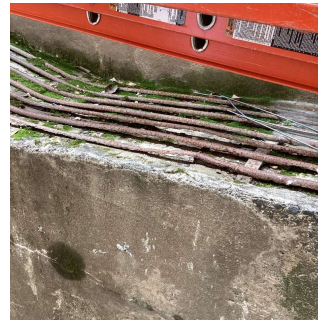
AW2

AREAWAY STAIRS: DETERIORATED MATERIAL SLIDE

REPLACE

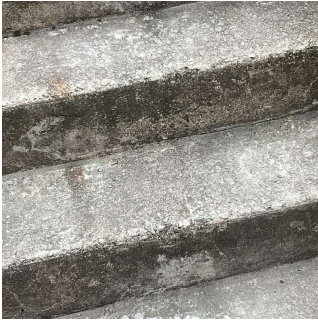
AREAWAY STAIRS: DETERIORATED TREADS/RISERS/NOSINGS

REPAIR

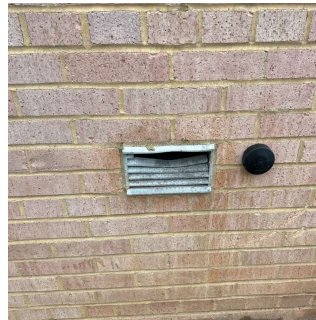
Facade C

BROKEN/ DENTED BLADES

REPLACE

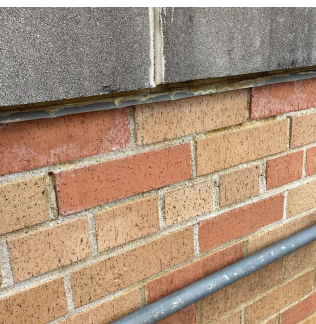
Question	Response
EXTERIOR	
PARAPETS	
Purpose of Action	LEVEL 1
Deficiency Photo1	No photo recorded
Violations	No violations recorded.
Deficiency	BRICK: DETERIORATED JOINTS
Roof Plan reference	<p>Q232</p>

Deficiency Quantity	60
Quantity Uom	S.F.
Potential Action	REPOINT
Urgency of Action	PRIORITY 3
Purpose of Action	LEVEL 2
Deficiency Photo1

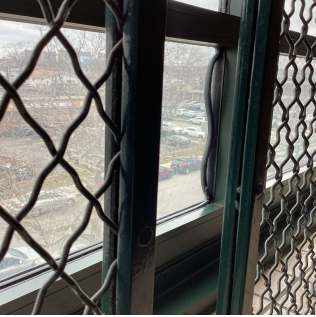
Question	Response
EXTERIOR	
ROOF	
Specialties	
BULKHEAD/PENTHOUSE	Inspected
Condition	3 - Fair
Deficiency	BULKHEAD/PENTHOUSE WINDOWS: DAMAGED, DETERIORATED WINDOWS
Roof Plan reference

Deficiency Quantity	40
Quantity Uom	S.F.
Potential Action	REPLACE
Urgency of Action	PRIORITY 4
Purpose of Action	LEVEL 2
Deficiency Photo1

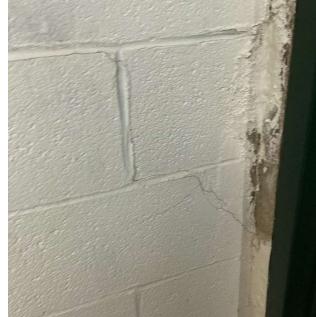
Violations	BH1 No violations recorded.
Deficiency	BULKHEAD/PENTHOUSE WALLS/INTERIOR: CMU CRACKS/SPALLING
Roof Plan reference

Deficiency Quantity	20
Quantity Uom	S.F.
Potential Action	REPLACE
Urgency of Action	PRIORITY 3
Purpose of Action	LEVEL 2

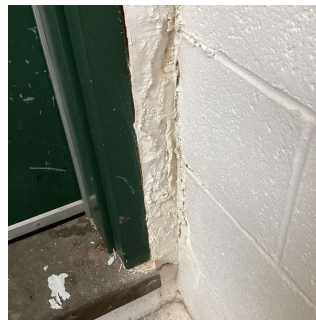
BH1

**BULKHEAD/PENTHOUSE WALLS/INTERIOR: PLASTER
CRACKS/SPALLING**

REPLACE

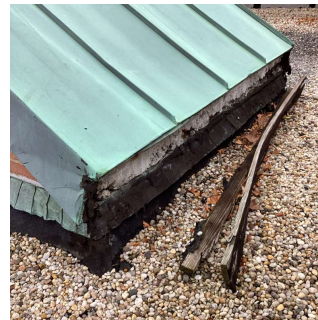
BH2
No violations recorded.

**BULKHEAD/PENTHOUSE WALLS/EXTERIOR:
CRACKS/SPALLING - MAJOR**

20
S.F.
REPLACE
PRIORITY 4
LEVEL 2

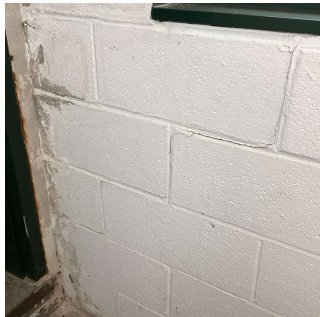
Violations	BH2 No violations recorded.
Deficiency	BULKHEAD/PENTHOUSE WALLS/INTERIOR: CMU DETERIORATED JOINTS
Roof Plan reference	Q232

Deficiency Quantity	40
Quantity Uom	S.F.
Potential Action	REPOINT
Urgency of Action	PRIORITY 3
Purpose of Action	LEVEL 2
Deficiency Photo1

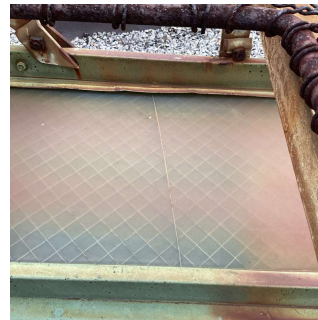
SK
No violations recorded.

Violations	BH2 No violations recorded.
CUPOLA/ SPIRES/ TOWERS	Does not Exist
DORMER	Does not Exist
DUNNAGE STEEL	Does not Exist
SKYLIGHT/ROOF VENT	Inspected
Material Type(s)	Plastic
Condition	3 - Fair
Deficiency	BROKEN GLASS

10
S.F.
MAINTENANCE
PRIORITY 3
LEVEL 2

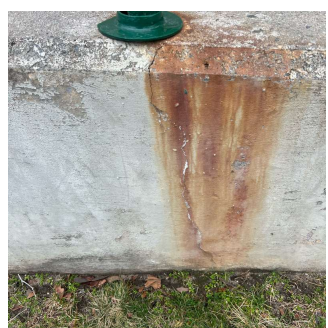
Question	Response
EXTERIOR	
STAIRS/RAMPS: EXTERIOR	
BUILDING CHEEK/FLANK WALLS	Inspected
Condition	3 - Fair
Deficiency	CAST IN PLACE CONCRETE: CRACKS/SPALLING - MINOR
Roof Plan reference

Deficiency Quantity	20
Quantity Uom	S.F.
Potential Action	REPAIR
Urgency of Action	PRIORITY 3
Purpose of Action	LEVEL 2
Deficiency Photo1

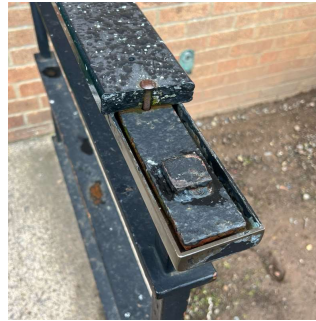
Facade A - Exit 2

Violations	Facade A No violations recorded.
RAILINGS	
Condition	Inspected
Condition	5 - Poor
Deficiency	DAMAGED
Roof Plan reference

Deficiency Quantity	60
Quantity Uom	L.F.
Potential Action	REPLACE
Urgency of Action	PRIORITY 4
Purpose of Action	LEVEL 2

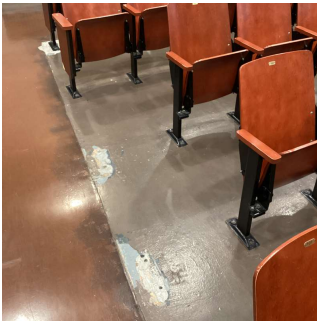
Instance on 1st Floor (416 Seats)	Inspected
Condition	2 - Between Good and Fair
Deficiency	DAMAGED/BROKEN/INOPERABLE
Deficiency Location/Instance	Seats D/101, L/101, N/101, O/101
Deficiency Quantity	4
Quantity Uom	EACH
Potential Action	REPLACE
Urgency of Action	PRIORITY 3
Purpose of Action	LEVEL 2

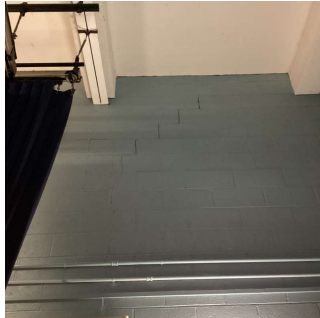
Near Entrance
Violations	No violations recorded.
Deficiency	MASONRY: CRACKS/SPALLING
Deficiency Location/Instance	Left Side of Stage
Deficiency Quantity	40
Quantity Uom	S.F.
Potential Action	REPLACE
Urgency of Action	PRIORITY 3
Purpose of Action	LEVEL 2
Deficiency Photo1

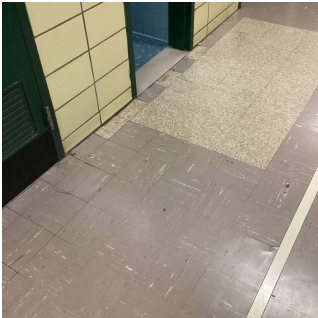
Violations	Room 315 No violations recorded.
Floor Finish	
Condition	Inspected
Condition	2 - Between Good and Fair
Deficiency	VINYL TILES: BROKEN/DETERIORATED/MISSING TILES
Deficiency Location/Instance	Corridor near Room 315, Rooms 322, 320, 206, 202 and others

Deficiency Quantity	650
Quantity Uom	S.F.
Potential Action	REPLACE
Urgency of Action	PRIORITY 3

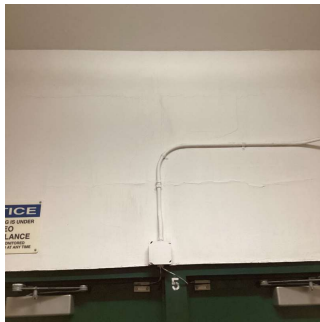
Corridor near Stair A/3
Violations	No violations recorded.
Deficiency	PLASTER: CRACKS/SPALLING
Deficiency Location/Instance	Exits 5, 9 Vestibules, Corridor near cafeteria, Corridor near stair A/3, 2 and others
Deficiency Quantity	120
Quantity Uom	S.F.
Potential Action	REPLACE
Urgency of Action	PRIORITY 3
Purpose of Action	LEVEL 2
Deficiency Photo1

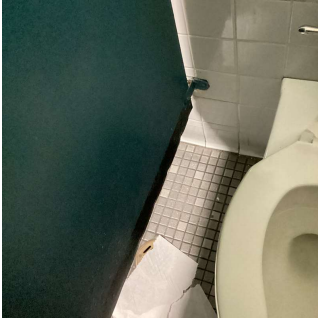
Question	Response
INTERIOR	
TOILET ROOMS - STAFF	
Stalls	Inspected
Condition	5 - Poor
Deficiency	RUST - MAJOR
Deficiency Location/Instance	Room 203
Deficiency Quantity	1
Quantity Uom	EACH
Potential Action	REPLACE
Urgency of Action	PRIORITY 3
Purpose of Action	LEVEL 2
Deficiency Photo1

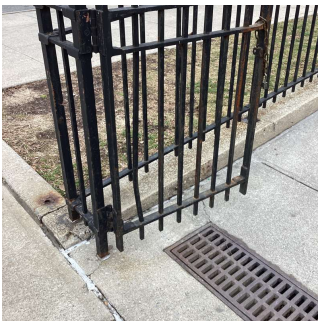
Condition	4 - Between Fair and Poor
Deficiency	WROUGHT IRON: DAMAGED/DETERIORATED
Deficiency Location/Instance	153rd Avenue
Deficiency Quantity	40
Quantity Uom	S.F.
Potential Action	REPLACE
Urgency of Action	PRIORITY 3
Purpose of Action	LEVEL 2
Deficiency Photo1

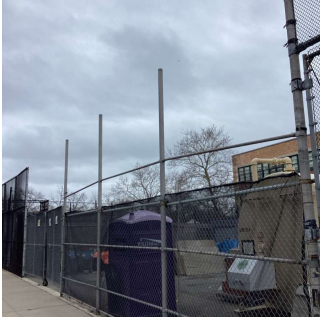
Violations	84th Street No violations recorded.
Deficiency	CHAIN LINK: MISSING SECTIONS
Deficiency Location/Instance	84th Street
Deficiency Quantity	150
Quantity Uom	S.F.
Potential Action	REPLACE
Urgency of Action	PRIORITY 3
Purpose of Action	LEVEL 2
Deficiency Photo1

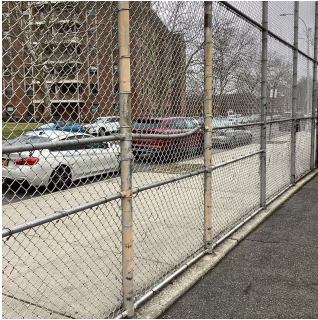
Violations	84th Street No violations recorded.
Deficiency	CHAIN LINK: DAMAGED POST/RAIL
Deficiency Location/Instance	84th Street
Deficiency Quantity	20
Quantity Uom	L.F.
Potential Action	REPLACE
Urgency of Action	PRIORITY 3
Purpose of Action	LEVEL 2

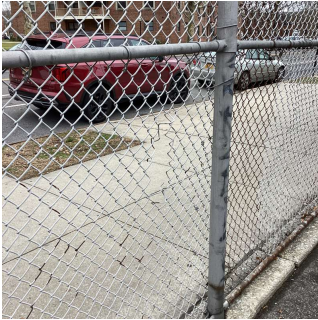
Violations	84th Street No violations recorded.
Deficiency	CHAIN LINK: DAMAGED/DETERIORATED
Deficiency Location/Instance	84th Street, Near TCUs, Near Exit 5
Deficiency Quantity	400
Quantity Uom	S.F.
Potential Action	REPLACE
Urgency of Action	PRIORITY 3
Purpose of Action	LEVEL 2
Deficiency Photo1
