NYC Department of Education
Building Condition Assessment Survey 2023 - 2024

Architectural Inspection

Asset: P.S. 234 - QUEENS, 30-15 29TH STREET, New York, 11102

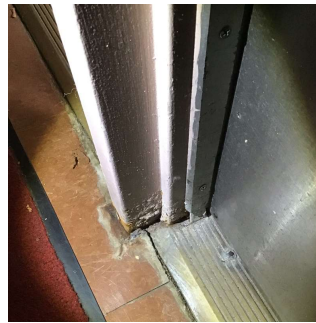
Facade B

METAL: DETERIORATED DOOR AND FRAME - MAJOR DETERIORATION

REPLACE

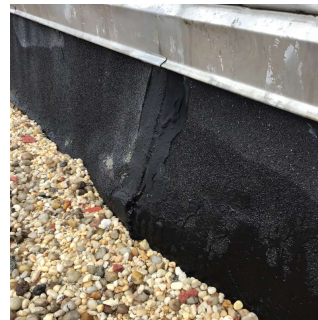
Roof 1
No violations recorded.

Is/Are the roof(s) suitable for Solar Panel installation?	Yes
Installation Year	2003
Source of Installation	Custodial Staff
Deficiency	BUILT-UP: FLASHING: DETERIORATED JOINTS

30
L.F.
MAINTENANCE
PRIORITY 3
LEVEL 2

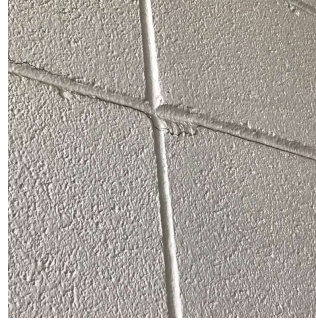
PH

BULKHEAD/PENTHOUSE WALLS/INTERIOR: CMU
CRACKS/SPALLING

15
S.F.
REPLACE

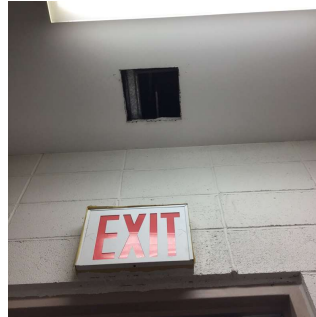
PH

BULKHEAD/PENTHOUSE CEILING: GYPSUM BOARD DAMAGED/DETERIORATED

10
S.F.
REPLACE
PRIORITY 4
LEVEL 2

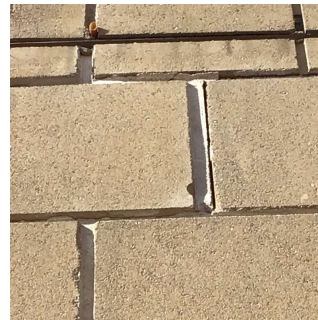
PH
 No violations recorded.

BULKHEAD/PENTHOUSE WALLS/EXTERIOR: MAJOR THRU CRACKS

20
 S.F.
 REMOVE AND REBUILD
 PRIORITY 4
 LEVEL 2

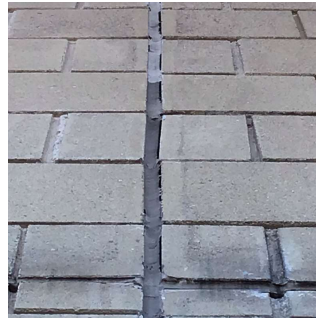
PH

Deficiency **BULKHEAD/PENTHOUSE WALLS/EXTERIOR: DETERIORATED JOINTS**

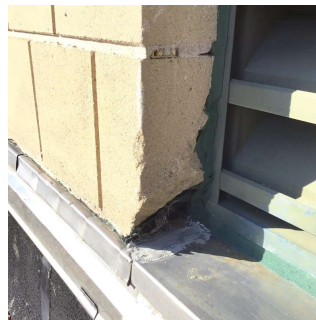
PH

**BULKHEAD/PENTHOUSE WALLS/EXTERIOR:
CRACKS/SPALLING - MAJOR**

REPLACE

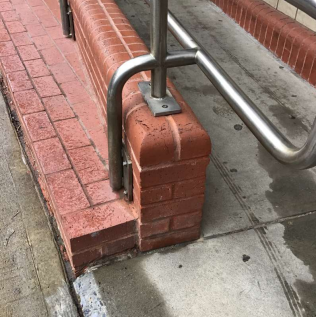
Question	Response
EXTERIOR	
STAIRS/RAMPS: EXTERIOR	Inspected
BUILDING CHEEK/FLANK WALLS	Inspected
Condition	2 - Between Good and Fair
Deficiency	BRICK: CRACKS/SPALLING - MINOR
Roof Plan reference	Q234

Deficiency Quantity	10
Quantity Uom	S.F.
Potential Action	REPAIR
Urgency of Action	PRIORITY 3
Purpose of Action	LEVEL 2
Deficiency Photo1

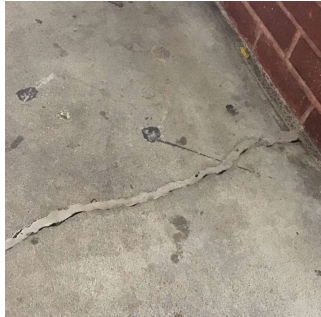
Violations	Facade A No violations recorded.
RAILINGS	Inspected
Condition	2 - Between Good and Fair
Deficiency	No deficiencies recorded
STAIRS/RAMPS	Inspected
Condition	4 - Between Fair and Poor
Deficiency	CONCRETE: CRACKS/SPALLING - MAJOR
Roof Plan reference	Q234

Deficiency Quantity	20
Quantity Uom	S.F.
Potential Action	REPLACE
Urgency of Action	PRIORITY 4

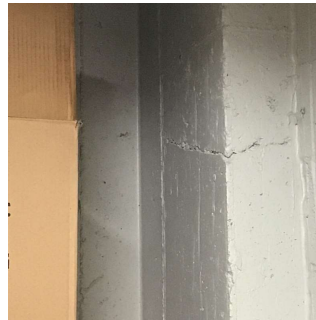
Basement - Room 47

STEEL COLUMNS/BEAMS: DETERIORATED CONCRETE FIREPROOFING

REPLACE

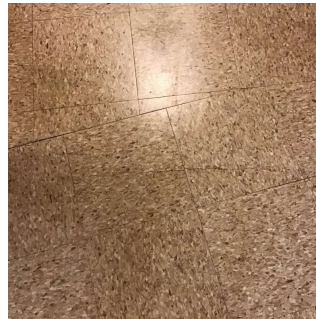
Near Seat A/109

Deficiency VINYL TILES: BROKEN/DETERIORATED/MISSING TILES

Deficiency Location/Instance Near Seat A/109, Ramp Area.

Potential Action REPLACE

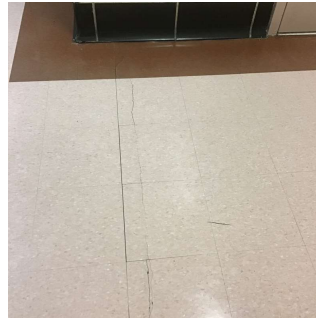
Corridor near Room 107

VINYL TILES: DETERIORATED SUBSTRATE

REPLACE

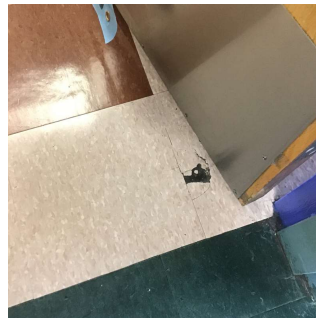
Room 428

VINYL TILES: BROKEN/DETERIORATED/MISSING TILES

REPLACE

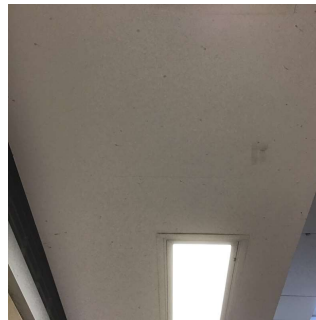
Deficiency	GYP SUM BOARD: DAMAGED/DETERIORATED
Deficiency Location/Instance	Serving Area
Deficiency Quantity	10
Quantity Uom	S.F.
Potential Action	REPLACE
Urgency of Action	PRIORITY 3
Purpose of Action	LEVEL 2
Deficiency Photo1
