NYC Department of Education
Building Condition Assessment Survey 2023 - 2024

Architectural Inspection

Asset: I.S. 238 - QUEENS, 88-15 182 STREET, New York, 11423

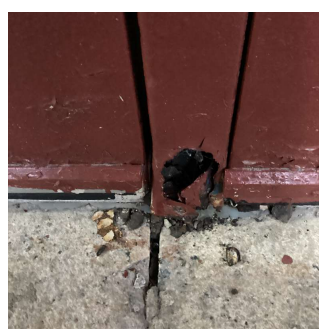
Question	Response
EXTERIOR	
AREAWAY	
Instance Quantity	2
Instance Quantity Uom	EACH
AWNINGS AND CANOPIES	Inspected
Condition	2 - Between Good and Fair
Deficiency	No deficiencies recorded
CHIMNEY	Under Construction
COPING	Under Construction
CORNICE	Does not Exist
DOORS	Inspected
DOORS AND FRAMES	Inspected
Condition	5 - Poor
Deficiency	METAL: DETERIORATED DOOR AND FRAME - MAJOR DETERIORATION
Roof Plan reference

Deficiency Quantity	8
Quantity Uom	EACH
Potential Action	REPLACE
Urgency of Action	PRIORITY 4
Purpose of Action	LEVEL 2
Deficiency Photo1

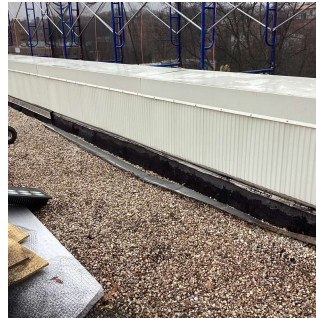
Roof 1
Instance Quantity	53,700
Instance Quantity Uom	S.F.
Does the roof have major mechanical equipment sitting on Dunnage Steel less than 18" above the Roofing?	Yes
Does this roof instance have a Sustainable Roof System?	No
Do solar panels exist on these roofs?	No
Is/Are the roof(s) suitable for Solar Panel installation?	Yes
Installation Year	2003
Source of Installation	Custodial Staff
Deficiency	BUILT-UP: FLASHING: CAP FLASHING DAMAGED

Deficiency Quantity	50
Quantity Uom	L.F.
Potential Action	REPLACE
Urgency of Action	PRIORITY 4
Purpose of Action	LEVEL 2

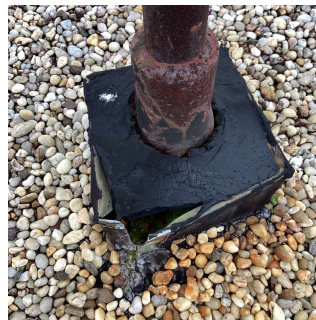
Roof 1

BUILT-UP: FLASHING: PITCH POCKET DETERIORATED - MAJOR

REPLACE

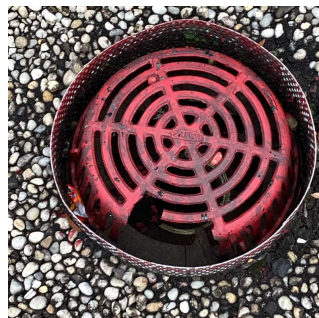
DETERIORATED

Deficiency Quantity	1
Quantity Uom	EACH
Potential Action	REPLACE
Urgency of Action	PRIORITY 4
Purpose of Action	LEVEL 2
Deficiency Photo1

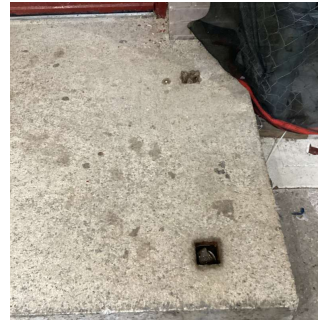
Facade C

MISSING RAILING

REPLACE

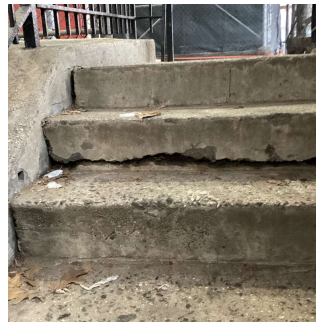
Facade C

CONCRETE: DETERIORATED SUBSTRATE

REPLACE SUBSTRATE AND RESET

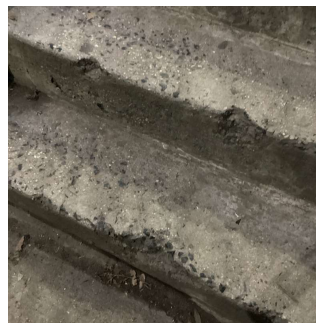
Facade C

CONCRETE: WORN-OUT TREAD/RISER/NOSING

REPLACE

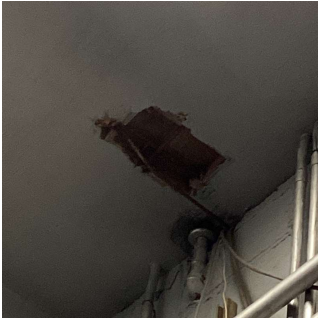
Violations	Facade A No violations recorded.
WINDOWS	Inspected
Replacement Quantity	11,000
Replacement Uom	S.F.
EXTERIOR GUARDS	Under Construction
LINTELS	Inaccessible
WINDOWS	Inspected
Material Type(s)	Aluminum
Instance on Aluminum - Other: All Facades	Under Construction
Instance Quantity	11,000
Instance Quantity Uom	S.F.
INTERIOR	Inspected
POOLS	Does not Exist
STRUCTURAL	Inspected
COLUMNS/BEAMS/BEARING WALLS	Inspected
Condition	2 - Between Good and Fair
Deficiency	No deficiencies recorded
FLOOR STRUCTURE	Inspected
Condition	2 - Between Good and Fair
Deficiency	CONCRETE: CRACKS/SPALLED/REINFORCEMENT EXPOSED
Deficiency Location/Instance	Basement - Electrical Panel Room

Question	Response
INTERIOR	
STRUCTURAL	
FLOOR STRUCTURE	
Deficiency Quantity	10
Quantity Uom	S.F.
Potential Action	REPAIR
Urgency of Action	PRIORITY 3
Purpose of Action	LEVEL 5
Deficiency Photo1

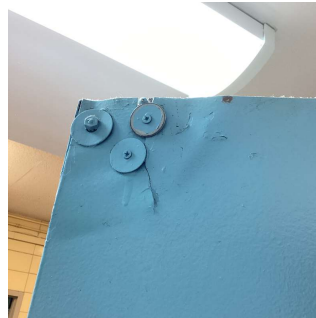
Lateral Entrance

METAL: DETERIORATED DOOR

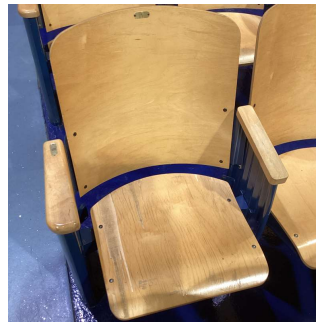
Seat B/1

DAMAGED/BROKEN/INOPERABLE

REPLACE

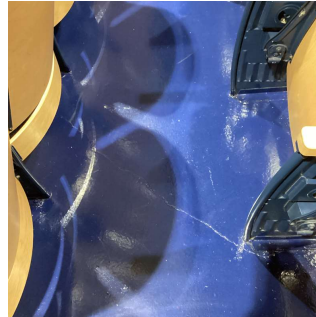
Near Seat N/21

CONCRETE: CRACKS

REPLACE

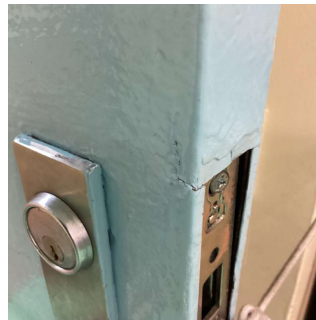
Room 255

METAL: DETERIORATED DOOR

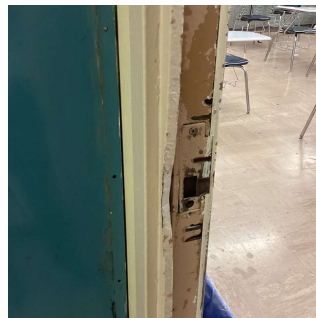
METAL: DETERIORATED DOOR AND FRAME

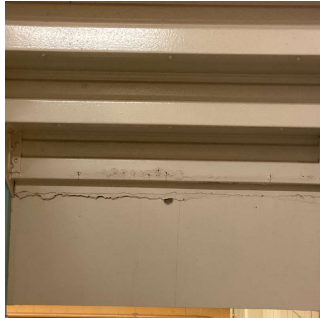
Priority Condition Exist Last Year?	Priority Category	Condition Description	Component Affected	Location Description	Person(s) Notified	Person(s) Title	PhotoImage
Yes	Potential Falling Debris	Severely rusted under underside of the Stair is a potential Safety Hazard.	INTERIOR STAIRS/RAMP S: INTERIOR Stairs and Landings	Stair , C/Ground Floor, 1, E/1	Kevin Fitzgerald	Custodian

Violations	Stair F/3 No violations recorded.
Stairs and Landings	
Condition	Inspected 2 - Between Good and Fair
Deficiency	METAL: RUST - MAJOR
Deficiency Location/Instance	Stair A/1
Deficiency Quantity	10
Quantity Uom	S.F.
Potential Action	REPLACE
Urgency of Action	PRIORITY 3
Purpose of Action	LEVEL 2
Deficiency Photo1
