NYC Department of Education
Building Condition Assessment Survey 2023 - 2024

Architectural Inspection

Asset: P.S. 242 - (ECC) - QUEENS, 29-66 137TH STREET, New York, 11354

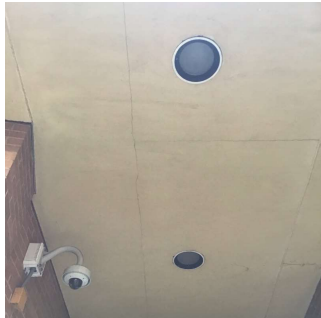
Question	Response
Architectural	
EXTERIOR	Inspected
AREAWAY	Does not Exist
AWNINGS AND CANOPIES	Inspected
Condition	3 - Fair
Deficiency	CONCRETE: MAJOR CRACKS/SPALLING
Roof Plan reference	
Deficiency Quantity	40
Quantity Uom	S.F.
Potential Action	REPAIR

Question	Response
EXTERIOR	
AWNINGS AND CANOPIES	
Urgency of Action	PRIORITY 4
Purpose of Action	LEVEL 2
Deficiency Photo1

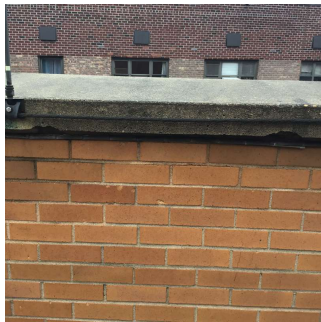
Violations	Facade A No violations recorded.
CHIMNEY	
Material Type(s)	Inspected Metal
Condition	2 - Between Good and Fair
Deficiency	No deficiencies recorded
COPING	
Condition	Inspected 3 - Fair
Deficiency	CAST STONE: CRACKED/BROKEN PIECES
Roof Plan reference	<p>Q242</p>

Deficiency Quantity	10
Quantity Uom	L.F.
Potential Action	REPLACE-IN-KIND
Urgency of Action	PRIORITY 4
Purpose of Action	LEVEL 2
Deficiency Photo1

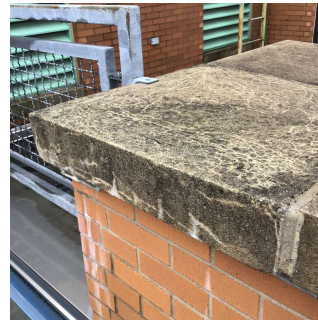
Roof 3

Violations	Roof 1 No violations recorded.
Deficiency	CAST STONE: DISINTEGRATING / FREEZE THAW

REPLACE-IN-KIND

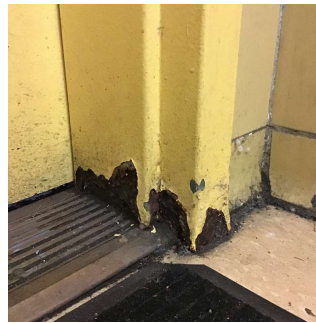
Exit D

METAL: DETERIORATED DOOR AND FRAME - MAJOR DETERIORATION

REPLACE

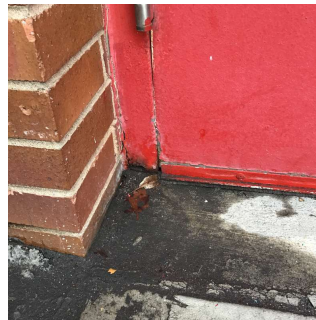
Facade B - Exit 4

METAL CLAD: DETERIORATED DOOR AND FRAME - MAJOR DETERIORATION

REPLACE

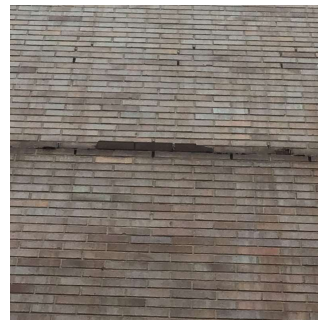
Elevation	 
Deficiency Quantity	20
Quantity Uom	S.F.
Potential Action	REMOVE AND REBUILD
Urgency of Action	PRIORITY 4
Purpose of Action	LEVEL 2
Deficiency Photo1	 
Violations	Facade C No violations recorded.
Deficiency	BRICK: MAJOR / THRU CRACKS

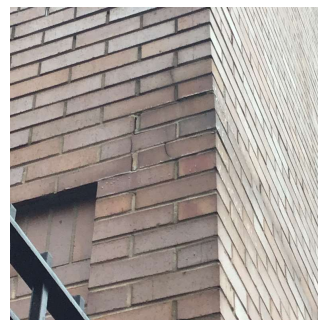
BRICK: CRACKS/DISPLACED/SPALLED BRICK AT BUILDING CORNERS

20
S.F.
REMOVE AND REBUILD
PRIORITY 4
LEVEL 2

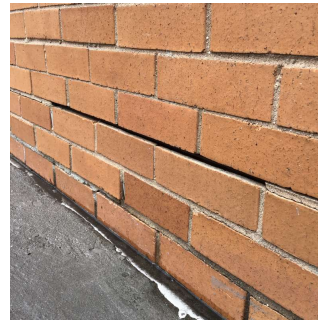
Facade B

BRICK: DETERIORATED JOINTS

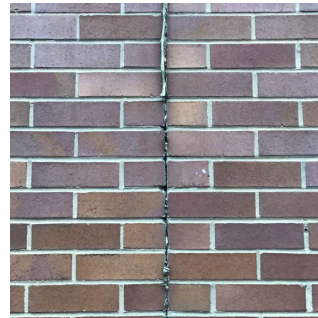
Facade C

BRICK: DETERIORATED CONTROL/EXPANSION JOINTS

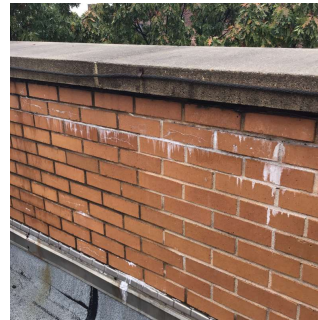
Roof 1
No violations recorded.

Deficiency BRICK: EFFLORESCENCE

40
S.F.
MAINTENANCE
PRIORITY 1
LEVEL 1

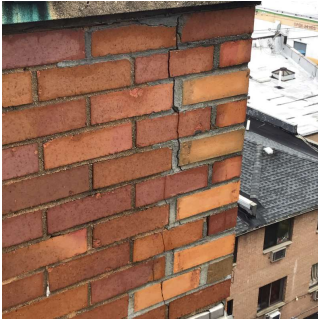
BRICK: MAJOR DETERIORATION/CRACKS

40
S.F.
REMOVE AND REBUILD
PRIORITY 4
LEVEL 2

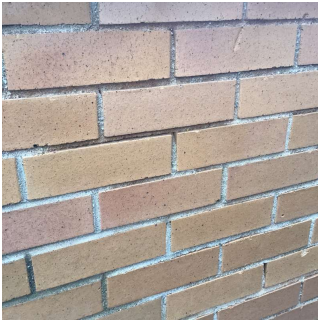
Violations	Roof 1 No violations recorded.
Deficiency	BRICK: DETERIORATED JOINTS
Roof Plan reference

Deficiency Quantity	40
Quantity Uom	S.F.
Potential Action	REPOINT
Urgency of Action	PRIORITY 3
Purpose of Action	LEVEL 2
Deficiency Photo1

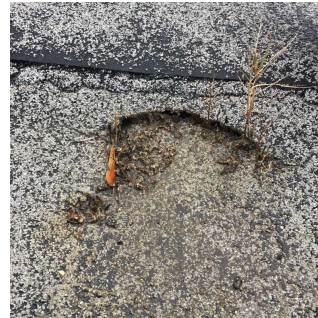
Roof 1
Instance Quantity	8,000
Instance Quantity Uom	S.F.
Does the roof have major mechanical equipment sitting on Dunnage Steel less than 18" above the Roofing?	Yes
Does this roof instance have a Sustainable Roof System?	No
Do solar panels exist on these roofs?	No
Is/Are the roof(s) suitable for Solar Panel installation?	No
Installation Year	2001
Source of Installation	Custodial Staff
Deficiency	MODIFIED BITUMEN: ROOFING: DELAMINATION
Roof Plan reference

Deficiency Quantity	20
Quantity Uom	S.F.
Potential Action	REPLACE ROOFING WITH MAJOR EQUIPMENT REMOVAL

Urgency of Action	PRIORITY 4
Purpose of Action	LEVEL 2

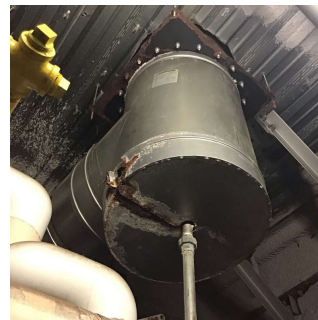
Roof 1 - Boiler Room, Fan Room

MODIFIED BITUMEN: ROOFING: MAJOR ACTIVE ROOF LEAKS IN NON-INSTRUCTIONAL SPACE

REPLACE ROOFING WITH MAJOR EQUIPMENT REMOVAL

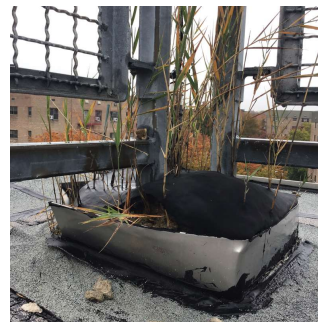
Roof 1
No violations recorded.

MODIFIED BITUMEN: FLASHING: PITCH POCKET DETERIORATED - MAJOR

70
EACH
REPLACE
PRIORITY 4
LEVEL 2

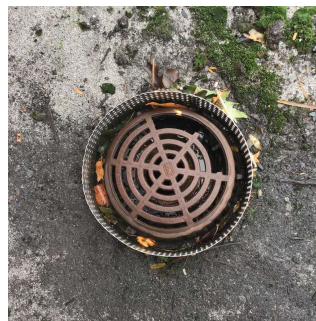
Roof 3

DETERIORATED

REPLACE

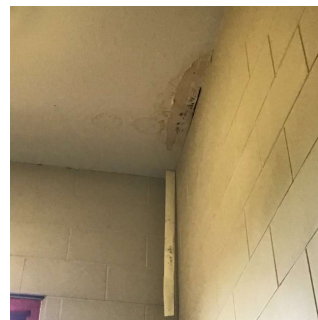
PH2
No violations recorded.

BULKHEAD/PENTHOUSE CEILING: GYPSUM BOARD DAMAGED/DETERIORATED

20
S.F.
REPLACE
PRIORITY 3
LEVEL 2

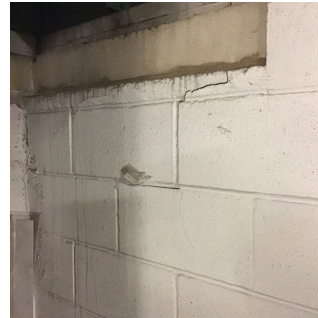
PH1

**BULKHEAD/PENTHOUSE WALLS/INTERIOR: CMU
CRACKS/SPALLING**

30
S.F.
REPLACE
PRIORITY 3
LEVEL 2

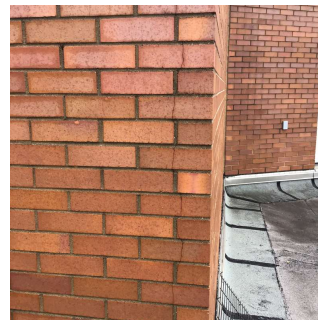
PH1

**BULKHEAD/PENTHOUSE WALLS/EXTERIOR:
CRACKS/SPALLING - MAJOR**

REPLACE

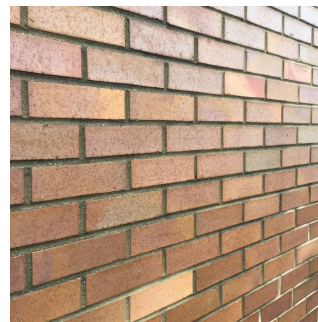
PH1
 No violations recorded.

**BULKHEAD/PENTHOUSE WALLS/EXTERIOR: DETERIORATED
JOINTS**

20
 S.F.
 REPOINT
 PRIORITY 3
 LEVEL 2

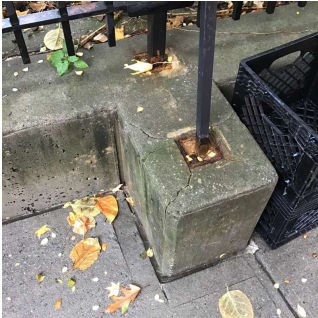
FENCES	Inspected
Condition	2 - Between Good and Fair
Deficiency	CONCRETE CURB: DAMAGED/DETERIORATED
Deficiency Location/Instance	31st Road, Rear of Building
Deficiency Quantity	20
Quantity Uom	S.F.
Potential Action	REPLACE
Urgency of Action	PRIORITY 3
Purpose of Action	LEVEL 2
Deficiency Photo1
