NYC Department of Education
Building Condition Assessment Survey 2023 - 2024

Architectural Inspection

Asset: P.S. 244 ECC (@ FRANKLIN AVE) - Q, 137-20 FRANKLIN AVE, New York, 11355

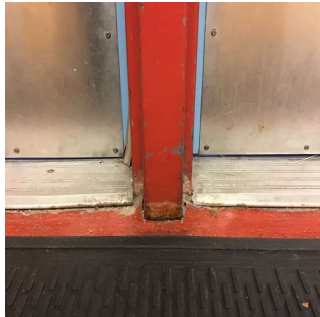
Question	Response
Architectural	
EXTERIOR	Inspected
AREAWAY	Does not Exist
AWNINGS AND CANOPIES	Inspected
Condition	2 - Between Good and Fair
Deficiency	No deficiencies recorded
CHIMNEY	Does not Exist
COPING	Inspected
Condition	2 - Between Good and Fair
Deficiency	No deficiencies recorded
CORNICE	Does not Exist
DOORS	Inspected
DOORS AND FRAMES	Inspected
Condition	3 - Fair
Deficiency	METAL: DETERIORATED DOOR AND FRAME - MINOR DETERIORATION
Roof Plan reference	Q244

Violations	Facade C - Exit 3 No violations recorded.
DOOR HARDWARE	Inspected
Condition	2 - Between Good and Fair
Deficiency	No deficiencies recorded
LINTELS	Inspected
Condition	2 - Between Good and Fair
Deficiency	No deficiencies recorded
TRANSOM/SIDE LIGHT	Inspected
Condition	2 - Between Good and Fair
Deficiency	No deficiencies recorded
EXTERIOR WALLS	Inspected
Material Type(s)	Masonry, Concrete
Replacement Quantity	19,000
Replacement Uom	S.F.
Instance on All Facades	Inspected
Instance Condition	2 - Between Good and Fair
Instance Quantity	19,000
Instance Quantity Uom	S.F.
Deficiency	BRICK: MINOR CRACKS AND SPALLING
Roof Plan reference	Q244

Deficiency Quantity
 Quantity Uom
 Potential Action
 Urgency of Action

2
 EACH
 MAINTENANCE
 PRIORITY 3

Question	Response
EXTERIOR	
DOORS	
DOORS AND FRAMES	
Purpose of Action	LEVEL 2
Deficiency Photo1

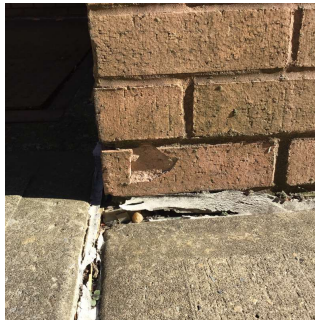
Facade D

CAST IN PLACE / PRE-CAST CONCRETE: DETERIORATED JOINTS

Deficiency Quantity

10

Potential Action

RESTITCH

Urgency of Action

PRIORITY 3

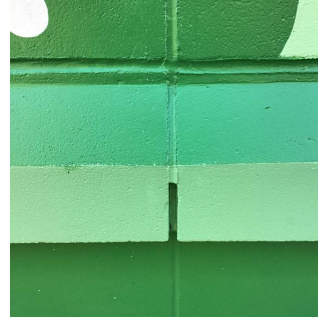
Facade A

BRICK: DETERIORATED MASONRY SILLS - MINOR

Potential Action
 Urgency of Action
 Purpose of Action
 Deficiency Photo1

REPOINT
 PRIORITY 3
 LEVEL 2

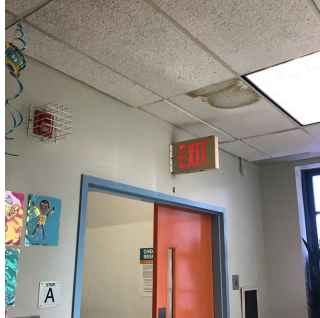
Question	Response
EXTERIOR	
ROOF	
Roofing	
LEADERS, GUTTERS, DOWNSPOUTS, SCUPPERS	
Deficiency Photo1	 
Violations	Facade B No violations recorded.
ROOF BARRIER/FENCE	Inspected
Condition	2 - Between Good and Fair
Deficiency	No deficiencies recorded
ROOF CAGE	Does not Exist
ROOFING	Inspected
Instance on IRMA: Roofs 1, 2	Inspected
Instance Condition	3 - Fair
Instance Photo	 
	Roof 1
Instance Quantity	9,000
Instance Quantity Uom	S.F.
Does the roof have major mechanical equipment sitting on Dunnage Steel less than 18" above the Roofing?	No
Does this roof instance have a Sustainable Roof System?	No
Do solar panels exist on these roofs?	No
Is/Are the roof(s) suitable for Solar Panel installation?	No
Installation Year	2008
Source of Installation	Custodial Staff
Deficiency	IRMA: ROOFING: MINOR LEAKAGE
Roof Plan reference	Q244

<p>Roof 1 - Corridor near Stair A/4 No violations recorded.</p>
Violations	
Instance on Metal: Roofs 3, 4	Inspected
Instance Condition	3 - Fair
Instance Photo

Question	Response
EXTERIOR	
ROOF	
Roofing	
ROOFING	
Potential Action	REPAIR
Urgency of Action	PRIORITY 5
Purpose of Action	LEVEL 2
Deficiency Photo1

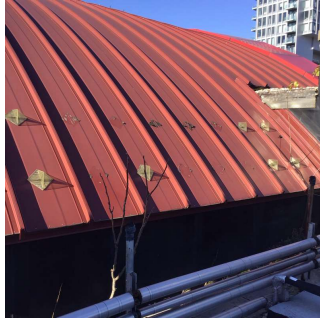
<p>Roof 3</p>
Instance Quantity	3,000
Instance Quantity Uom	S.F.
Does the roof have major mechanical equipment sitting on Dunnage Steel less than 18" above the Roofing?	No
Does this roof instance have a Sustainable Roof System?	No
Do solar panels exist on these roofs?	No
Is/Are the roof(s) suitable for Solar Panel installation?	No
Installation Year	2008
Source of Installation	Custodial Staff
Deficiency	METAL: ROOFING: DAMAGED OR MISSING SNOW GUARDS
Roof Plan reference	<p>Q244</p>

Roof 3
Violations	No violations recorded.
ROOFING DRAINS	Inspected
Condition	2 - Between Good and Fair
Deficiency	No deficiencies recorded
Specialties	Inspected
BULKHEAD/PENTHOUSE	Inspected
Condition	2 - Between Good and Fair
Deficiency	BULKHEAD/PENTHOUSE WALLS/INTERIOR: GYPSUM BOARD DAMAGED/DETERIORATED
Roof Plan reference	Q244

Deficiency Quantity	20
Quantity Uom	L.F.
Potential Action	REPLACE
Urgency of Action	PRIORITY 4

Question	Response
EXTERIOR	
ROOF	
Roofing	
ROOFING	
Purpose of Action	LEVEL 2
Deficiency Photo1

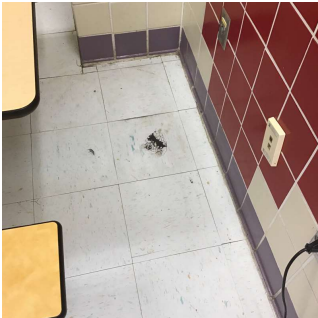
Instance on Basement	Inspected
Condition	2 - Between Good and Fair
Deficiency	No deficiencies recorded
Fixed Equipment	
Instance on Basement	Does not Exist
Floor Finish	
Instance on Basement	Inspected
Condition	2 - Between Good and Fair
Deficiency	VINYL TILES: BROKEN/DETERIORATED/MISSING TILES
Deficiency Location/Instance	Left Side

Question	Response
INTERIOR	
CAFETERIA	
Floor Finish	
Deficiency Quantity	10
Quantity Uom	S.F.
Potential Action	REPLACE
Urgency of Action	PRIORITY 3
Purpose of Action	LEVEL 2
Deficiency Photo1

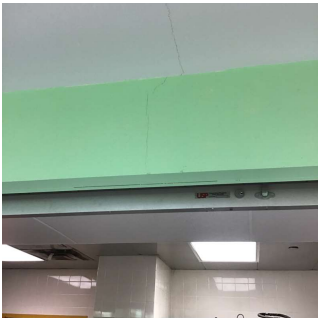
Near Servery
Violations	No violations recorded.
Window Curtains/Shades/Blinds	
Instance on Basement	Does not Exist
CLASSROOMS/CORRIDORS/ADMIN SPACES	
Ceiling	
Condition	2 - Between Good and Fair
Deficiency	ACOUSTIC TILES: DAMAGED/MISSING - ACTIVE LEAK

Left Side
Violations	No violations recorded.
Sliding-folding Partition	
Instance on Basement	Does not Exist
Stage	
Instance on Basement	Does not Exist
Walls	
Instance on Basement	Inspected
Condition	2 - Between Good and Fair
Deficiency	GYPSUM BOARD: DETERIORATED
Deficiency Location/Instance	Near Servery
Deficiency Quantity	10
Quantity Uom	S.F.
Potential Action	REPLACE
Urgency of Action	PRIORITY 3
Purpose of Action	LEVEL 2
Deficiency Photo1

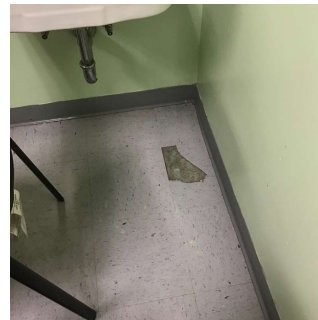
Room 107C

VINYL TILES: BROKEN/DETERIORATED/MISSING TILES

Potential Action

REPLACE

Urgency of Action

PRIORITY 3

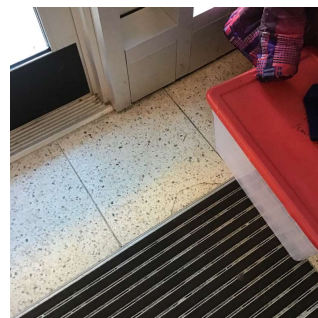
CERAMIC TILE: BROKEN/MISSING TILES

Main Entrance Lobby

Question	Response
INTERIOR	
CLASSROOMS/CORRIDORS/ADMIN SPACES	
Floor Finish	Inspected
	Main Entrance Lobby
Violations	No violations recorded.
Walls	Inspected
Condition	2 - Between Good and Fair
Deficiency	GYPSUM BOARD: DETERIORATED
Deficiency Location/Instance	Rooms 102C, 107B, Main Entrance
Deficiency Quantity	30
Quantity Uom	S.F.
Potential Action	REPLACE
Urgency of Action	PRIORITY 3
Purpose of Action	LEVEL 2
Deficiency Photo1

Potential Action

REPLACE

Urgency of Action

PRIORITY 3

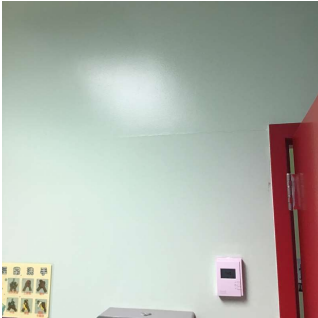
Violations	Room 102C No violations recorded.
Specialties	Does not Exist
GYMNASIUM	Does not Exist
INTERIOR DOOR HARDWARE	Inspected
Condition	2 - Between Good and Fair
Deficiency	No deficiencies recorded
INTERIOR GUARDS	Inspected
Condition	2 - Between Good and Fair
Deficiency	No deficiencies recorded
KITCHEN	Inspected
Instance on Basement	Inspected
Ceiling	
Instance on Basement	Inspected
Condition	2 - Between Good and Fair
Deficiency	METAL PAN: DAMAGED/MISSING
Deficiency Location/Instance	Near sinks

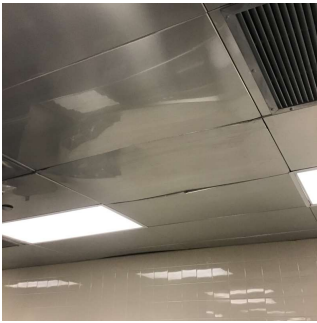
Violations	Near sinks No violations recorded.
Door(s)	
Instance on Basement	Inspected
Condition	2 - Between Good and Fair
Deficiency	No deficiencies recorded
Floor Finish	
Instance on Basement	Inspected
Condition	2 - Between Good and Fair
Deficiency	No deficiencies recorded
Walls	
Instance on Basement	Inspected
Condition	2 - Between Good and Fair
Deficiency	GYPSON BOARD: DETERIORATED
Deficiency Location/Instance	Left Side
Deficiency Quantity	10
Quantity Uom	S.F.
Potential Action	REPLACE
Urgency of Action	PRIORITY 3
Purpose of Action	LEVEL 2
Deficiency Photo1	 
Violations	Office No violations recorded.
LIBRARY	
Instance on Room 408	Inspected
Built-in Furnishing	
Instance on Room 408	Does not Exist
Ceiling	
Instance on Room 408	Inspected
Condition	3 - Fair

Deficiency Quantity	10
Quantity Uom	S.F.
Potential Action	REPLACE
Urgency of Action	PRIORITY 3
Purpose of Action	LEVEL 2

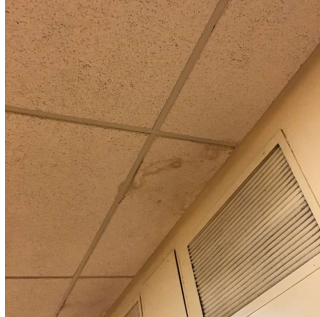
Question	Response
INTERIOR	
LIBRARY	
Floor Finish	
Potential Action	REPLACE
Urgency of Action	PRIORITY 3
Purpose of Action	LEVEL 2
Deficiency Photo1	 
	Left Side
Violations	No violations recorded.
Walls	
Instance on Room 408	Inspected
Condition	2 - Between Good and Fair
Deficiency	GYPSUM BOARD: DETERIORATED
Deficiency Location/Instance	Near Entrance
Deficiency Quantity	20
Quantity Uom	S.F.
Potential Action	REPLACE
Urgency of Action	PRIORITY 3
Purpose of Action	LEVEL 2
Deficiency Photo1	 
	Near Entrance
Violations	No violations recorded.
LOCKER ROOM	
	Does not Exist
MULTI-PURPOSE ROOM	
	Inspected
Instance on 1st Floor	Inspected
Ceiling	
Instance on 1st Floor	Inspected
Condition	2 - Between Good and Fair
Deficiency	ACOUSTIC TILES: DAMAGED/MISSING
Deficiency Location/Instance	Near Entrance, Near Toilet Room
Deficiency Quantity	20
Quantity Uom	S.F.
Potential Action	REPLACE
Urgency of Action	PRIORITY 3

Near Entrance
Violations	No violations recorded.
Door(s)	
Instance on 1st Floor	Inspected
Condition	2 - Between Good and Fair
Deficiency	No deficiencies recorded
Fixed Equipment	
Instance on 1st Floor	Does not Exist
Floor Finish	
Instance on 1st Floor	Inspected
Condition	2 - Between Good and Fair
Deficiency	No deficiencies recorded
Sliding-folding Partition	
Instance on 1st Floor	Does not Exist
Stage	
Instance on 1st Floor	Inspected
Stage	
Instance on 1st Floor	Inspected
Condition	2 - Between Good and Fair
Deficiency	No deficiencies recorded
Stage Curtain Rigging	
Instance on 1st Floor	Inspected
Condition	5 - Poor
Deficiency	INOPERABLE
Deficiency Location/Instance	Center
Deficiency Quantity	1
Quantity Uom	EACH
Potential Action	MAINTENANCE
Urgency of Action	PRIORITY 3
Purpose of Action	LEVEL 2
Deficiency Photo1	No photo recorded

Question	Response
INTERIOR	
MULTI-PURPOSE ROOM	
Ceiling	
Purpose of Action	LEVEL 2
Deficiency Photo1

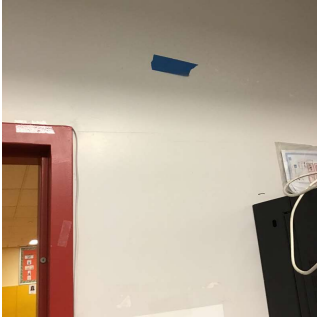
Question	Response
INTERIOR	
MULTI-PURPOSE ROOM	
Stage	
Stage Curtains	
Deficiency Quantity	100
Quantity Uom	S.F.
Potential Action	REPLACE
Urgency of Action	PRIORITY 3
Purpose of Action	LEVEL 2
Deficiency Photo1	 
	Left Side
Violations	No violations recorded.
Walls	
Instance on 1st Floor	Inspected
Condition	2 - Between Good and Fair
Deficiency	GYPSUM BOARD: DETERIORATED
Deficiency Location/Instance	Office
Deficiency Quantity	10
Quantity Uom	S.F.
Potential Action	REPLACE
Urgency of Action	PRIORITY 3
Purpose of Action	LEVEL 2
Deficiency Photo1

Office
Violations	No violations recorded.
Deficiency	WALL PADDING: DETERIORATED
Deficiency Location/Instance	Near Windows, Near Entrance, Left Side
Deficiency Quantity	60
Quantity Uom	S.F.
Potential Action	REPLACE
Urgency of Action	PRIORITY 3
Purpose of Action	LEVEL 2

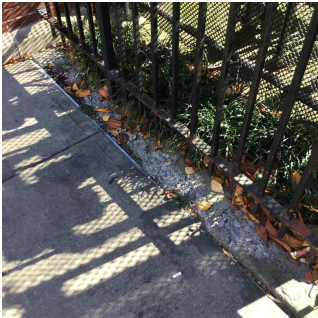
Franklin Avenue
Violations	No violations recorded.

Culverts - Soil Covering	Does not Exist
DRINKING FOUNTAINS	Does not Exist
FENCES	Inspected
Condition	3 - Fair
Deficiency	CONCRETE CURB: DAMAGED/DETERIORATED
Deficiency Location/Instance	Franklin Avenue
Deficiency Quantity	20
Quantity Uom	S.F.
Potential Action	REPLACE
Urgency of Action	PRIORITY 3
Purpose of Action	LEVEL 2
Deficiency Photo1

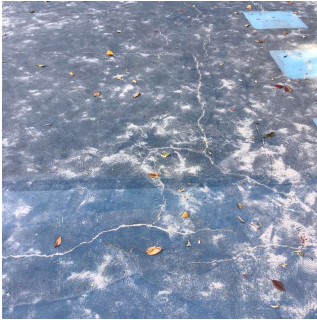
Question	Response
SITE	
PAVING	
Student Use	
Asphalt	
Condition	3 - Fair
Deficiency	CRACKS - MAJOR
Deficiency Location/Instance	Schoolyard
Deficiency Quantity	450
Quantity Uom	S.F.
Potential Action	REPLACE
Urgency of Action	PRIORITY 3
Purpose of Action	LEVEL 2
Deficiency Photo1

Schoolyard
Violations	No violations recorded.
Concrete	Inspected
Condition	2 - Between Good and Fair
Deficiency	No deficiencies recorded
Pavers	Does not Exist
Site Sidewalks & Walkways	Inspected
Asphalt	Does not Exist
Concrete	Inspected
Condition	3 - Fair
Deficiency	HEAVING
Deficiency Location/Instance	Franklin Avenue
Deficiency Quantity	25
Quantity Uom	S.F.
Potential Action	REPLACE
Urgency of Action	PRIORITY 3
Purpose of Action	LEVEL 2
Deficiency Photo1

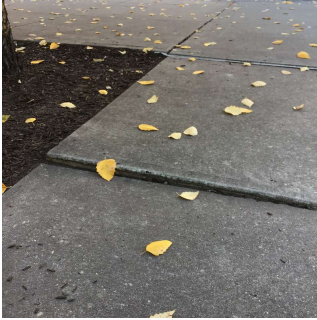
Franklin Avenue
Violations	No violations recorded.
Deficiency	CRACKS - MAJOR

Question	Response
SITE	
PAVING	
Site Sidewalks & Walkways	
Concrete	
Deficiency Location/Instance	Franklin Avenue, rear of Building
Deficiency Quantity	50
Quantity Uom	S.F.
Potential Action	REPLACE
Urgency of Action	PRIORITY 3
Purpose of Action	LEVEL 2
Deficiency Photo1	 
Violations	Franklin Avenue No violations recorded.
Pavers	Does not Exist
DOT Sidewalk	Inspected
Asphalt	Does not Exist
Concrete	Inspected
Condition	3 - Fair
Deficiency	DAMAGED/DETERIORATED/MISSING SECTIONS
Deficiency Location/Instance	Franklin Avenue
Deficiency Quantity	175
Quantity Uom	S.F.
Potential Action	REPLACE
Urgency of Action	PRIORITY 3
Purpose of Action	LEVEL 2
Deficiency Photo1	 
Violations	Franklin Avenue No violations recorded.
Deficiency	DAMAGED CURBS
Deficiency Location/Instance	Franklin Avenue
Deficiency Quantity	30
Quantity Uom	L.F.
Potential Action	REPLACE
Urgency of Action	PRIORITY 3

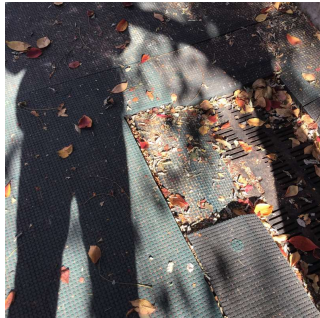
Question	Response
SITE	
PLAYGROUNDS	
Safety Surfacing	
Deficiency	DETERIORATED/MISSING
Deficiency Location/Instance	Right Side
Deficiency Quantity	10
Quantity Uom	S.F.
Potential Action	REPLACE
Urgency of Action	PRIORITY 3
Purpose of Action	LEVEL 2
Deficiency Photo1

Violations	Right Side No violations recorded.
Unpaved Area	
Instance on Schoolyard	Does not Exist
PLAYING SURFACE	
	Does not Exist
RETAINING WALLS	
Are there any Retaining Walls 6' OR higher facing public street/sidewalk?	Inspected No
Condition	3 - Fair
Deficiency	CAST IN PLACE CONCRETE: DETERIORATED CONTROL/EXPANSION JOINT
Deficiency Location/Instance	Schoolyard
Deficiency Quantity	40
Quantity Uom	L.F.
Potential Action	REPLACE
Urgency of Action	PRIORITY 3
Purpose of Action	LEVEL 2
Deficiency Photo1

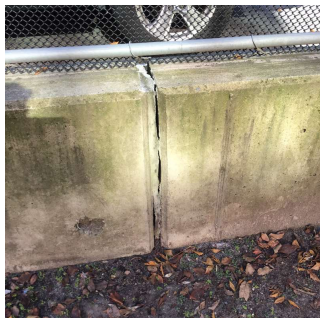
Violations	Schoolyard No violations recorded.
SEATING	
	Inspected
Benches	
	Inspected
Concrete	
	Does not Exist
