NYC Department of Education
Building Condition Assessment Survey 2023 - 2024

Architectural Inspection

Asset: P.S. 245 ECC (@ SENECA AVE) - Q, 378 SENECA AVE, New York, 11385

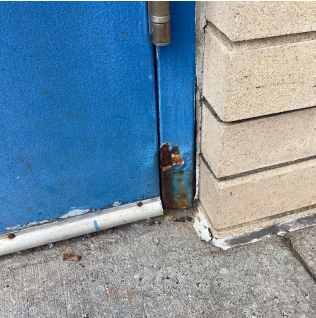
Question	Response
EXTERIOR	
COPING	Inspected
Condition	2 - Between Good and Fair
Deficiency	No deficiencies recorded
CORNICE	Does not Exist
DOORS	Inspected
DOORS AND FRAMES	Inspected
Condition	5 - Poor
Deficiency	METAL: DETERIORATED DOOR AND FRAME - MAJOR DETERIORATION
Roof Plan reference	<div style="text-align: right;">

</div>
Deficiency Quantity	4
Quantity Uom	EACH
Potential Action	REPLACE
Urgency of Action	PRIORITY 4
Purpose of Action	LEVEL 2
Deficiency Photo1

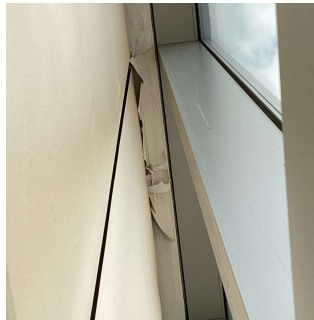
Facade F - Library

METAL/GLASS CURT WALL: WATER INFILTRATION IN INSTRUCTIONAL SPACE

REPAIR

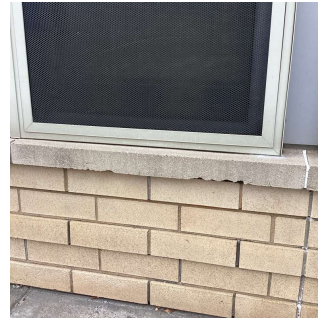
Facade A

BRICK: DETERIORATED MASONRY SILLS - MINOR

REPAIR

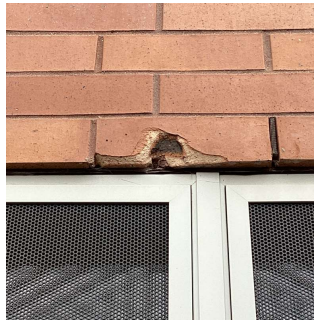
Facade C

BRICK: MAJOR / THRU CRACKS

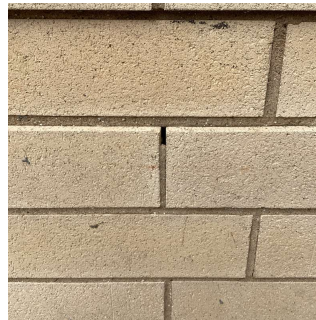
Facade D

BRICK: DETERIORATED JOINTS

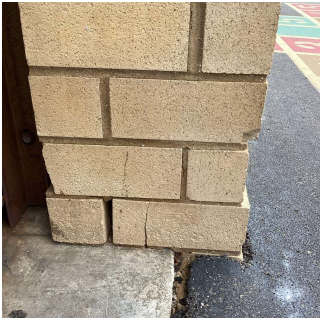
BRICK: MINOR CRACKS AND SPALLING

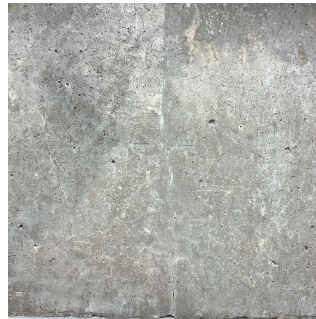
Roof 1

CONCRETE: MINOR CRACKS, SPALLING

REPAIR

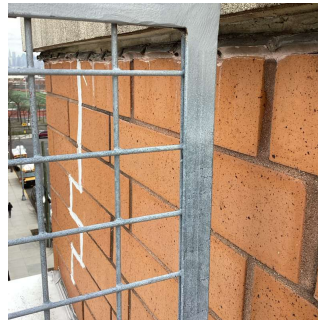
Roof 1

BRICK: DETERIORATED JOINTS

10
S.F.
REPOINT
PRIORITY 3
LEVEL 2

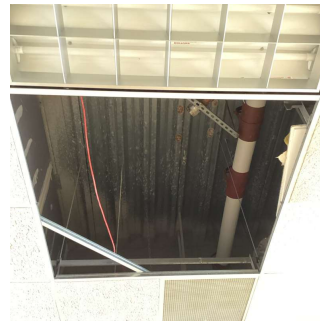
Is/Are the roof(s) suitable for Solar Panel installation?	No
Installation Year	2008
Source of Installation	Custodial Staff
Deficiency	IRMA: ROOFING: MAJOR ACTIVE ROOF LEAKS IN INSTRUCTIONAL SPACE

Roof 1 - Room 301 shown, Roof 1 - Room 305 similar
No violations recorded.

REPLACE ROOFING WITHOUT MAJOR EQUIPMENT
REMOVAL

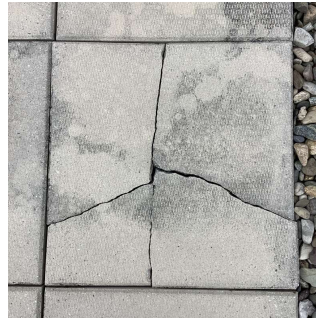
Roof 1

IRMA: ROOFING: DETERIORATED PAVERS WITH INTEGRAL
INSULATION

REPLACE

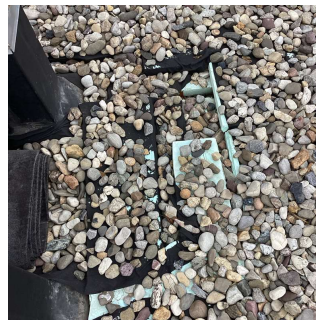
Roof 1

IRMA: ROOFING: DAMAGED INSULATION

REPLACE

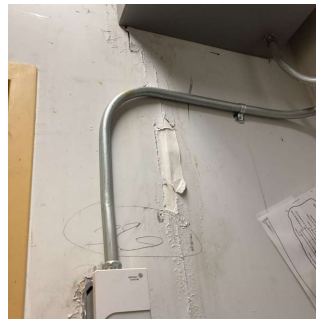
IRMA: ROOFING: MAJOR ACTIVE ROOF LEAKS IN NON-INSTRUCTIONAL SPACE

Roof 1 - Room 307
 No violations recorded.

100
 S.F.
 REPLACE ROOFING WITHOUT MAJOR EQUIPMENT
 REMOVAL
 PRIORITY 5
 LEVEL 2

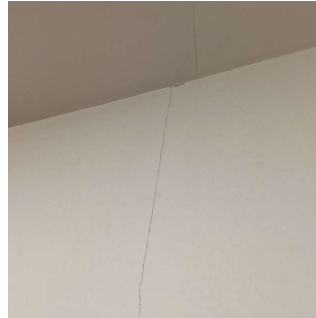
BH
No violations recorded.

BULKHEAD/PENTHOUSE WALLS/INTERIOR: GYPSUM
 BOARD DAMAGED/DETERIORATED

REPLACE
PRIORITY 3
LEVEL 2

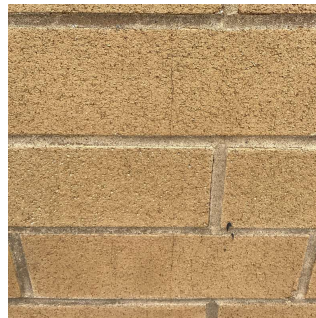
BH
No violations recorded.

BULKHEAD/PENTHOUSE WALLS/EXTERIOR:
CRACKS/SPALLING - MINOR

30
S.F.
REPAIR
PRIORITY 3
LEVEL 2

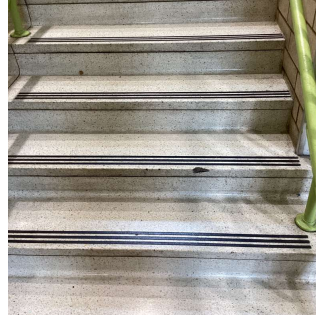
Deficiency	No deficiencies recorded
Stairs and Landings	Inspected
Condition	2 - Between Good and Fair
Deficiency	TERRAZZO: CRACKS
Deficiency Location/Instance	Main Entrance Lobby
Deficiency Quantity	10
Quantity Uom	S.F.
Potential Action	REPLACE

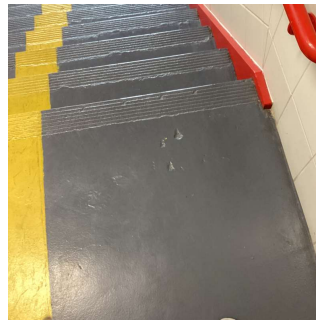
CONCRETE: CRACKS/SPALLING - MAJOR
Stair B/1
25
S.F.
REPLACE
PRIORITY 3
LEVEL 2

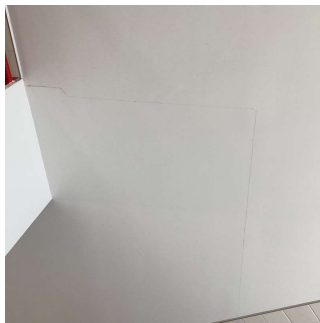
Inspected
3 - Fair
GYPSUM BOARD: DETERIORATED
Stairs A/3, 2, 1, B/3, 2 and others
250
S.F.
REPLACE
PRIORITY 3
LEVEL 2

Violations	Stair B/2 No violations recorded.
TOILET ROOMS - STAFF	Inspected
Ceiling	Inspected
Condition	2 - Between Good and Fair
Deficiency	No deficiencies recorded
Door(s)	Inspected
Condition	2 - Between Good and Fair
Deficiency	No deficiencies recorded
Floor Finish	Inspected
Condition	2 - Between Good and Fair
Deficiency	CERAMIC TILE: BROKEN/MISSING TILES
Deficiency Location/Instance	Room 310
Deficiency Quantity	10
Quantity Uom	S.F.
Potential Action	REPLACE
Urgency of Action	PRIORITY 3
Purpose of Action	LEVEL 2
Deficiency Photo1

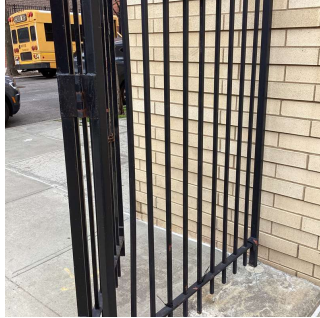
Violations	Stockholm Street No violations recorded.
Deficiency	CONCRETE CURB: DAMAGED/DETERIORATED
Deficiency Location/Instance	Stockholm Street
Deficiency Quantity	10
Quantity Uom	S.F.
Potential Action	REPLACE
Urgency of Action	PRIORITY 3
Purpose of Action	LEVEL 2
Deficiency Photo1

Question	Response
SITE	
FENCES	
Quantity Uom	S.F.
Potential Action	REPLACE
Urgency of Action	PRIORITY 3
Purpose of Action	LEVEL 2
Deficiency Photo1

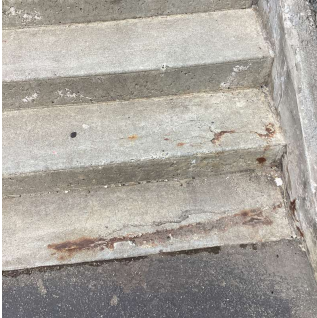
Question	Response
SITE	
STAIRS/RAMPS: EXTERIOR	
Stairs/ramps	Inspected
Condition	2 - Between Good and Fair
Deficiency	CAST IN PLACE CONCRETE: CRACKS/SPALLING - MAJOR
Deficiency Location/Instance	Stockholm Street
Deficiency Quantity	20
Quantity Uom	S.F.
Potential Action	REPLACE
Urgency of Action	PRIORITY 3
Purpose of Action	LEVEL 2
Deficiency Photo1

Violations	Stockholm Street No violations recorded.
Deficiency	CAST IN PLACE CONCRETE: CRACKS/SPALLING - MAJOR
Deficiency Location/Instance	Stockholm Street
Deficiency Quantity	25
Quantity Uom	S.F.
Potential Action	REPLACE
Urgency of Action	PRIORITY 5
Purpose of Action	LEVEL 6
Deficiency Photo1
